# the play inspection company

## Annual Inspection

Carlton Parish Council

Toddlers Play Area

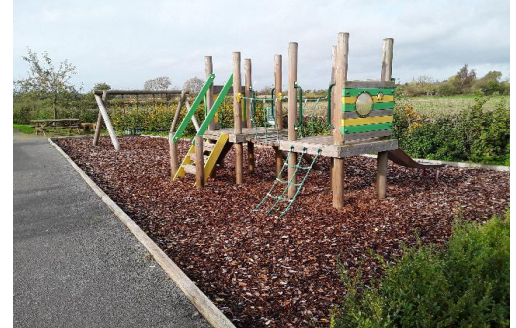
There is algae, silt or moss growth on the compacted surface resulting in slippery conditions - Clean and treat appropriately

There are trip hazards present over the bark pit edgings - Remove the trip points

There are some particles present within the surface that comprise of long, shard like pieces and carry some risk of puncture injuries - We would recommend that any long, shard like pieces are hand picked and removed from the area as they appear

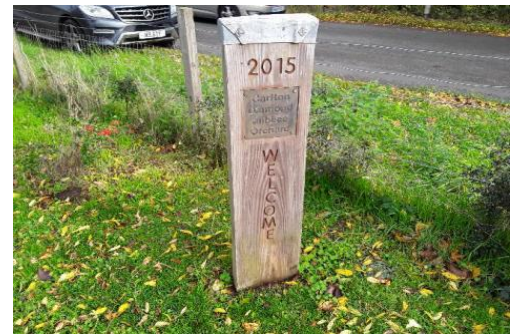
Lead flashing has been used to form a cap on the top of the sign - Refer to the supplier for a toxicology assessment

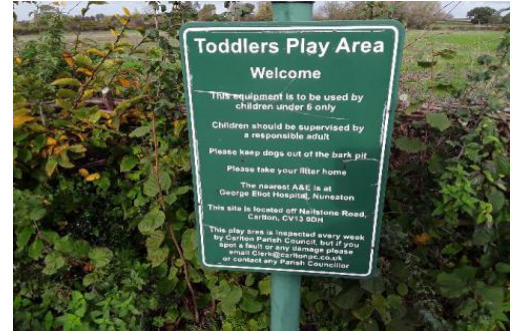
BS EN 1176 Part 7 recommends that signage shall include the site name / address - Provide additional information

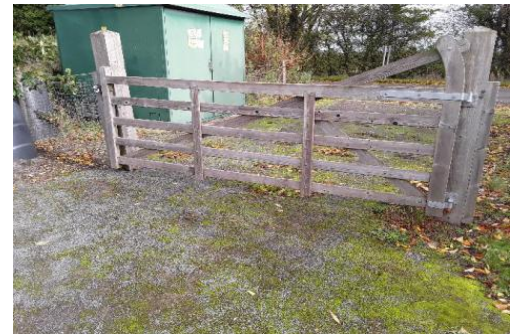
There are projecting bolt thread(s) present - Remove excess thread length and deburr or provide cap

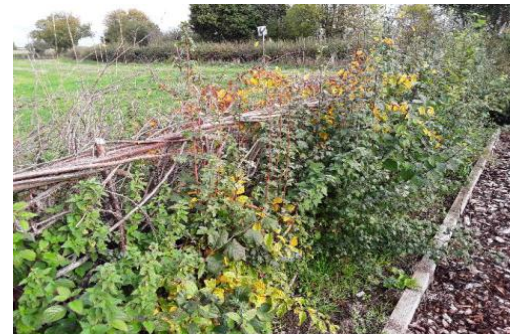
There are nettles growing through the hedge - Remove the nettles

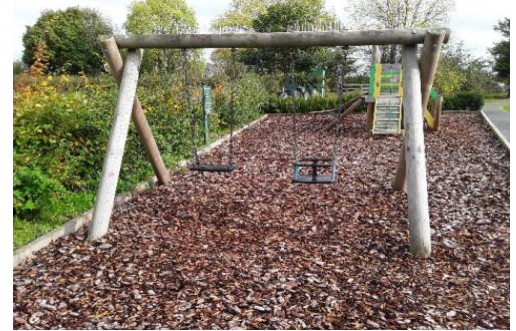
There are sharp bird deterrents on the crossbar - Replace with soft deterrents or cable ties

The timber has a number of splits/shakes or air cracks and this may affect the stability or allow water ingress which will accelerate the rotting process - Monitor to ensure the splits do not cross through fixing points of the structure and/or cause any instability

There is some notable evidence of chain wear - Monitor for any further deterioration and replace when 40% worn

There is some wear to the shackles. - Monitor for any further deterioration and replace when 40% worn

The chain openings are in excess of the 8.6mm as recommended by BS EN 1176 - Monitor - No remedial work recommended

The swing seat frames are corroding - Monitor for any further deterioration and replace as required

The bushes are worn or missing - Replace worn or missing bushes

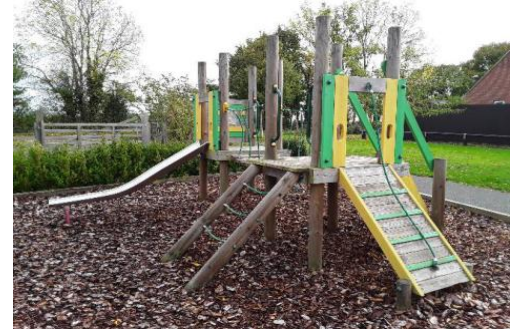
The item fails to meet the requirements of BS EN 1176 Part 1 4.2.7.2 head and neck entrapment in the barriers and/or steps - Monitor - No remedial work recommended

The timber has a number of splits/shakes or air cracks and this may affect the stability or allow water ingress which will accelerate the rotting process - Monitor to ensure the splits do not cross through fixing points of the structure and/or cause any instability

The edging forms a hard object within the impact area of the equipment in contravention of the requirements of BS EN 1176 Part 1 - Monitor - No remedial work recommended

There is/are finger entrapment/s in the structure and the item fails to meet the requirements of BS EN 1176 Part 1 4.2.7.6 Entrapment of fingers - Monitor - No remedial work recommended

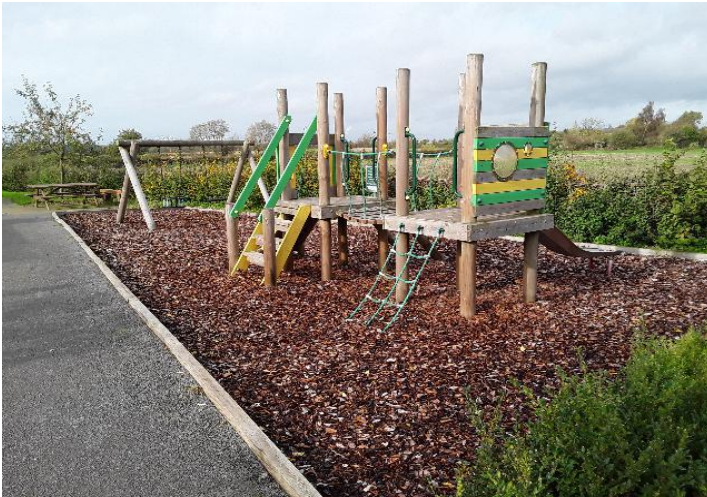
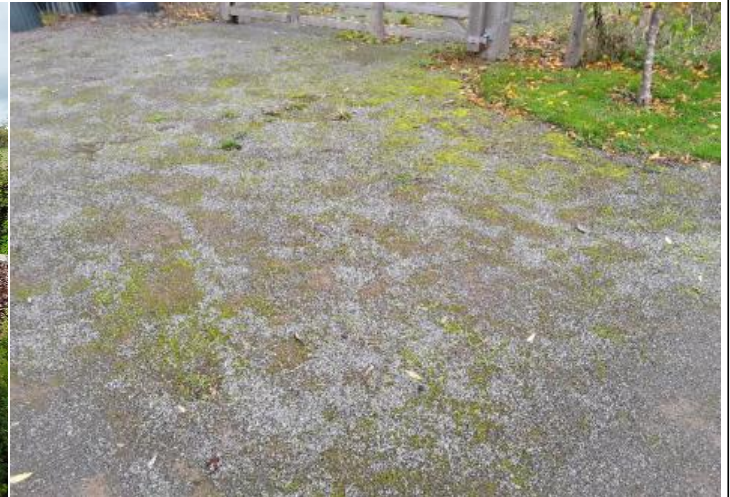
**i** 8 - Low Risk (Finding 1)

**Finding:** There is algae, silt or moss growth on the compacted surface resulting in slippery conditions

**Action:** Clean and treat appropriately

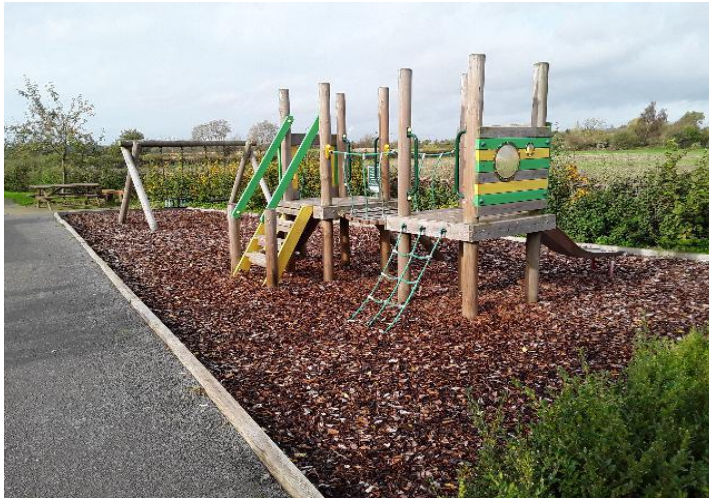
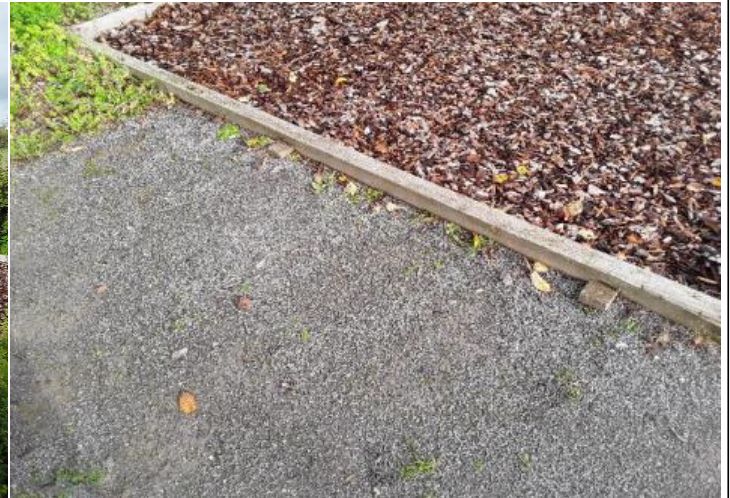
**i** 8 - Low Risk (Finding 2)

**Finding:** There are trip hazards present over the bark pit edgings

**Action:** Remove the trip points

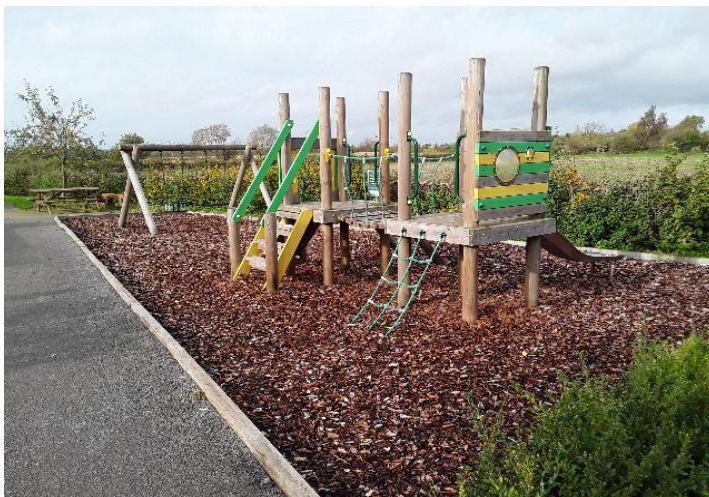
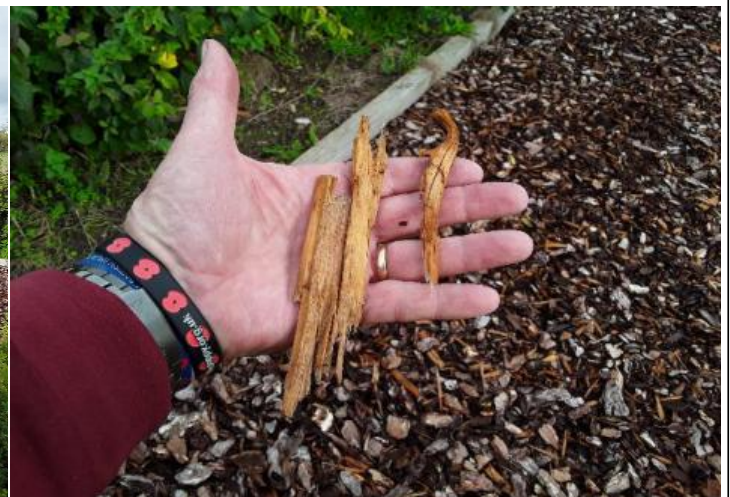
**i** 8 - Low Risk (Finding 3)

**Finding:** There are some particles present within the surface that comprise of long, shard like pieces and carry some risk of puncture injuries

**Action:** We would recommend that any long, shard like pieces are hand picked and removed from the area as they appear

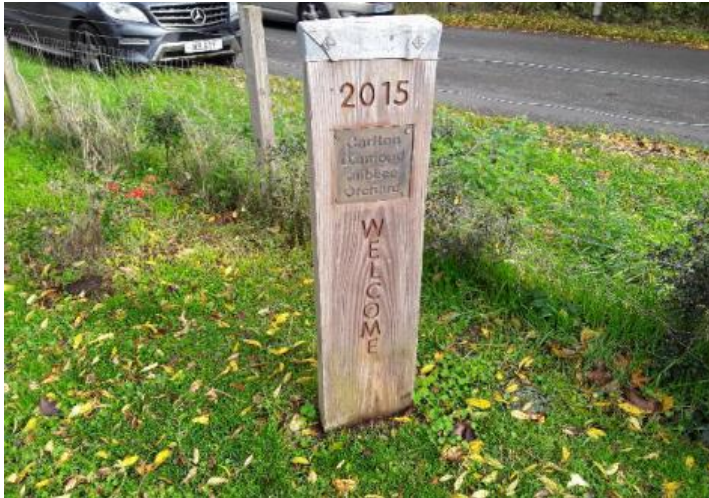
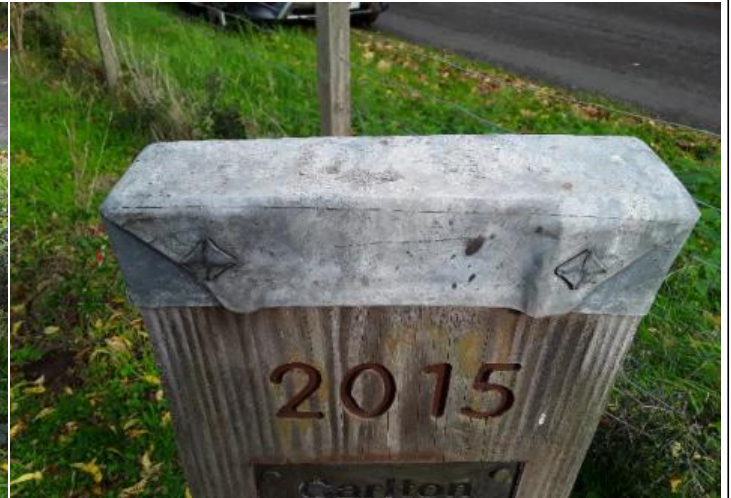
**i** 0 - Risk Assessment not Undertaken (Finding 1)

**Finding:** Lead flashing has been used to form a cap on the top of the sign

**Action:** Refer to the supplier for a toxicology assessment

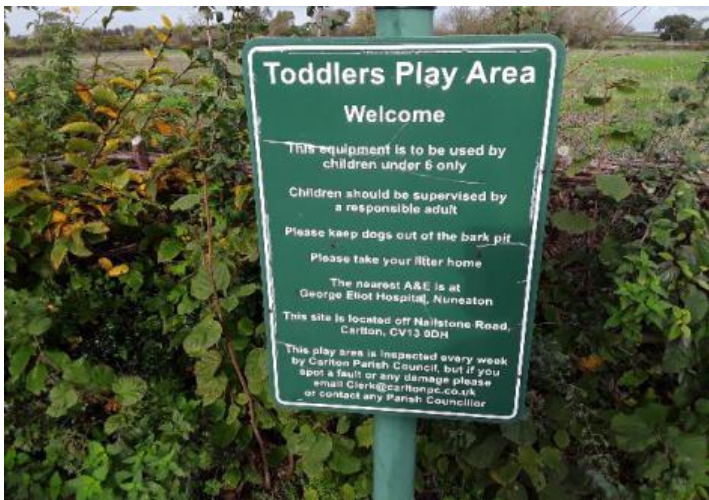
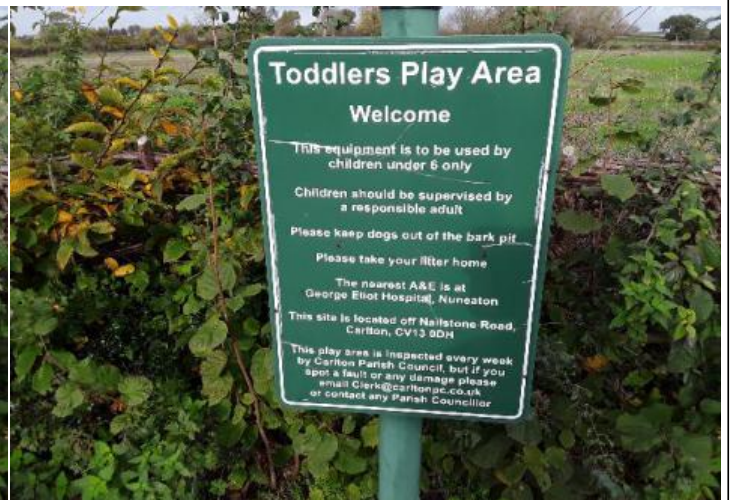
**i** 5 - Very Low Risk (Finding 1)

**Finding:** BS EN 1176 Part 7 recommends that signage shall include the site name / address

**Action:** Provide additional information

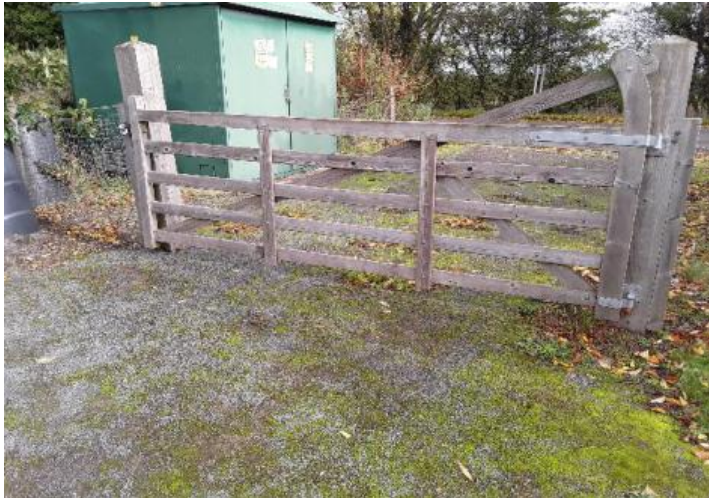
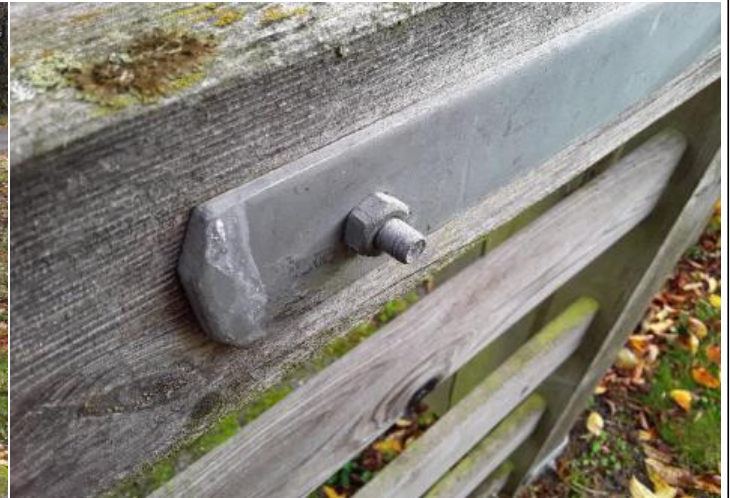
**i** 8 - Low Risk (Finding 1)

**Finding:** There are projecting bolt thread(s) present

**Action:** Remove excess thread length and deburr or provide cap

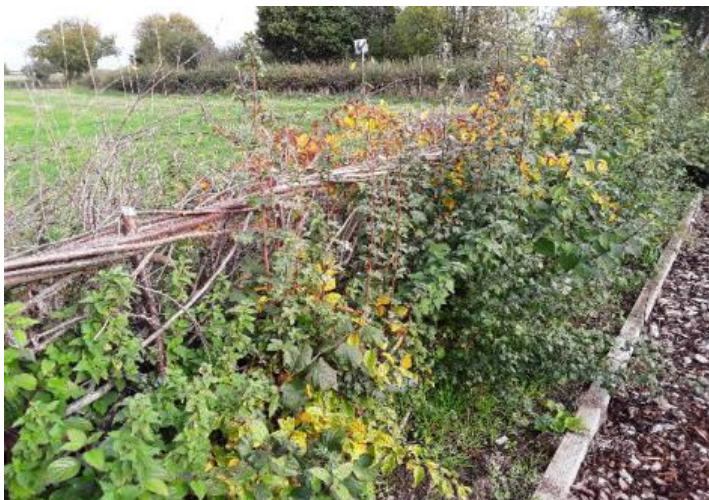
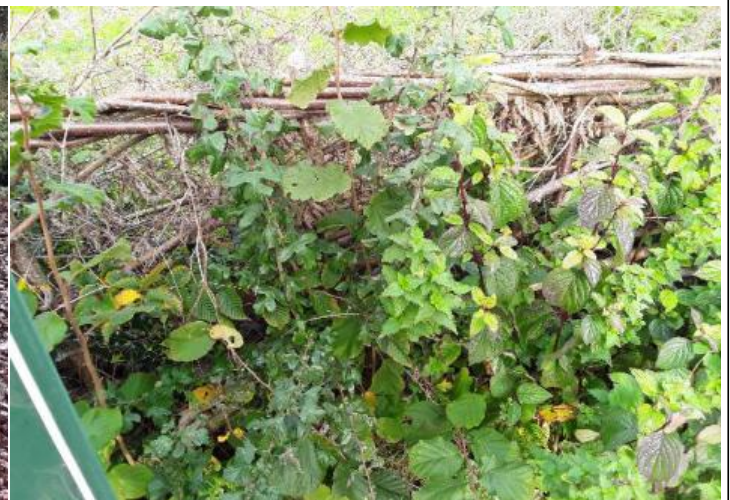
**i** 6 - Low Risk (Finding 1)

**Finding:** There are nettles growing through the hedge

**Action:** Remove the nettles

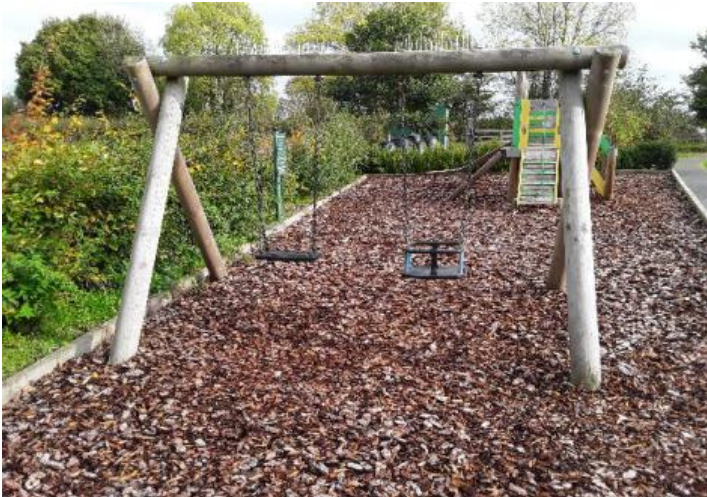
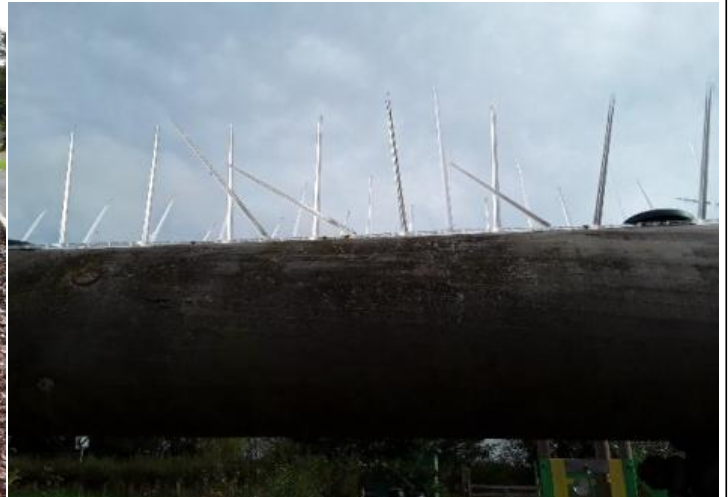
**8 - Low Risk (Finding 1)**

**Finding:** There are sharp bird deterrents on the crossbar

**Action:** Replace with soft deterrents or cable ties

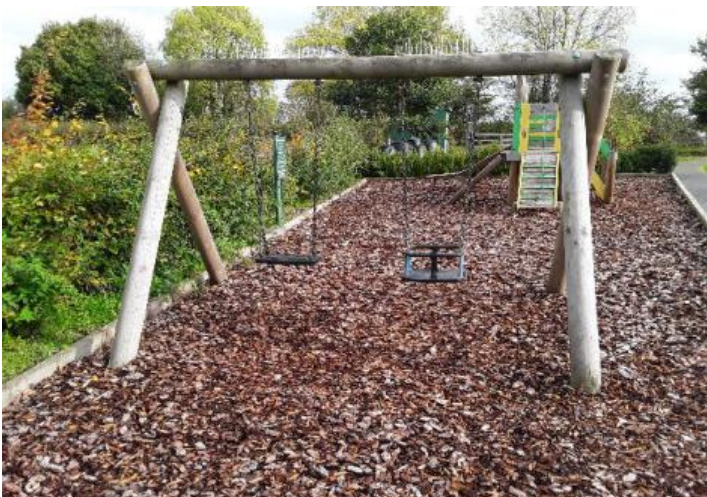
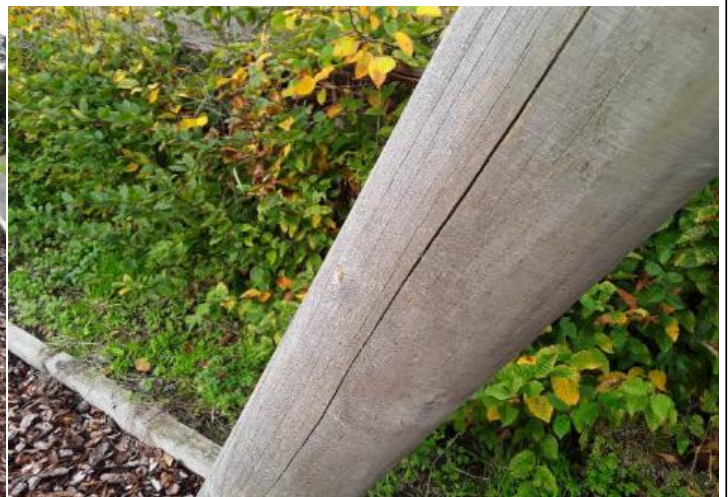
**6 - Low Risk (Finding 2)**

**Finding:** The timber has a number of splits/shakes or air cracks and this may affect the stability or allow water ingress which will accelerate the rotting process

**Action:** Monitor to ensure the splits do not cross through fixing points of the structure and/or cause any instability

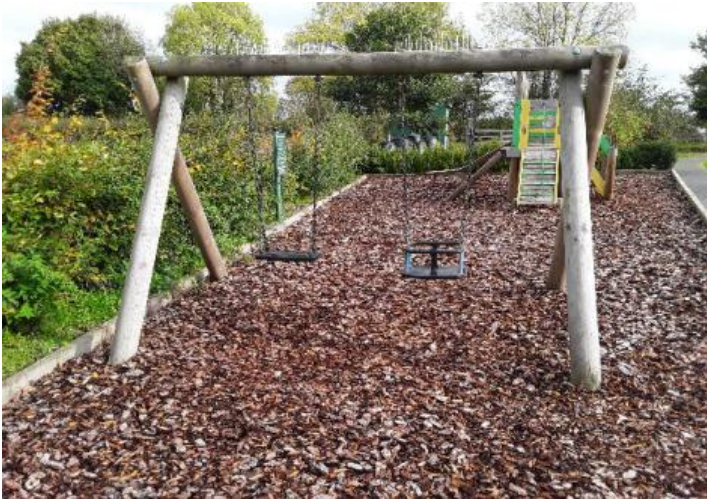
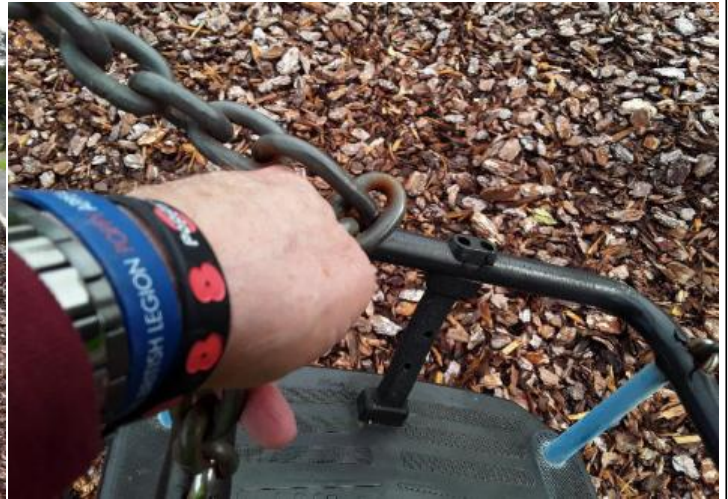
**i** 6 - Low Risk (Finding 3)

**Finding:** There is some notable evidence of chain wear

**Action:** Monitor for any further deterioration and replace when 40% worn

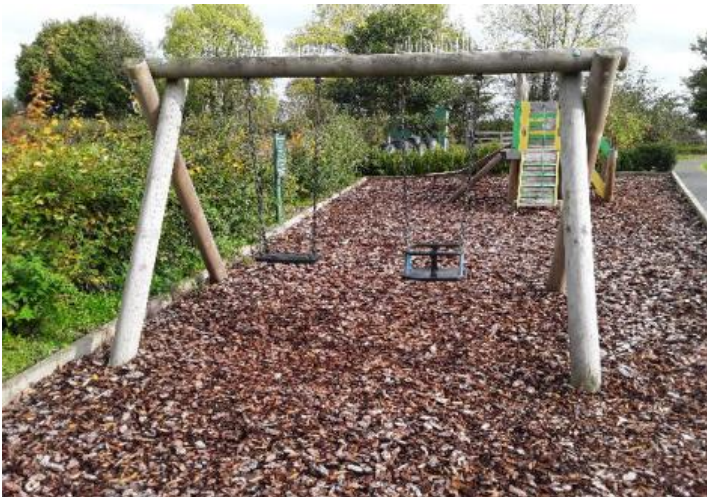
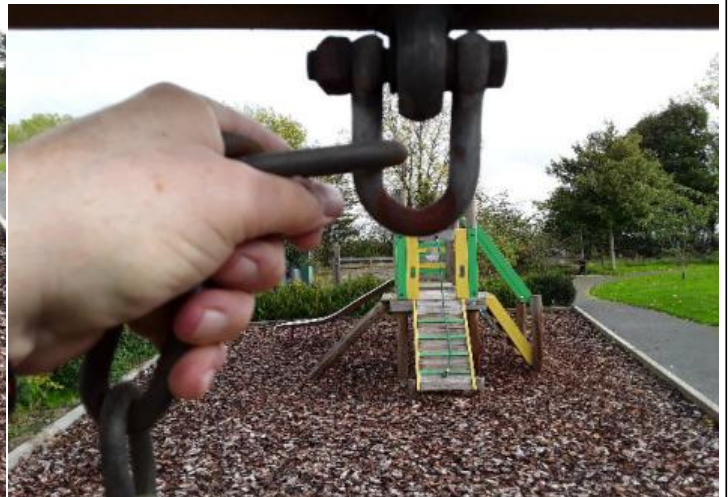
**i** 6 - Low Risk (Finding 4)

**Finding:** There is some wear to the shackles.

**Action:** Monitor for any further deterioration and replace when 40% worn

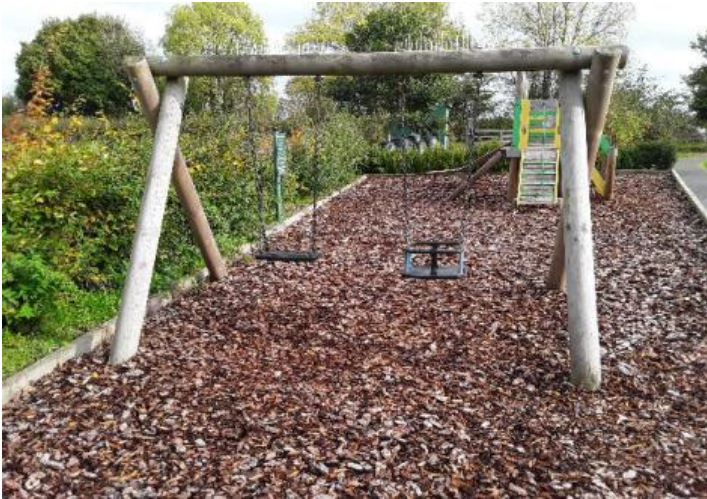
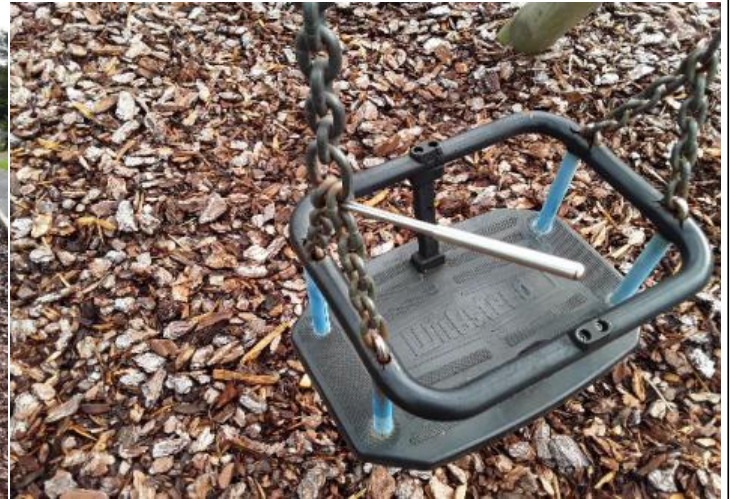
**i** 5 - Very Low Risk (Finding 5)

**Finding:** The chain openings are in excess of the 8.6mm as recommended by BS EN 1176  
**Action:** Monitor - No remedial work recommended

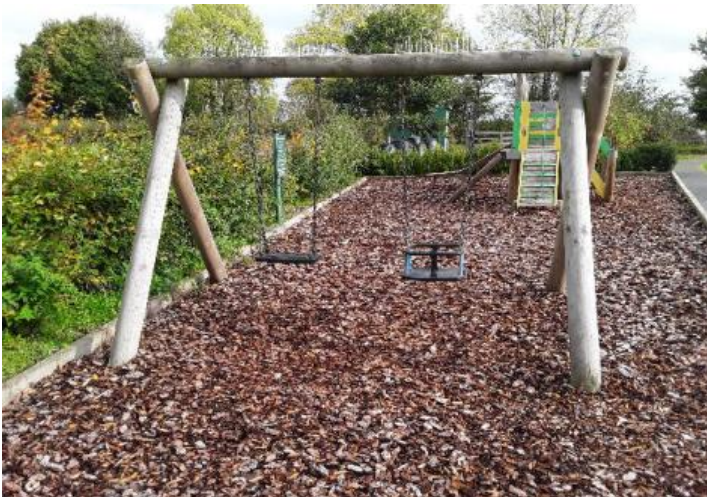
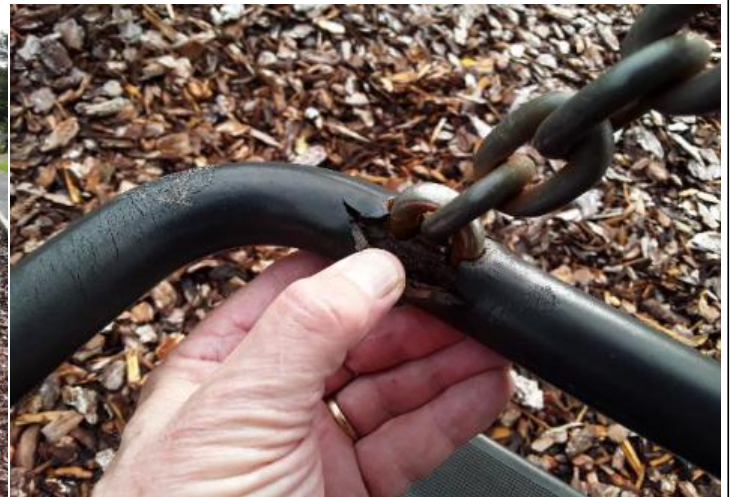
**i** 6 - Low Risk (Finding 6)

**Finding:** The swing seat frames are corroding  
**Action:** Monitor for any further deterioration and replace as required

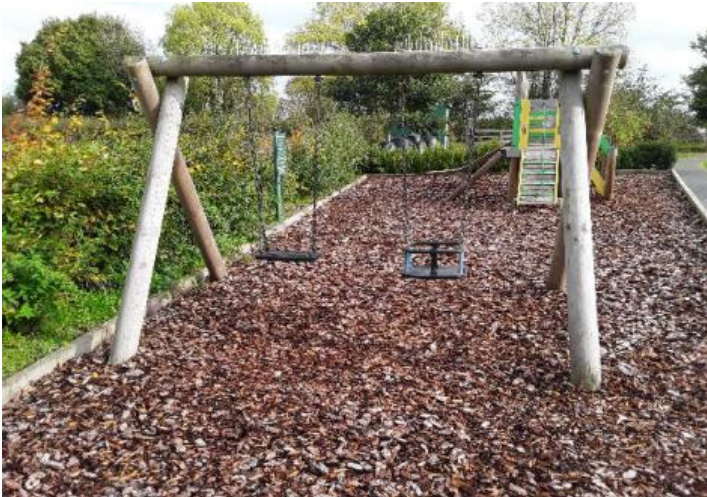
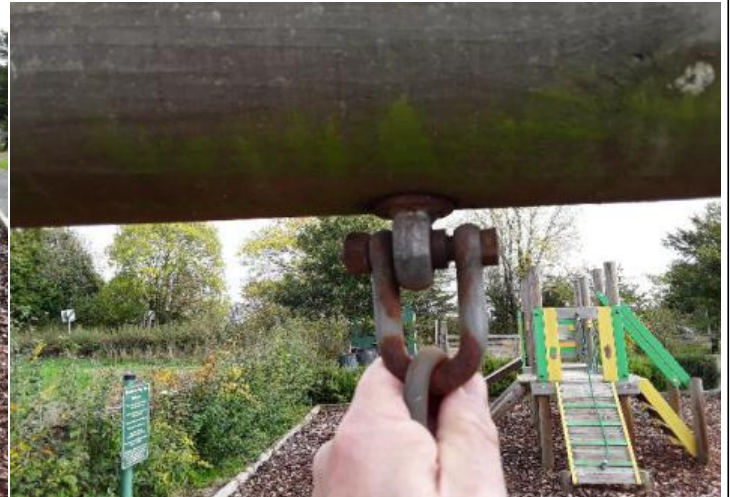
**i** 8 - Low Risk (Finding 7)

**Finding:** The bushes are worn or missing

**Action:** Replace worn or missing bushes

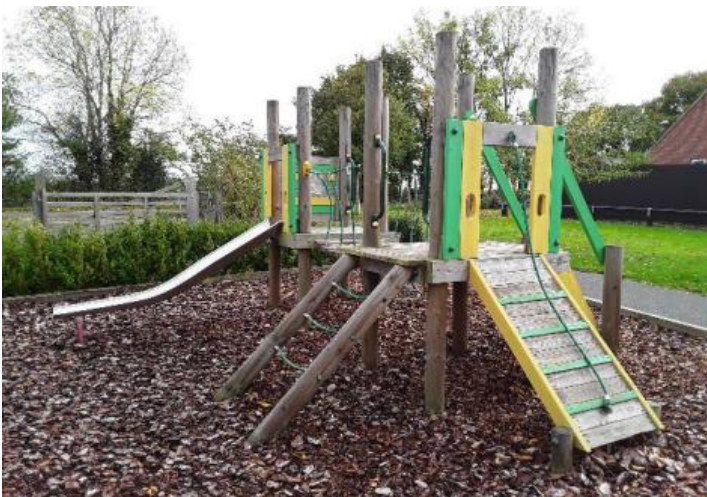
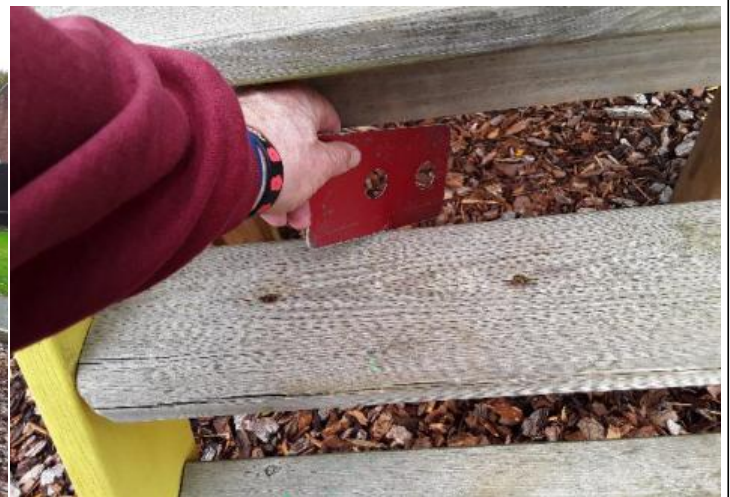
**i** 5 - Very Low Risk (Finding 1)

**Finding:** The item fails to meet the requirements of BS EN 1176 Part 1 4.2.7.2 head and neck entrapment in the barriers and/or steps

**Action:** Monitor - No remedial work recommended

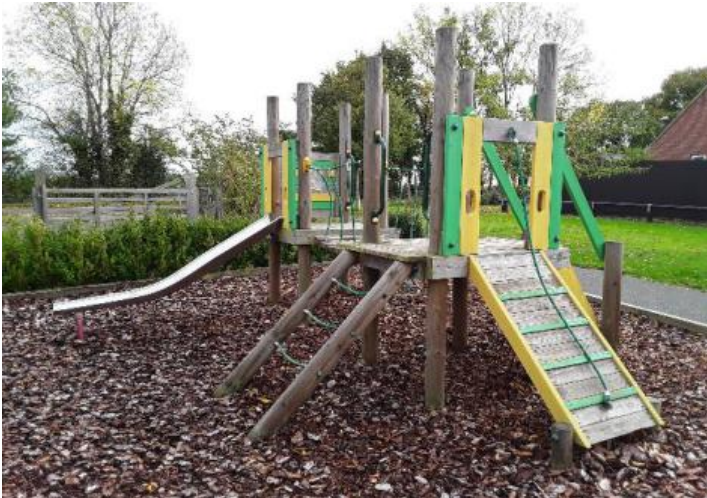
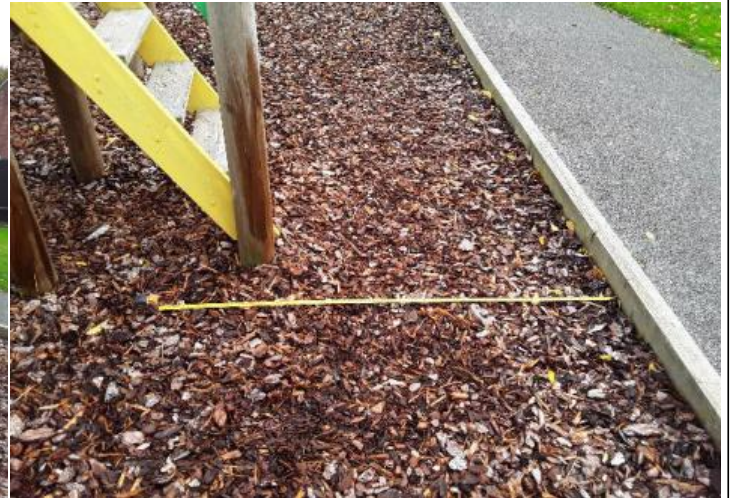
**i** 5 - Very Low Risk (Finding 2)

**Finding:** The edging forms a hard object within the impact area of the equipment in contravention of the requirements of BS EN 1176 Part 1

**Action:** Monitor - No remedial work recommended

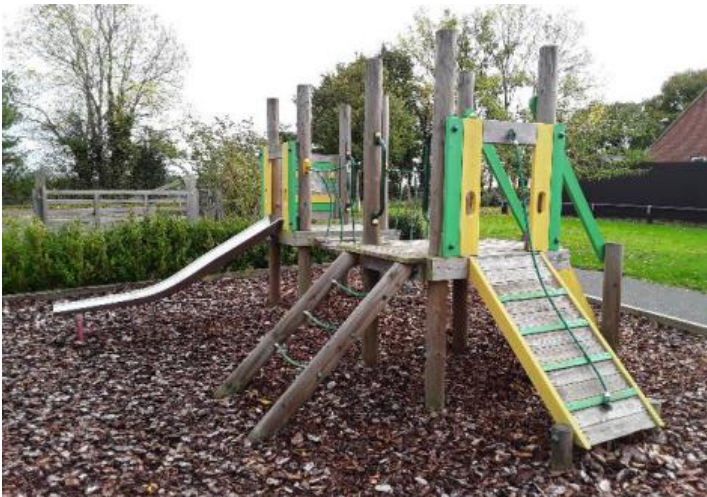
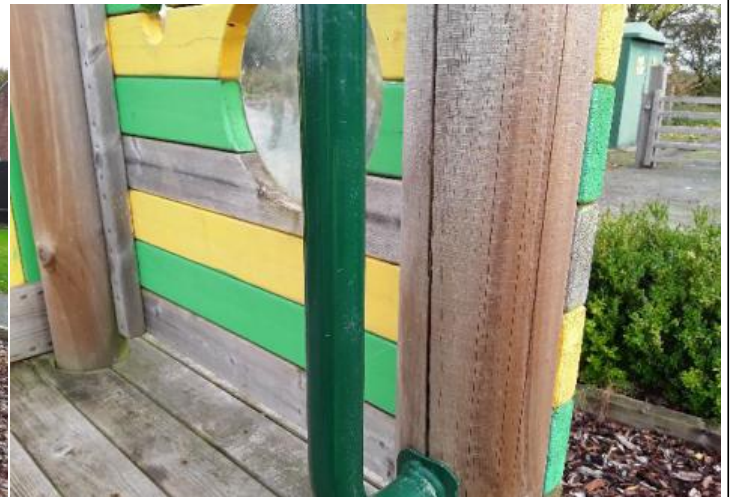
**i** 6 - Low Risk (Finding 3)

**Finding:** The timber has a number of splits/shakes or air cracks and this may affect the stability or allow water ingress which will accelerate the rotting process

**Action:** Monitor to ensure the splits do not cross through fixing points of the structure and/or cause any instability

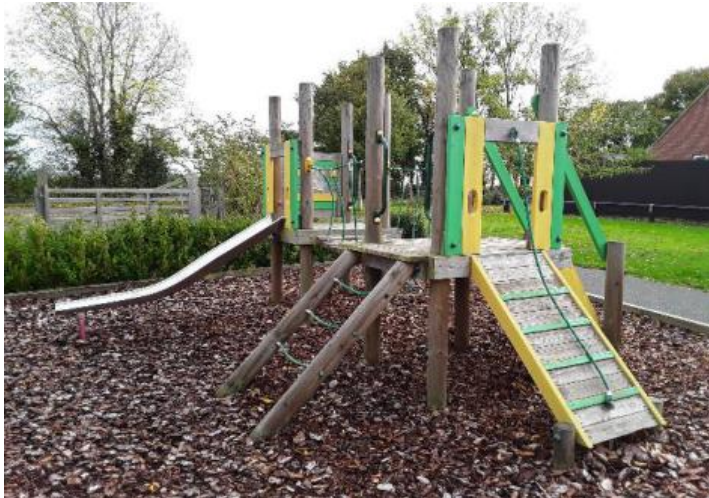
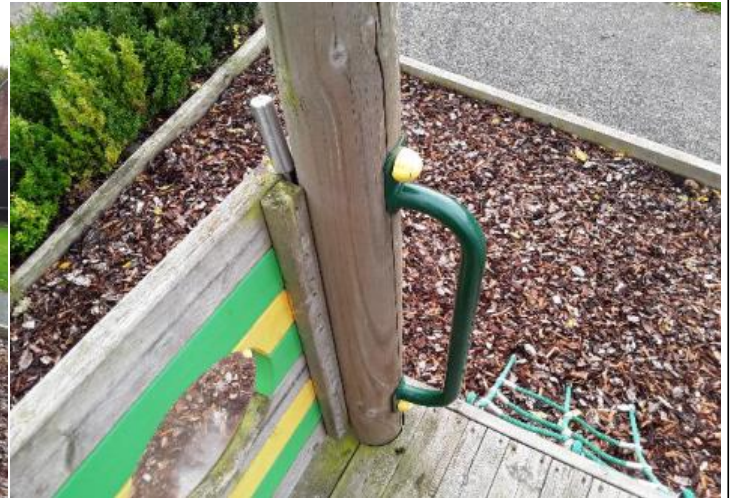
**i** 5 - Very Low Risk (Finding 4)

**Finding:** There is/are finger entrapment/s in the structure and the item fails to meet the requirements of BS EN 1176 Part 1 4.2.7.6 Entrapment of fingers

**Action:** Monitor - No remedial work recommended
