Report on the condition of the churchyard retaining wall

Report 2018-07

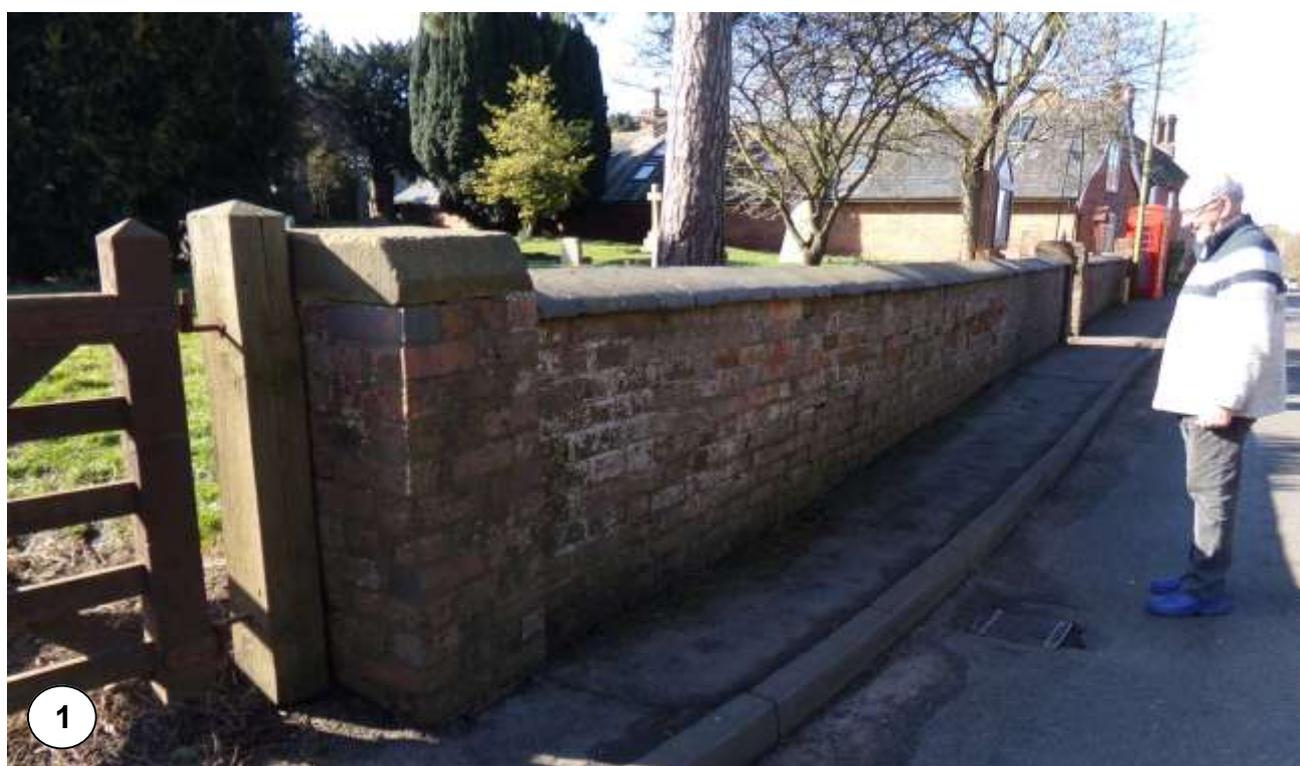
Figure 1. Eastern end of churchyard retaining wall. The bulging area is in front of the standing figure.

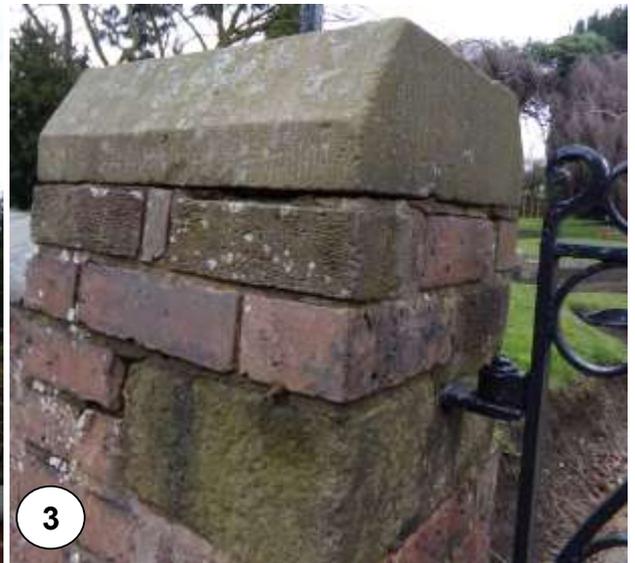
Figures 2-4. 2. Church gates. 3. Gate column patched with modern brick and showing stone cap and hinge bracket support. 4. Lower hinge bracket for western gate showing adjustment ring and decayed brickwork.

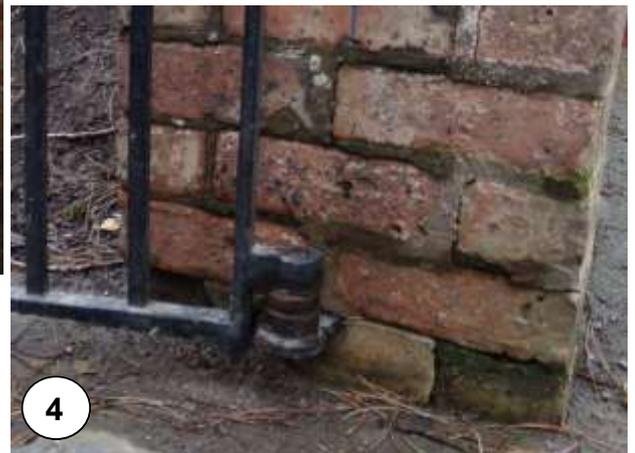
The double church gates are wrought iron, and the top hinges are supported by stone blocks. There is a wrought iron arch with a lamp holder over the gateway. The gates do not close, probably because the lower hinge bracket for the western gate has moved.

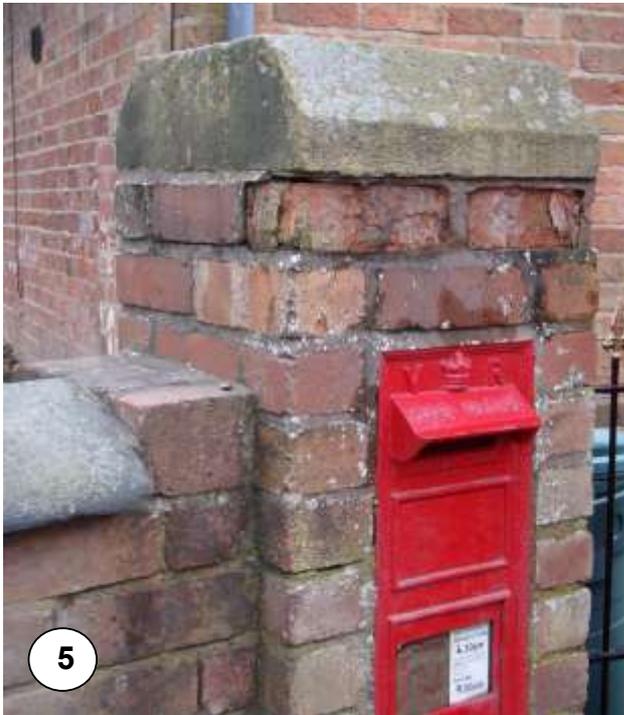
The western half of the wall is 13m long and appears to be in good condition, apart from two spalled bricks above the letter box and a few joints missing mortar. The different kinds of bricks can be clearly seen in the pillar with the letter box and the wall near the fire hydrant post.

Figure 5. Spalled bricks above the letter box

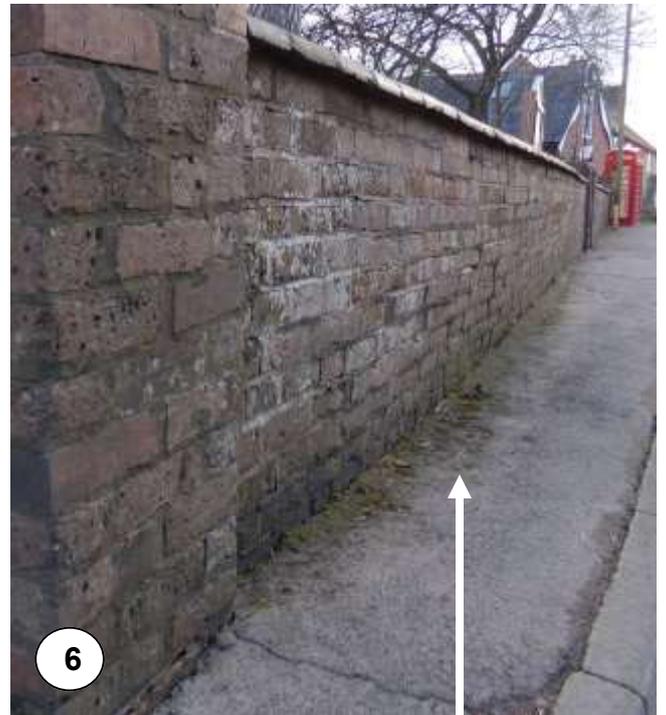
Figure 6. Location of bulge near eastern end of wall

The eastern section of the wall is 13.6m long, and exhibits a bulge with an apex 4m from the eastern end of the wall. At this point the upper part of the wall is leaning 80mm over the footway, the mortar joints are missing or loose, and there are vertical cracks running up the joints and in one place through a brick. Mortar is also missing from between the capstones above these vertical cracks, indicating that movement has taken place.

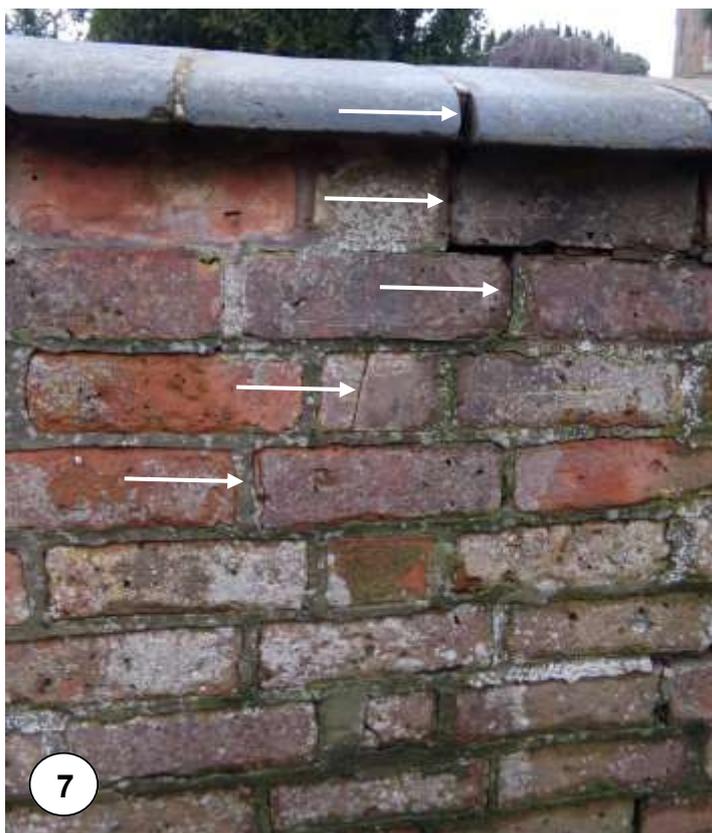
Figure 7. Vertical crack marked by arrows.

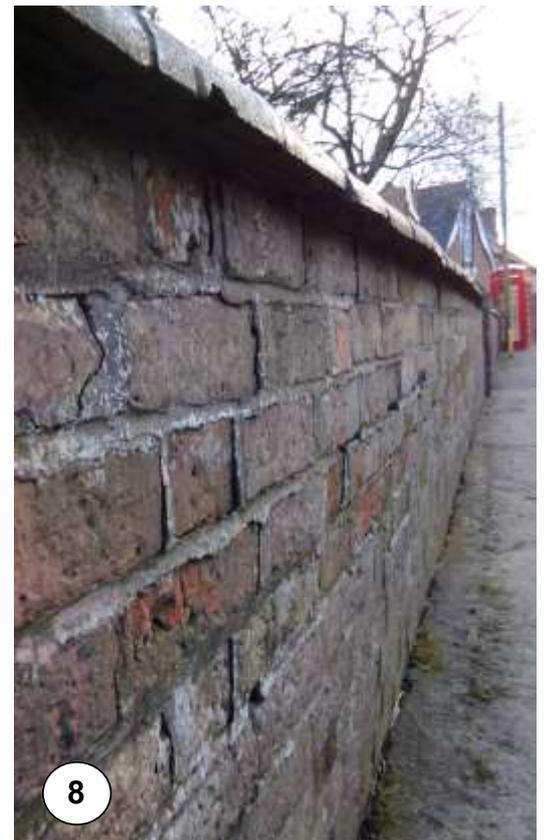
Figure 8. Spalling mortar and irregular brickwork

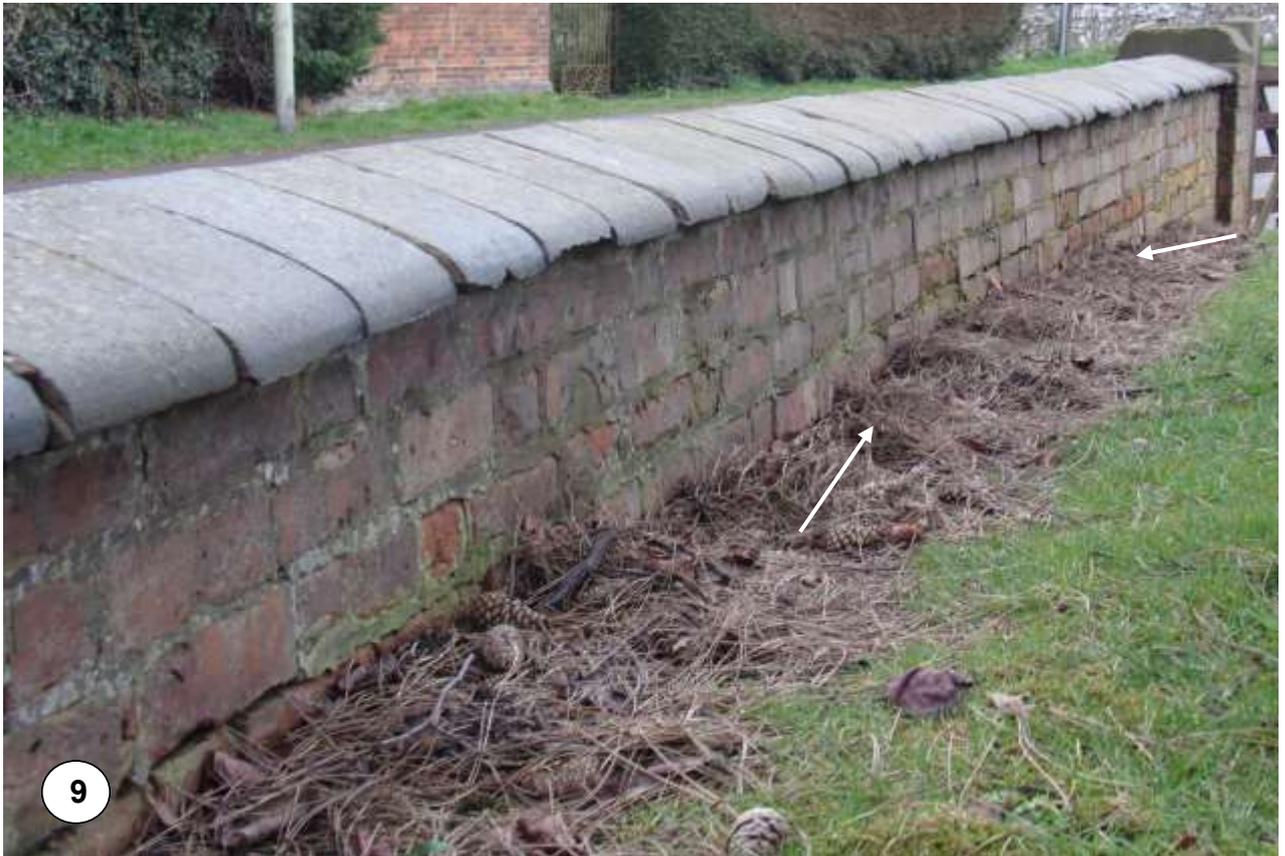
Figure 9. Churchyard side of wall. Curvature of bulge is clearly visible between the arrows. Note absence of mortar in brickwork at ground level at bottom left.

The curvature and leaning of the wall are most apparent on the churchyard side of the wall. At ground level, there is very little mortar remaining in the joints along the whole length of the wall.

1. The condition of the wall be monitored for evidence of movement or instability.
2. A shallow excavation be made between the arrows in Figure 9 to determine the extent of mortar decay, any cracks, and the condition of the brickwork below ground level.
3. Advice be sought from the H&BBC Conservation Officer and the Church Architect about procedure, further investigations, and the most appropriate approach to repair and maintenance.
