## Annual Inspection

Carlton Parish Council

Toddlers Play Area

Inspection Ref: 2540185

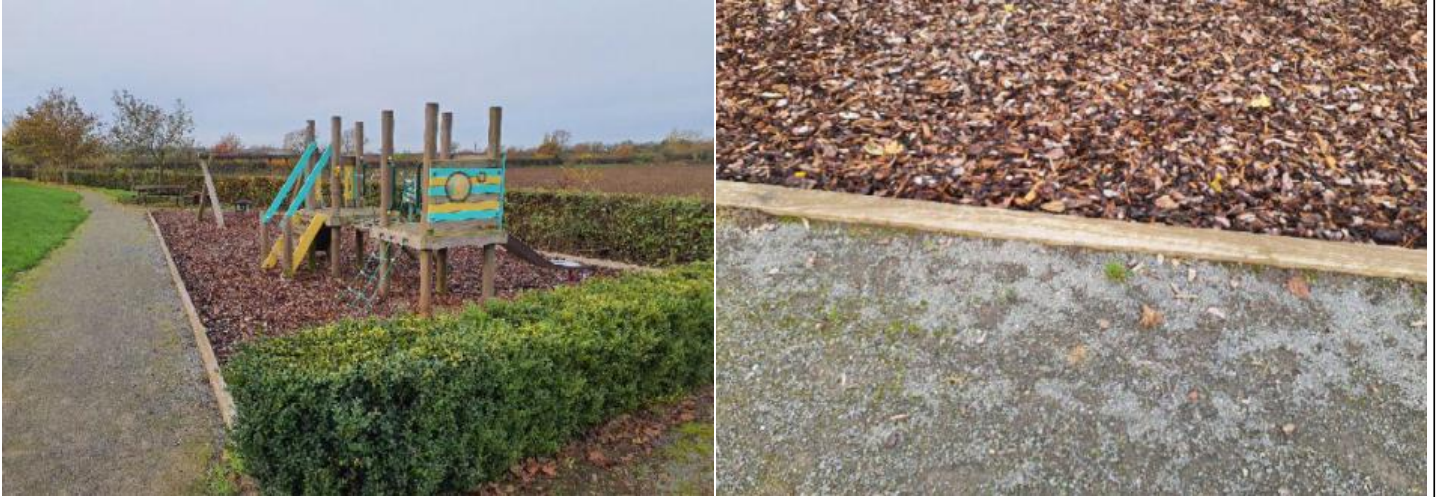
### 8 - Low Risk (Finding 1)

There are trip hazards at the edges of the walkway -  
Remove trip hazard

**Finding:** There are trip hazards at the edges of the walkway **Action:** Remove trip hazard

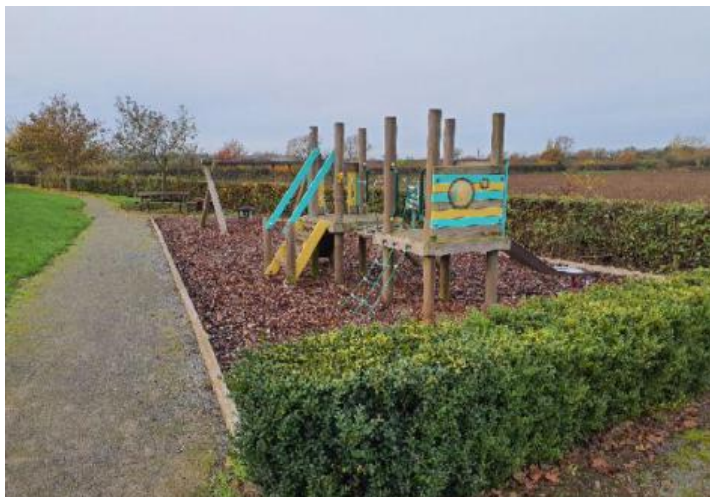
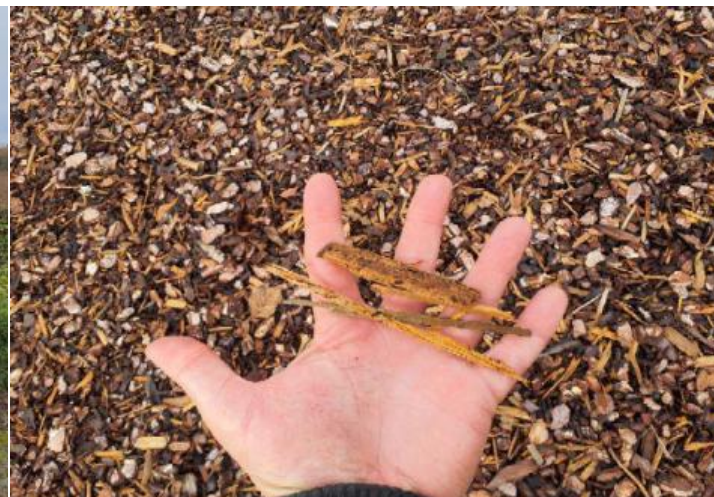
**i** 8 - Low Risk (Finding 2)

There are some particles present within the surface that  
comprise of long, shard like pieces and carry some risk of  
puncture injuries - We would recommend that any long,  
shard like pieces are hand picked and removed from the  
area as they appear

**Finding:** There are some particles present within the surface that comprise of long, shard like pieces and carry some risk of puncture injuries

**Action:** We would recommend that any long, shard like pieces are hand picked and removed from the area as they appear

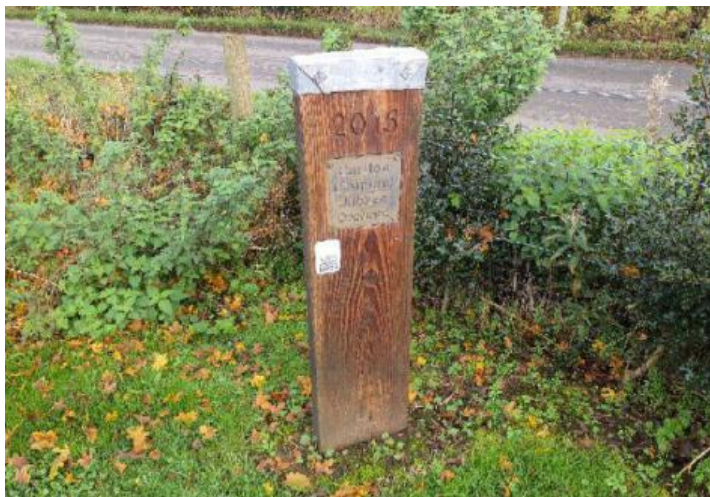
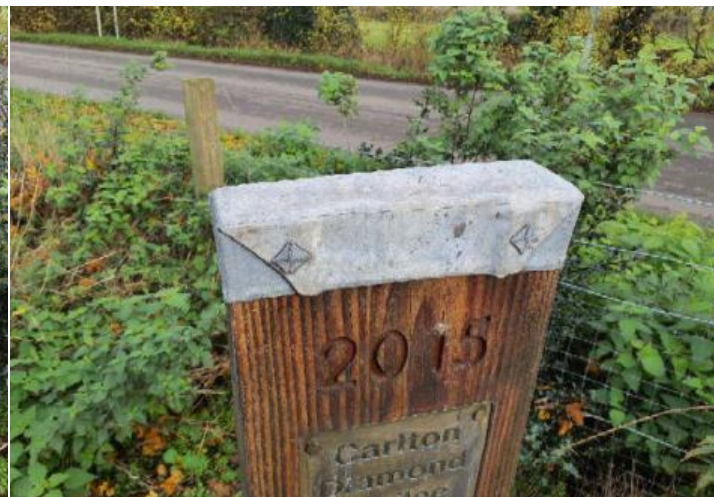
**i** 0 - Risk Assessment not Undertaken (Finding 1)

Lead flashing has been used to form a cap on the top of the sign - Refer to the supplier for a toxicology assessment

**Finding:** Lead flashing has been used to form a cap on the top of the sign

**Action:** Refer to the supplier for a toxicology assessment

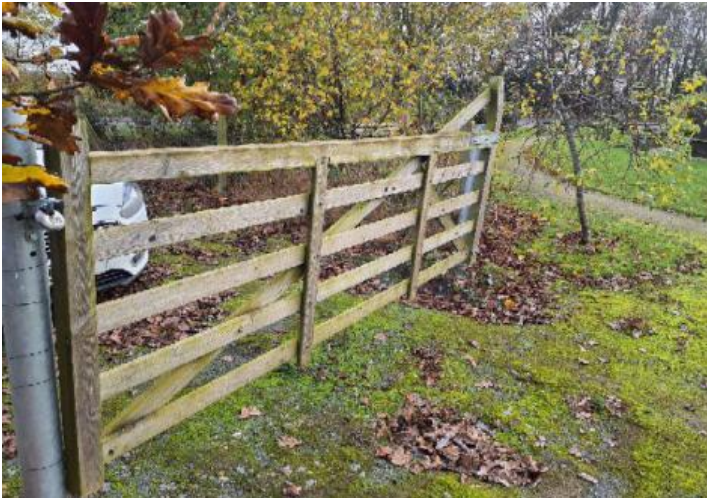
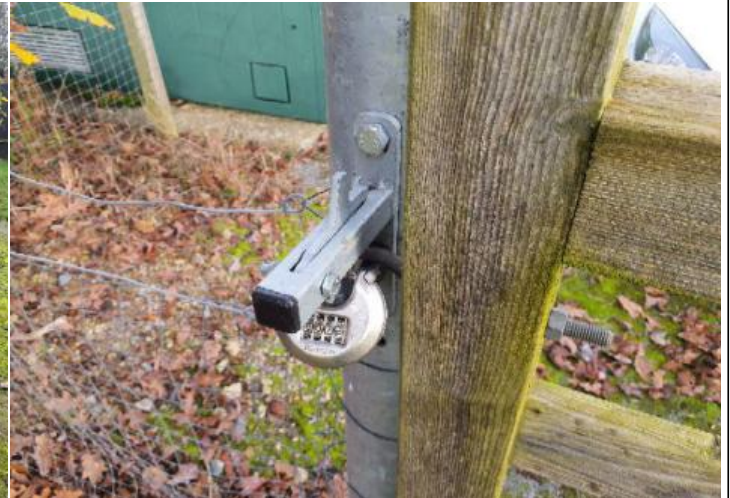
**i** 0 - Risk Assessment not Undertaken (Finding 1)

The maintenance gate was correctly padlocked at the time of inspection, however this means that the inspector was unable to fully assess the gate - Ensure that there are 12mm gaps throughout the full range of motion on gate/s and between leaves where relevant

**Finding:** The maintenance gate was correctly padlocked at the time of inspection, however this means that the inspector was unable to fully assess the gate

**Action:** Ensure that there are 12mm gaps throughout the full range of motion on gate/s and between leaves where relevant

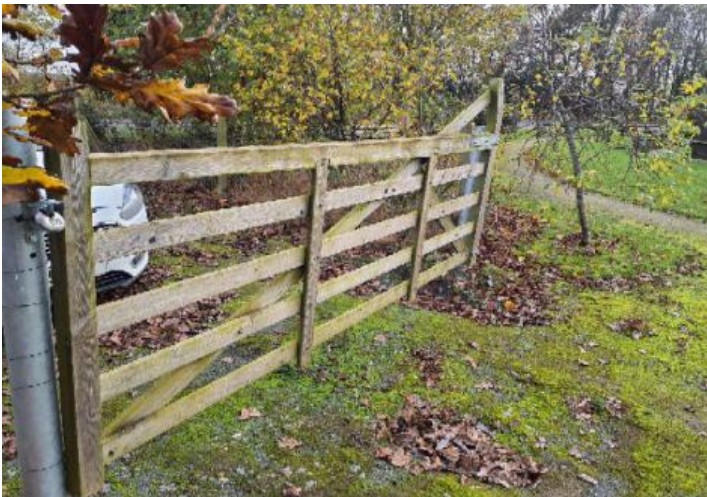
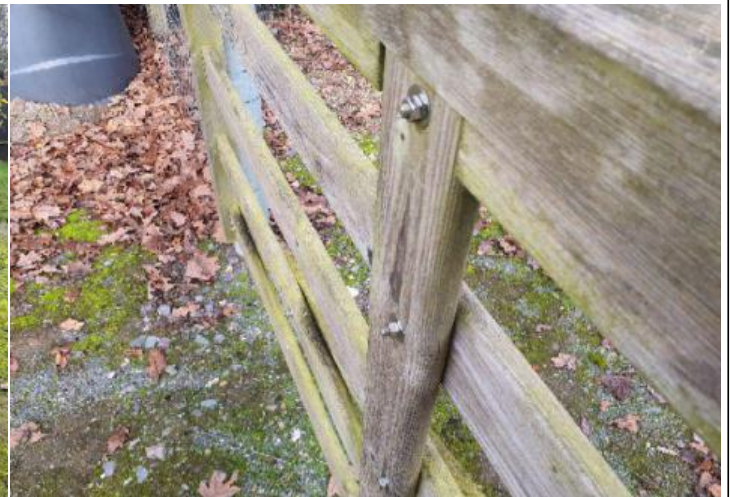
**i** 8 - Low Risk (Finding 2)

There are projecting bolt thread(s) present - Remove excess thread length and deburr or provide cap

**Finding:** There are projecting bolt thread(s) present

**Action:** Remove excess thread length and deburr or provide cap

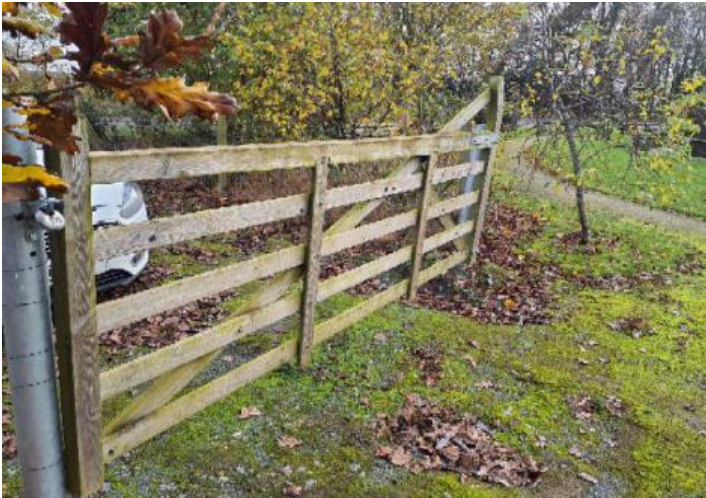
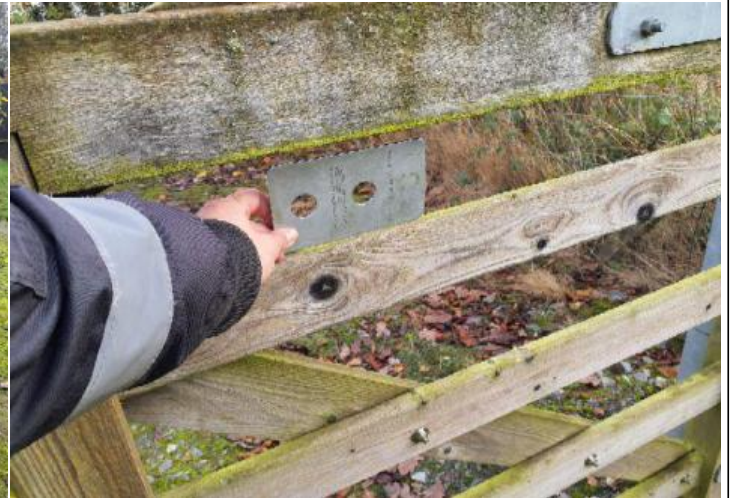
**i** 5 - Very Low Risk (Finding 3)

The configuration of the timbers poses a risk of head and neck entrapment in the framework - Monitor - No remedial work recommended

**Finding:** The configuration of the timbers poses a risk of head and neck entrapment in the framework

**Action:** Monitor - No remedial work recommended

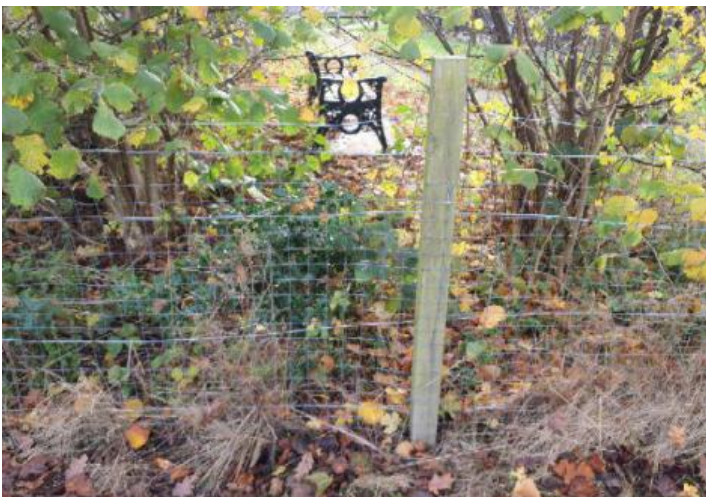
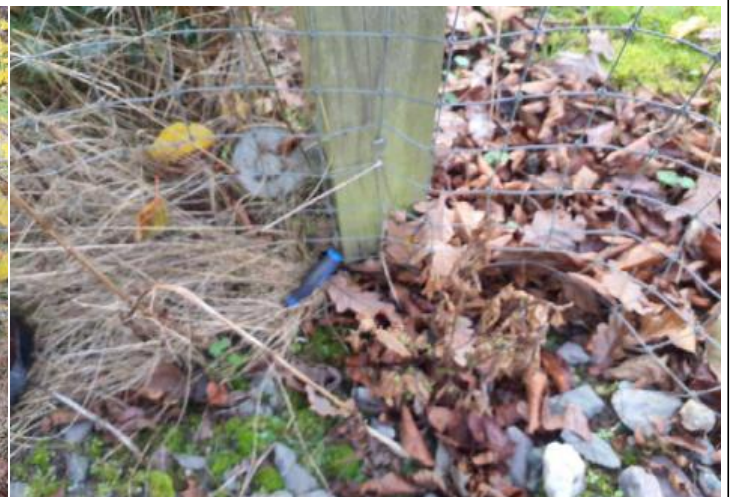
**i** 8 - Low Risk (Finding 1)

There are areas or parts of the timber posts on the structure that have rotted - Replace all affected timbers

**Finding:** There are areas or parts of the timber posts on the structure that have rotted

**Action:** Replace all affected timbers

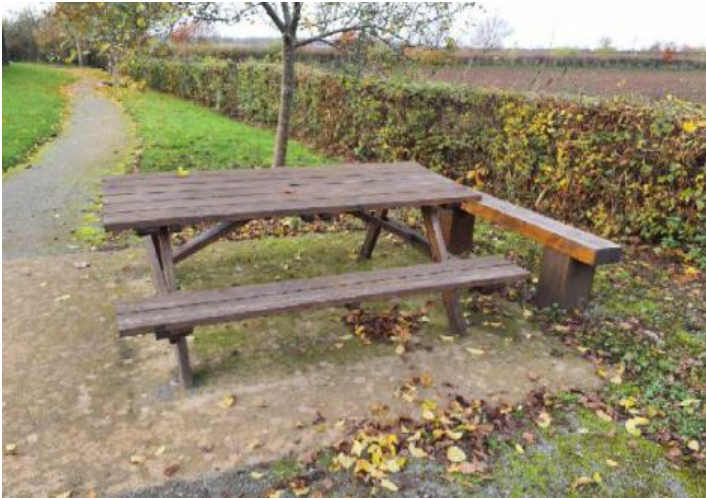
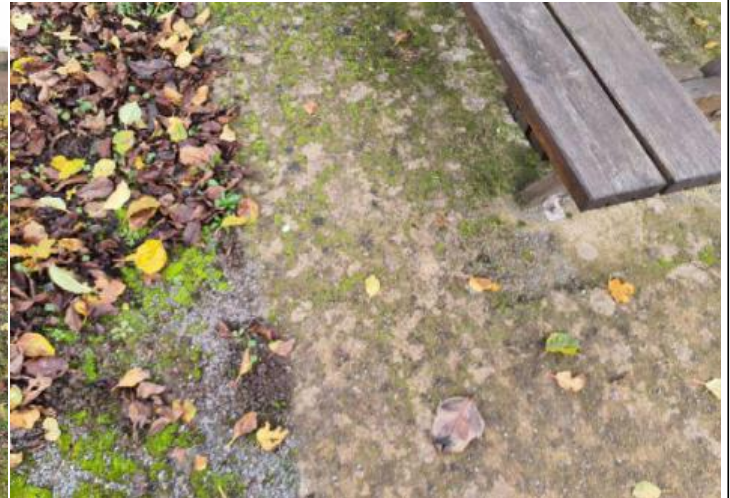
**i 8 - Low Risk (Finding 1)**

There is algae, silt or moss growth on the surface resulting in slippery conditions - Clean and treat appropriately

**Finding:** There is algae, silt or moss growth on the surface resulting in slippery conditions

**Action:** Clean and treat appropriately

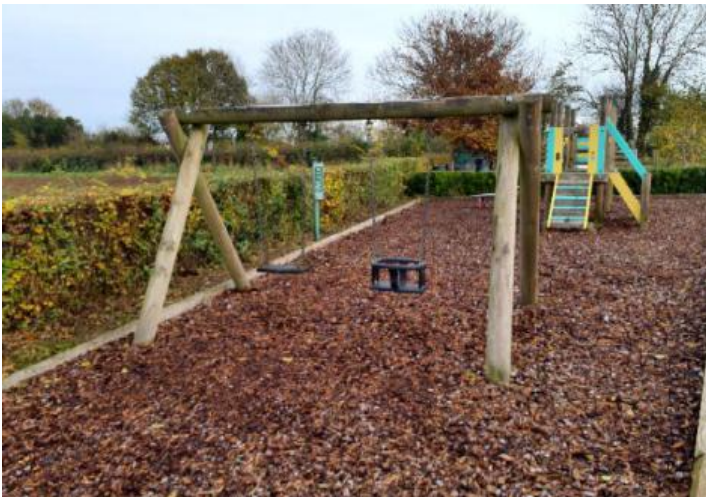
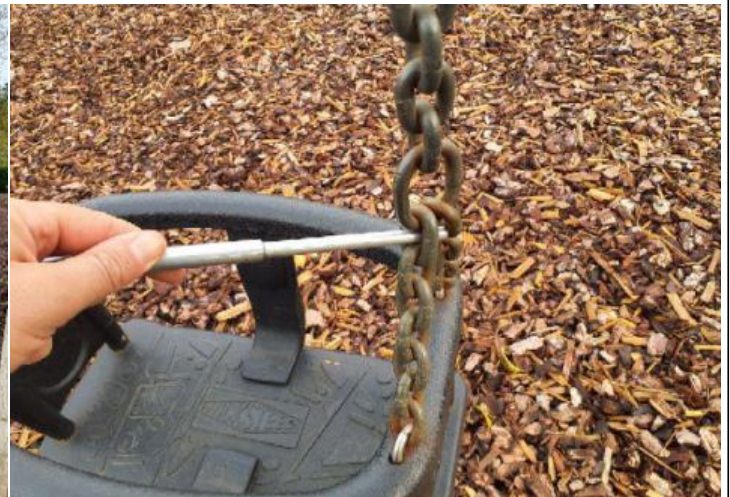
**i 5 - Very Low Risk (Finding 1)**

The chain openings are in excess of the 8.6mm as recommended by BS EN 1176 - Monitor - No remedial work recommended

**Finding:** The chain openings are in excess of the 8.6mm as recommended by BS EN 1176

**Action:** Monitor - No remedial work recommended

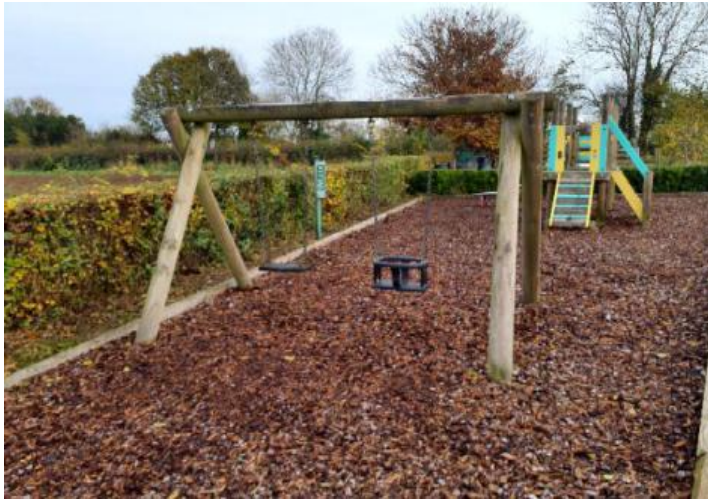
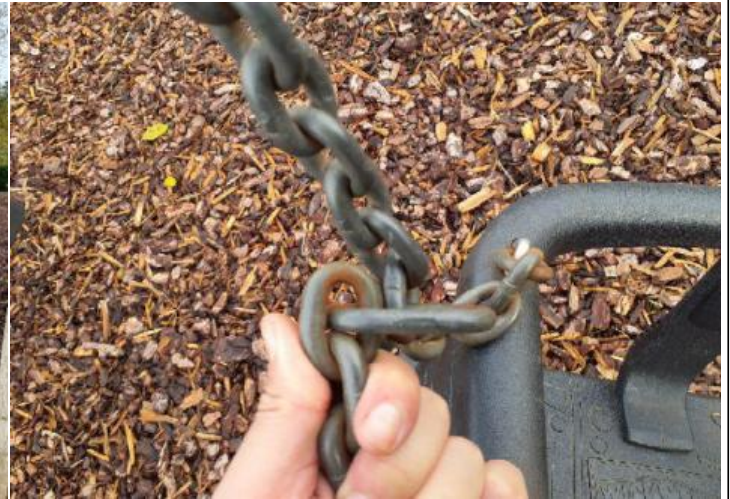
**i** 6 - Low Risk (Finding 2)

There is some notable evidence of chain wear - Monitor for any further deterioration and replace when 40% worn

**Finding:** There is some notable evidence of chain wear

**Action:** Monitor for any further deterioration and replace when 40% worn

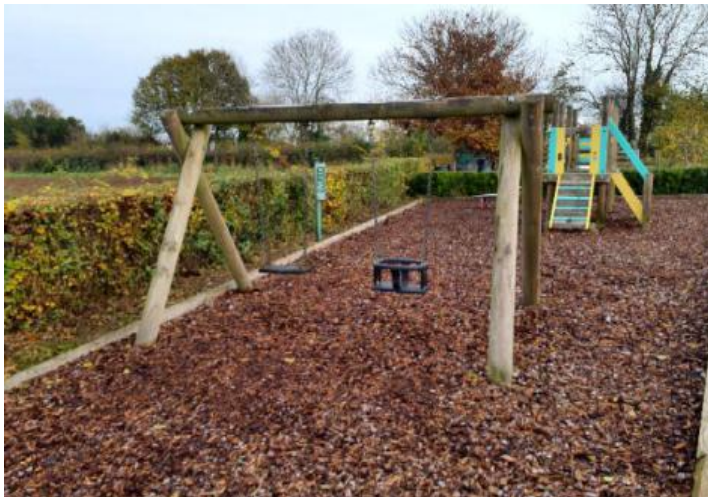
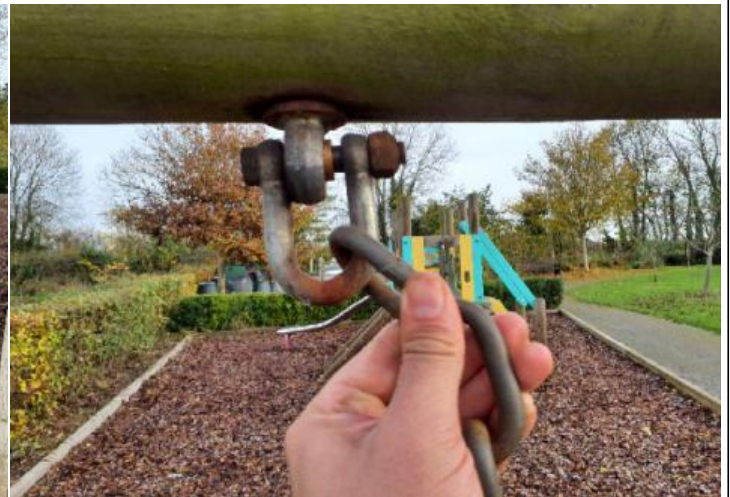
**i** 6 - Low Risk (Finding 3)

There is some wear to the shackles. - Monitor for any further deterioration and replace when 40% worn

**Finding:** There is some wear to the shackles.

**Action:** Monitor for any further deterioration and replace when 40% worn

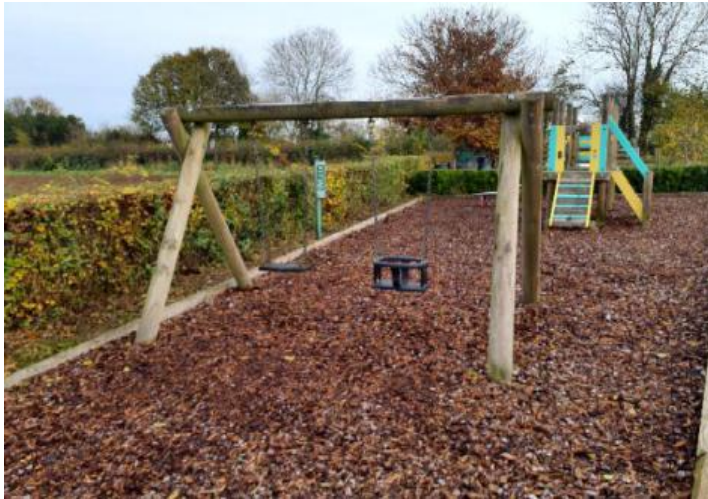
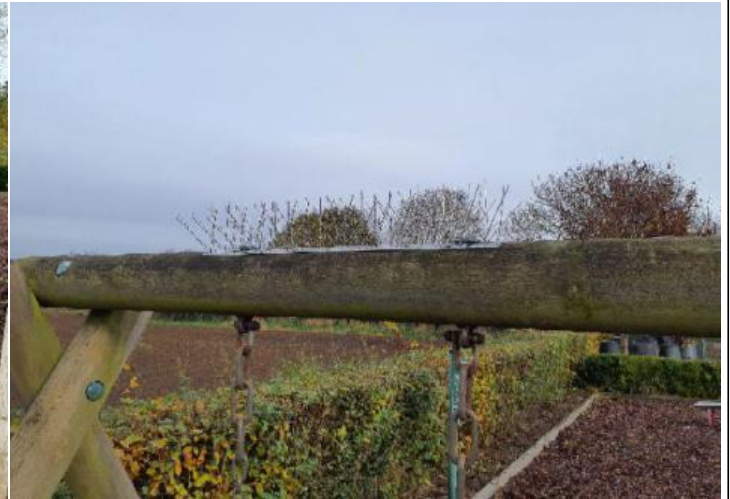
**i** 6 - Low Risk (Finding 4)

Bird deterrent spikes have been fitted to the swing and present hazards - Remove and replace with upturned cable ties

**Finding:** Bird deterrent spikes have been fitted to the swing and present hazards **Action:** Remove and replace with upturned cable ties

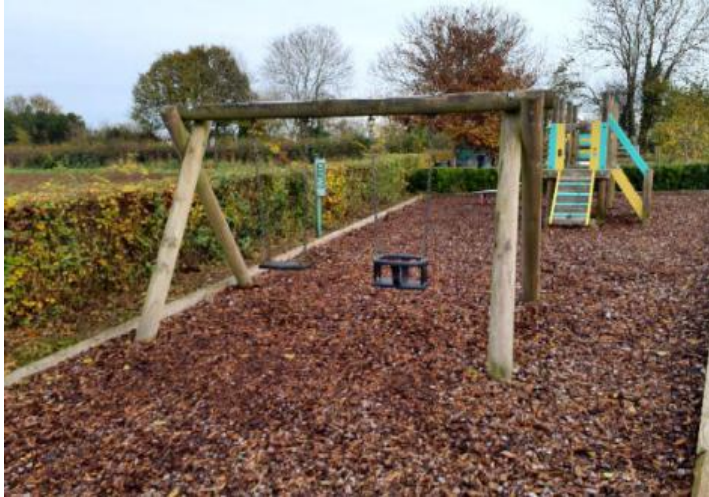
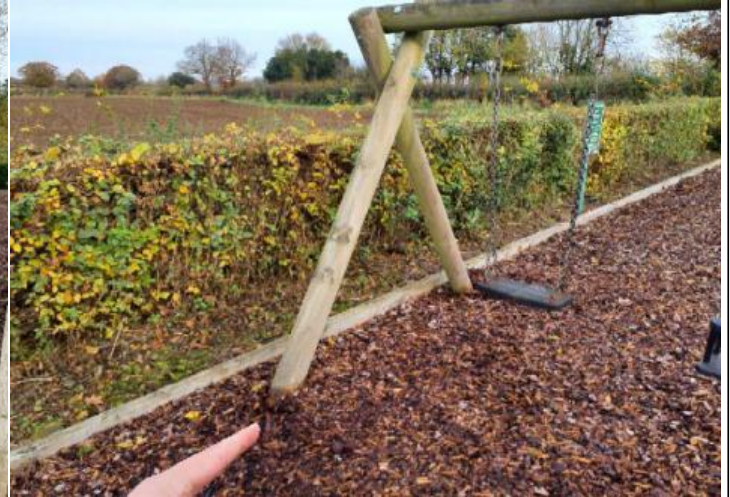
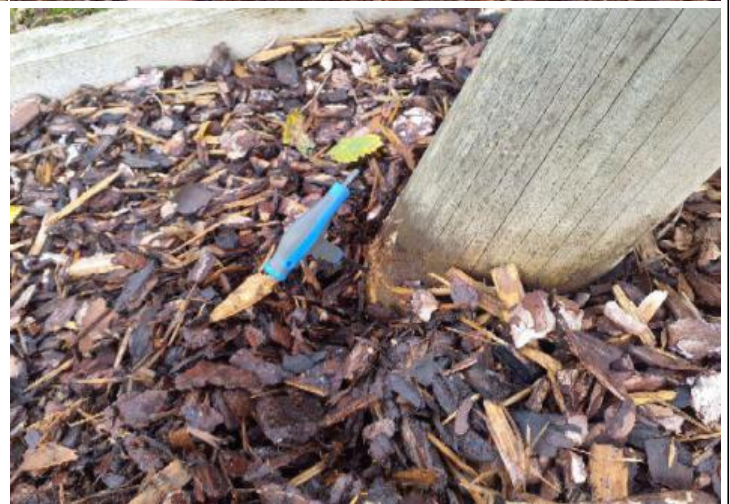
**!** 12 - Moderate Risk (Finding 5)

There are areas or parts of the timber support on the structure that have rotted - Replace all affected timbers

**Finding:** There are areas or parts of the timber support on the structure that have rotted

**Action:** Replace all affected timbers

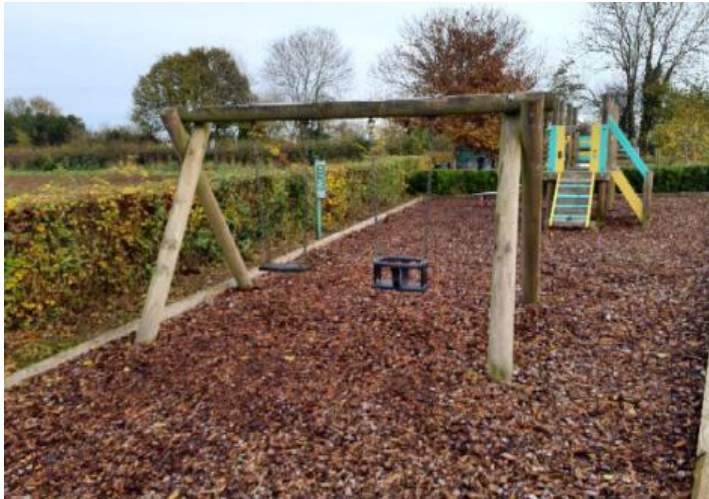
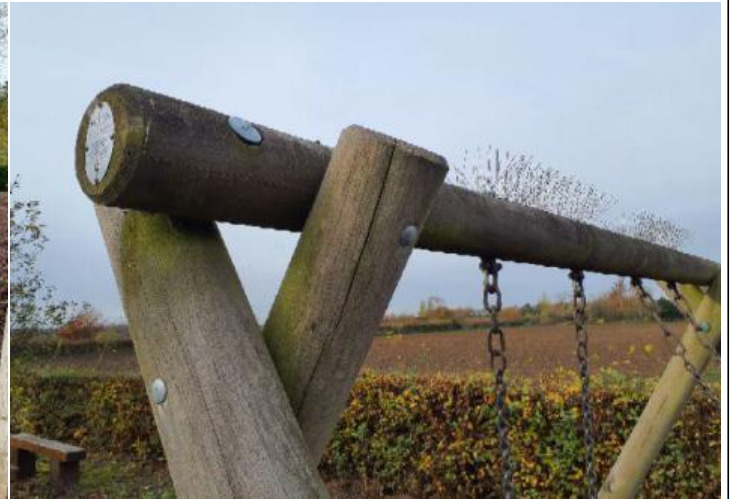
**i 6 - Low Risk (Finding 6)**

The timber has a number of splits/shakes or air cracks and this may affect the stability or allow water ingress which will accelerate the rotting process - Monitor to ensure the splits do not cross through fixing points of the structure and/or cause any instability

**Finding:** The timber has a number of splits/shakes or air cracks and this may affect the stability or allow water ingress which will accelerate the rotting process  
**Action:** Monitor to ensure the splits do not cross through fixing points of the structure and/or cause any instability

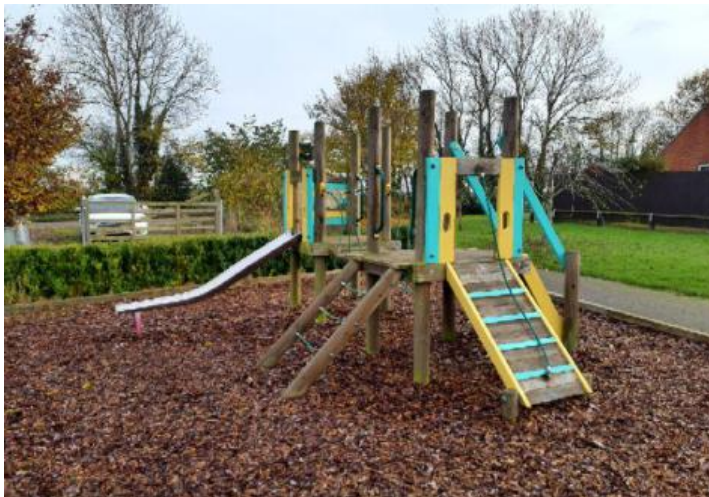
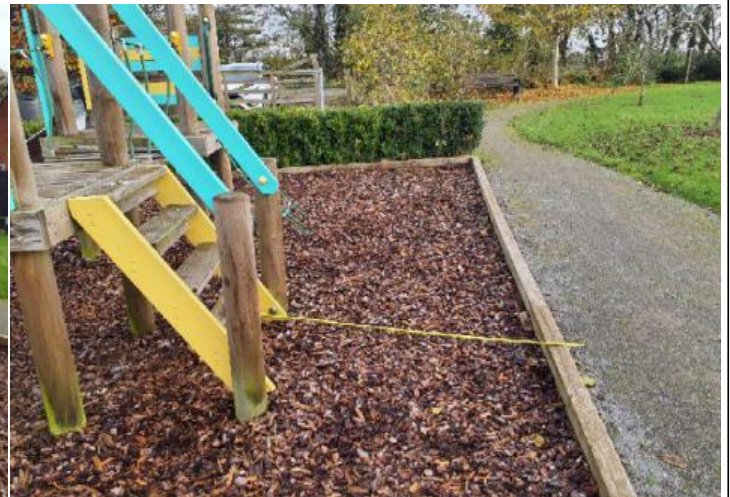
**i 8 - Low Risk (Finding 1)**

The raised timber edging forms a hard object within the falling space of the equipment and there is also insufficient surfacing provided in contravention of BS EN 1176 Part 1 - Monitor - no remedial work recommended

**Finding:** The raised timber edging forms a hard object within the falling space of the equipment and there is also insufficient surfacing provided in contravention of BS EN 1176 Part 1  
**Action:** Monitor - no remedial work recommended

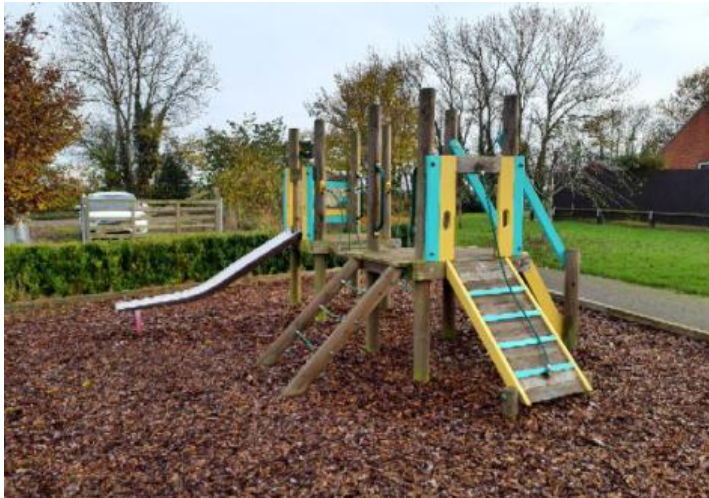
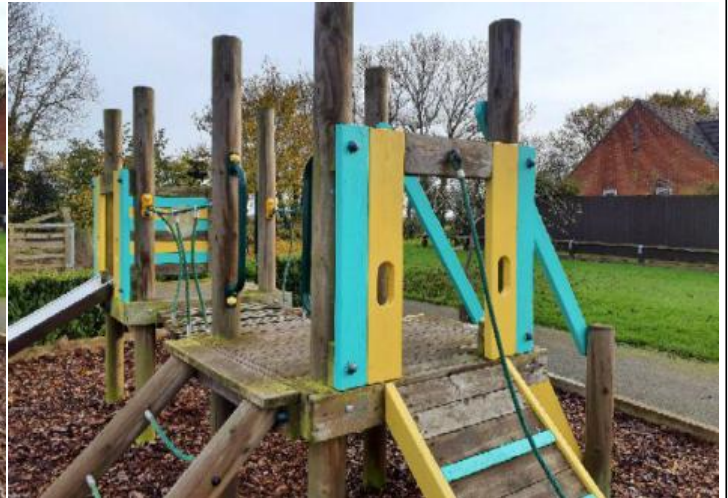
**i** 6 - Low Risk (Finding 2)

The unit is easily accessible and has an opening in the barrier to steep play elements in excess of 500mm in contravention of BS EN 1176 Part 1 - Monitor - No remedial work recommended

**Finding:** The unit is easily accessible and has an opening in the barrier to steep play elements in excess of 500mm in contravention of BS EN 1176 Part 1

**Action:** Monitor - No remedial work recommended

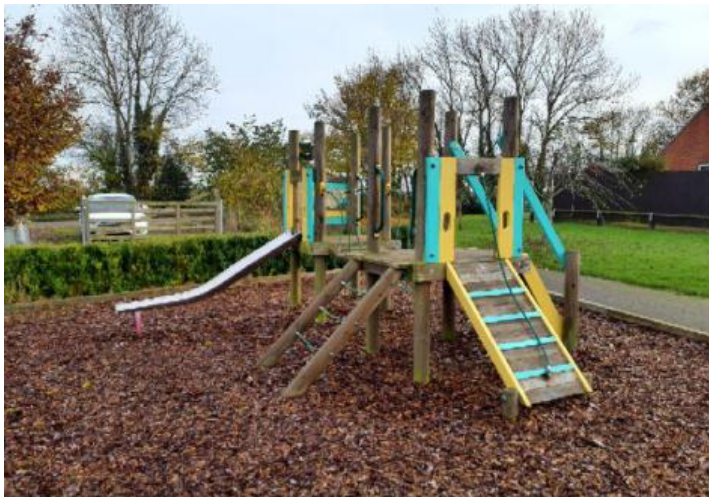
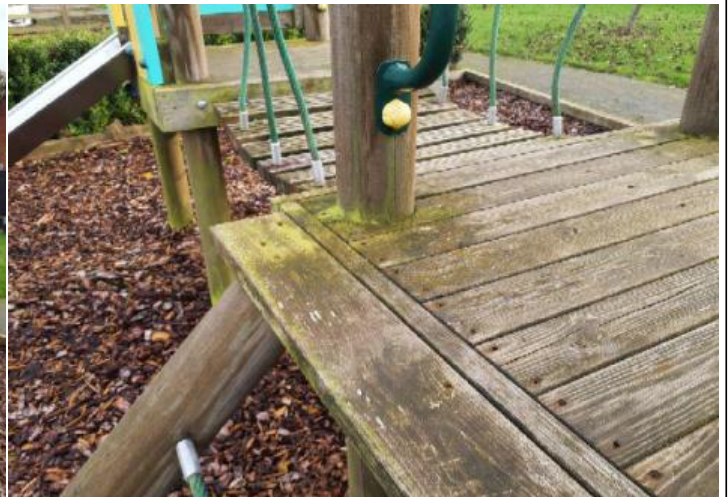
**i** 8 - Low Risk (Finding 3)

There is algae or moss on the surface of the equipment - Clean and treat appropriately

**Finding:** There is algae or moss on the surface of the equipment

**Action:** Clean and treat appropriately

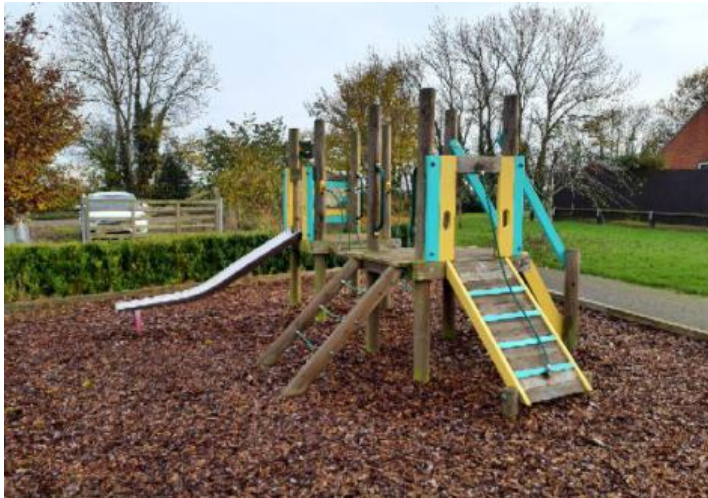
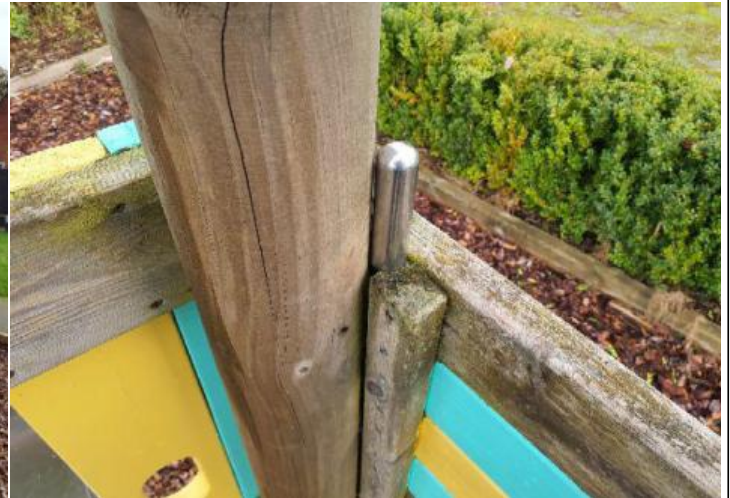
**i** 5 - Very Low Risk (Finding 4)

There is/are finger entrapment/s in the barrier and the item fails to meet the requirements of BS EN 1176 Part 1 4.2.7.6 Entrapment of fingers - Monitor - No remedial work recommended

**Finding:** There is/are finger entrapment/s in the barrier and the item fails to meet the requirements of BS EN 1176 Part 1 4.2.7.6 Entrapment of fingers  
**Action:** Monitor - No remedial work recommended

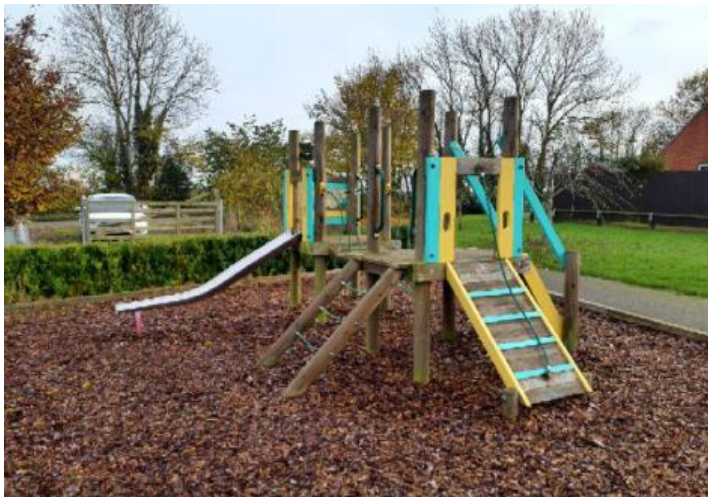
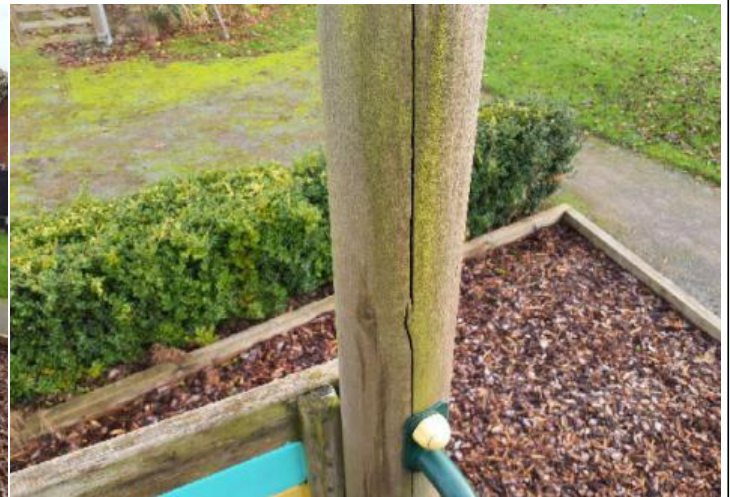
**i** 6 - Low Risk (Finding 5)

The timber has a number of splits/shakes or air cracks and this may affect the stability or allow water ingress which will accelerate the rotting process - Monitor to ensure the splits do not cross through fixing points of the structure and/or cause any instability

**Finding:** The timber has a number of splits/shakes or air cracks and this may affect the stability or allow water ingress which will accelerate the rotting process  
**Action:** Monitor to ensure the splits do not cross through fixing points of the structure and/or cause any instability
