## Annual Inspection

Carlton Parish Council

Toddlers Play Area

Carlton Diamond Jubilee Orchard, Nailstone Road /  
Northfields, Carlton, Nuneaton , CV13 0EW

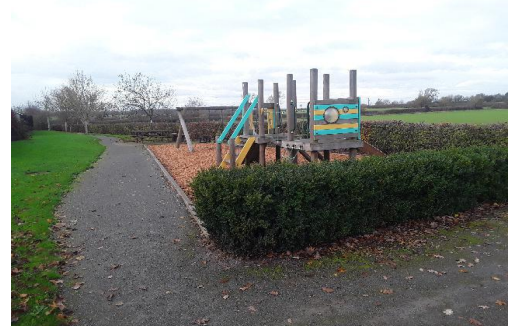
There is algae, silt or moss growth on the footpath surface resulting in slippery conditions - Clean and treat appropriately

There are trip hazards present over the raised edgings - Remove trip hazard

There is some tree debris present - Remove and maintain

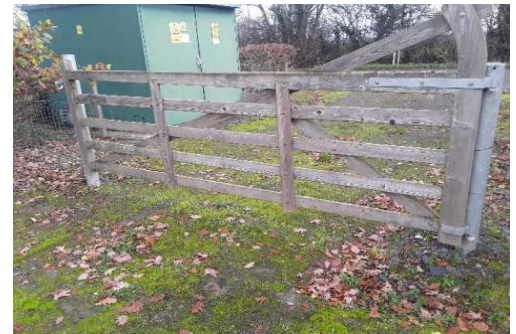
There are projecting bolt thread(s) present - Remove excess thread length and deburr or provide cap

The maintenance gate was correctly padlocked at the time of inspection, however this means that the inspector was unable to fully assess the gate - Ensure that there are 12mm gaps throughout the full range of motion on gate/s and between leaves where relevant

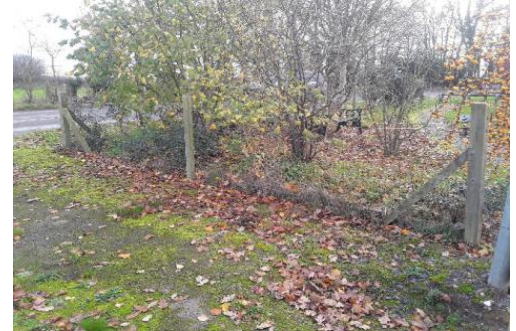
A number of posts have rotted at ground level - Replace the posts as required

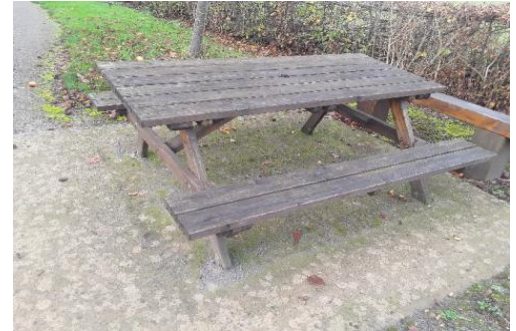
There is algae, silt or moss growth on the surface under the table - Clean and treat appropriately

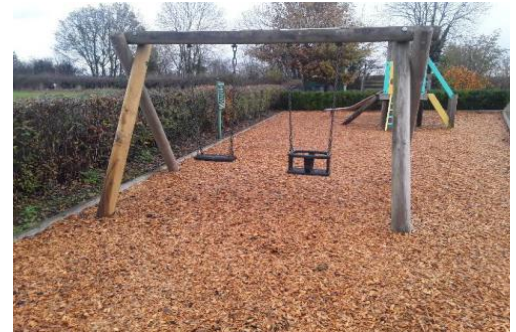
Hard wire bird deterrents have been used on the cross bar - Replace with a soft option such as rubber spikes or upturned cable ties

The bushes are showing signs of wear - Monitor for any further deterioration and replace as required

The seat clearance from finished surface level to the underside of the seat is too low and does not meet the requirements of BS EN 1176 Part 2 (350mm minimum clearance required) - Adjust seat height/s (400mm-500mm is recommended)

The chain openings are in excess of the 8.6mm as recommended by BS EN 1176 - Monitor - No action given the risk assessment

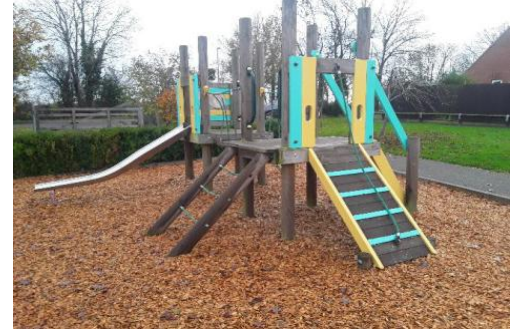
The timber has a number of splits/shakes or air cracks and this may affect the stability or allow water ingress which will accelerate the rotting process. Timber splits may also create rough / splintering edges. - Monitor, sand down any rough edges and ensure the splits do not cross through fixing points of the structure and/or cause any instability

There is some evidence of rot in the timber cladding adjacent to the slide entry - Monitor for any further deterioration and replace as required

There is/are finger entrapment/s in the barriers and the item fails to meet the requirements of BS EN 1176 Part 1 4.2.7.6 Entrapment of fingers - Monitor - No action given the risk assessment

There is algae or moss on the equipment - Clean and treat appropriately

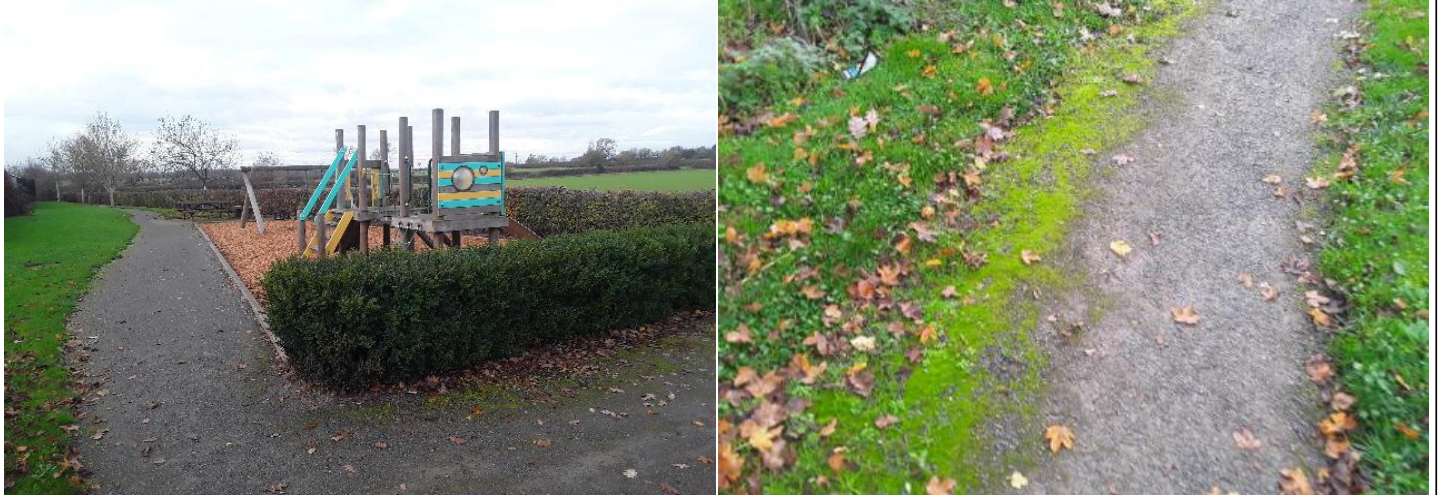
### 8 - Low Risk (Finding 1)

**Finding:** There is algae, silt or moss growth on the footpath surface resulting in slippery conditions  
**Action:** Clean and treat appropriately

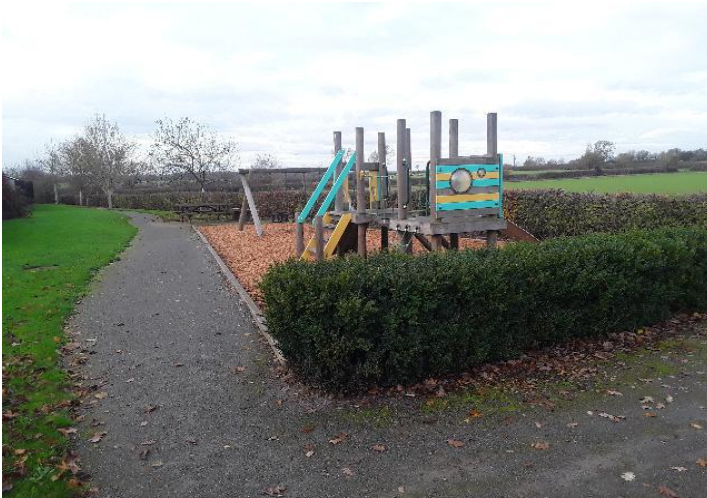
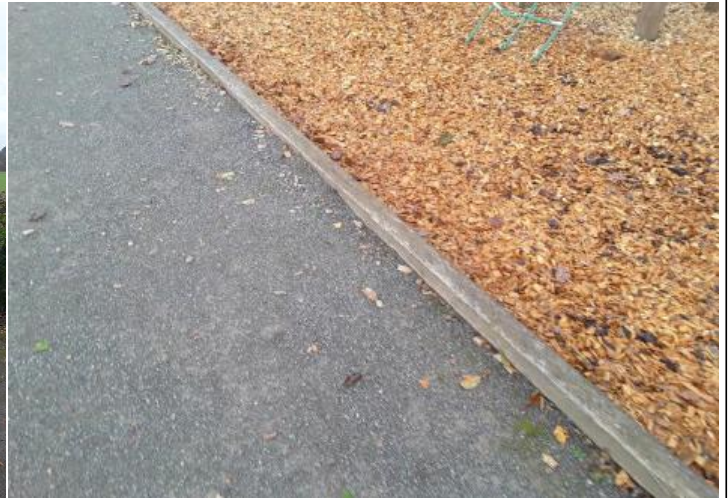
### 8 - Low Risk (Finding 2)

**Finding:** There are trip hazards present over the raised edgings

**Action:** Remove trip hazard

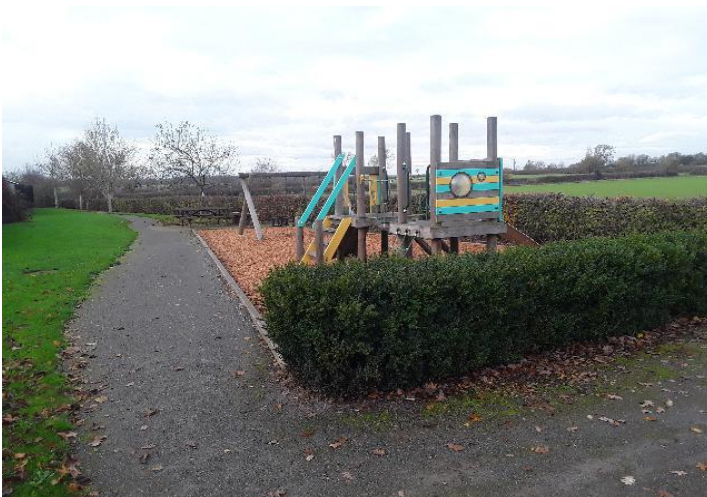
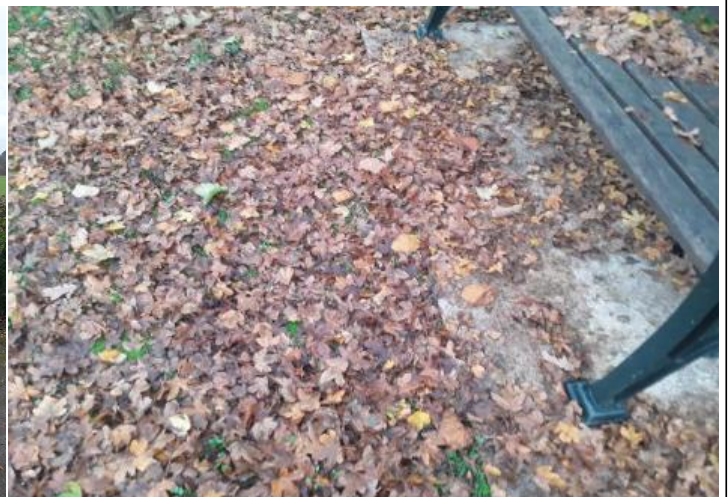
### 6 - Low Risk (Finding 3)

**Finding:** There is some tree debris present

**Action:** Remove and maintain

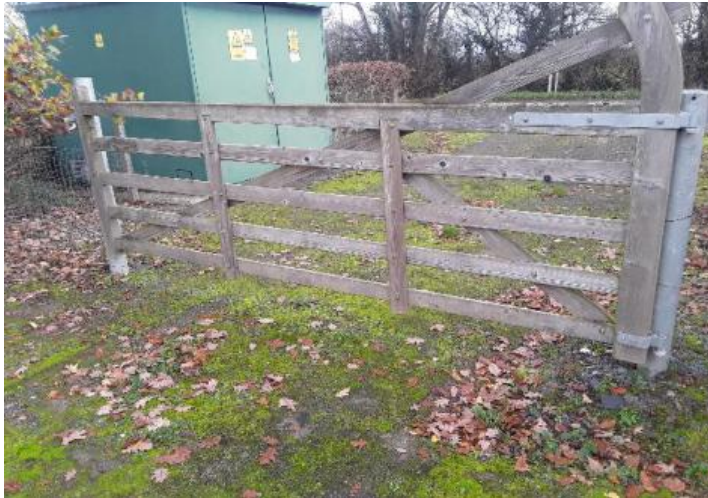
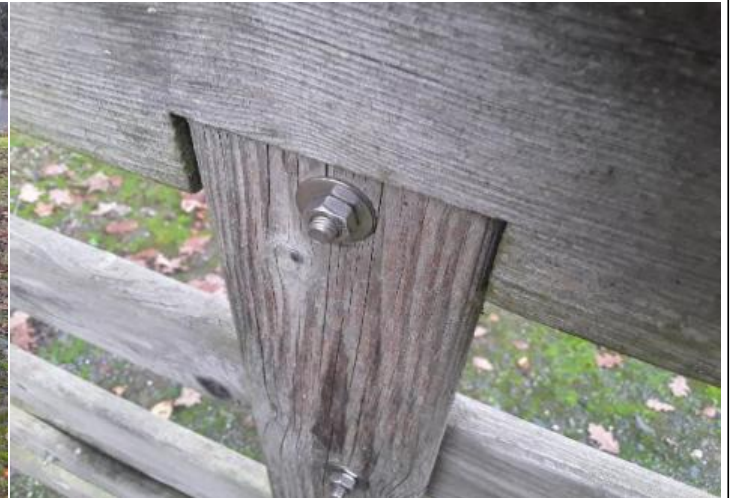
### 8 - Low Risk (Finding 1)

**Finding:** There are projecting bolt thread(s) present

**Action:** Remove excess thread length and deburr or provide cap

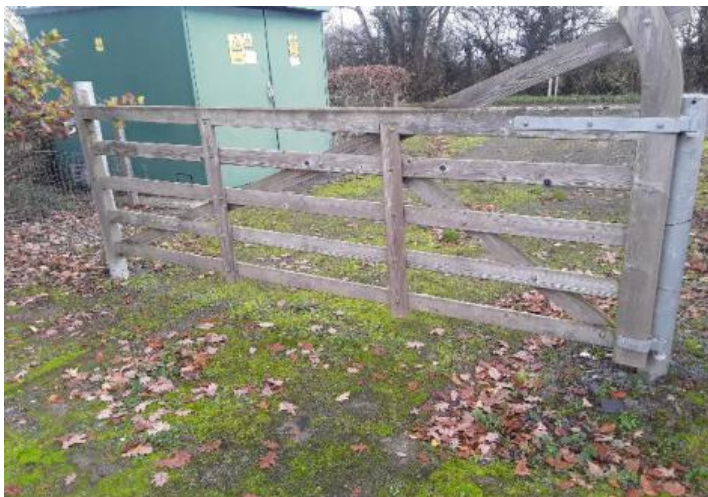
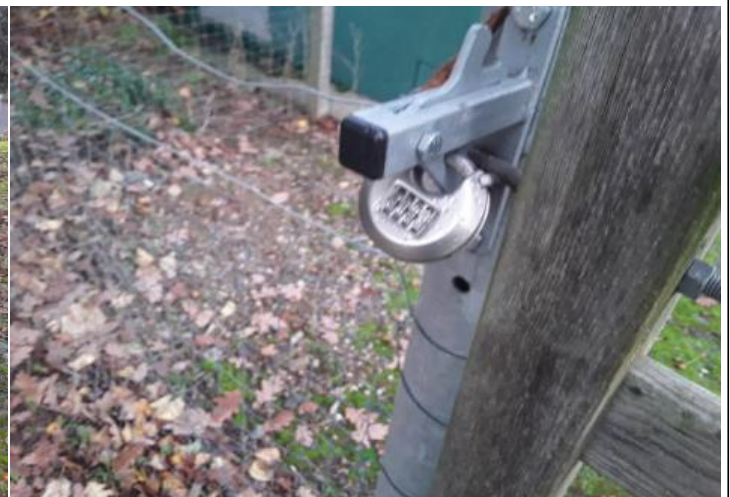
### 0 - Risk Assessment not Undertaken (Finding 2)

**Finding:** The maintenance gate was correctly padlocked at the time of inspection, however this means that the inspector was unable to fully assess the gate

**Action:** Ensure that there are 12mm gaps throughout the full range of motion on gate/s and between leaves where relevant

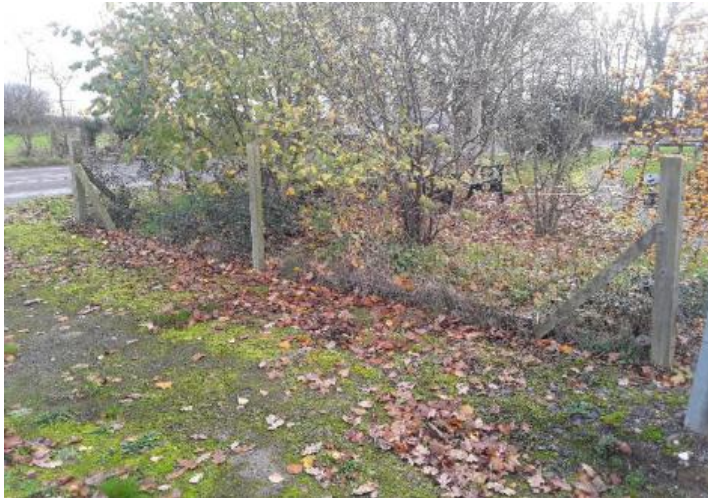
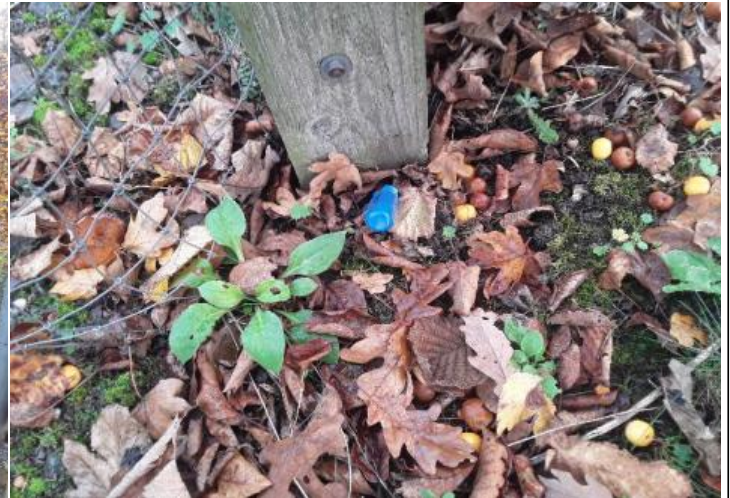
### 8 - Low Risk (Finding 1)

**Finding:** A number of posts have rotted at ground level

**Action:** Replace the posts as required

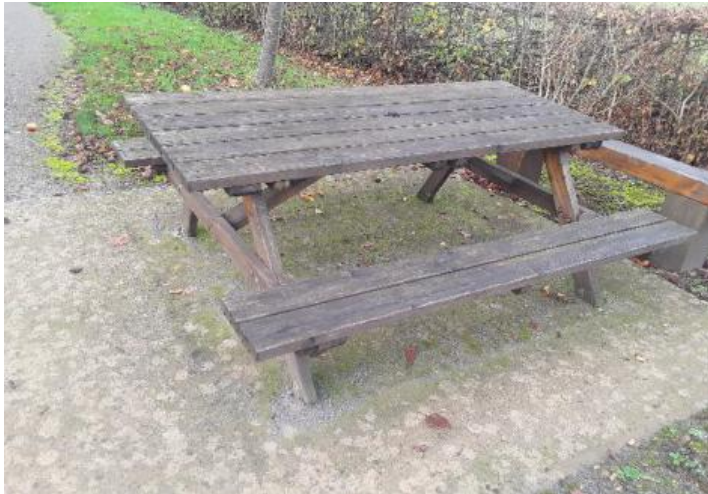
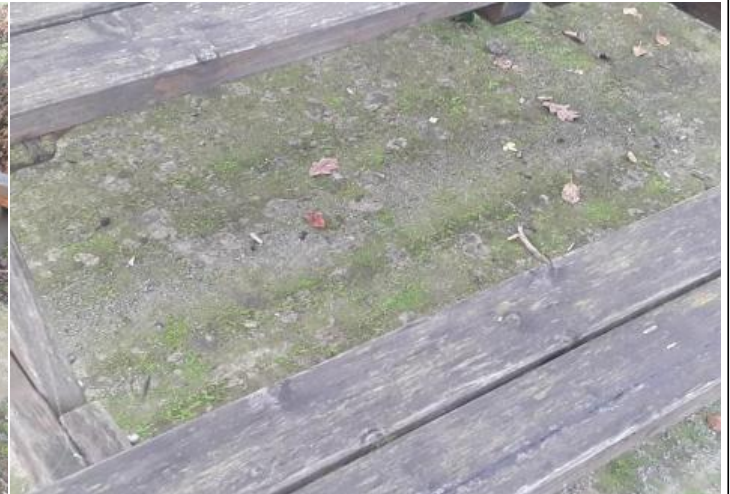
### 6 - Low Risk (Finding 1)

**Finding:** There is algae, silt or moss growth on the surface under the table

**Action:** Clean and treat appropriately

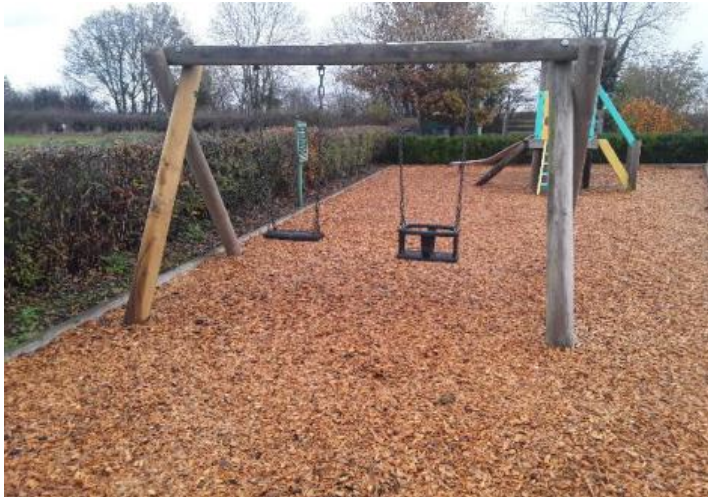
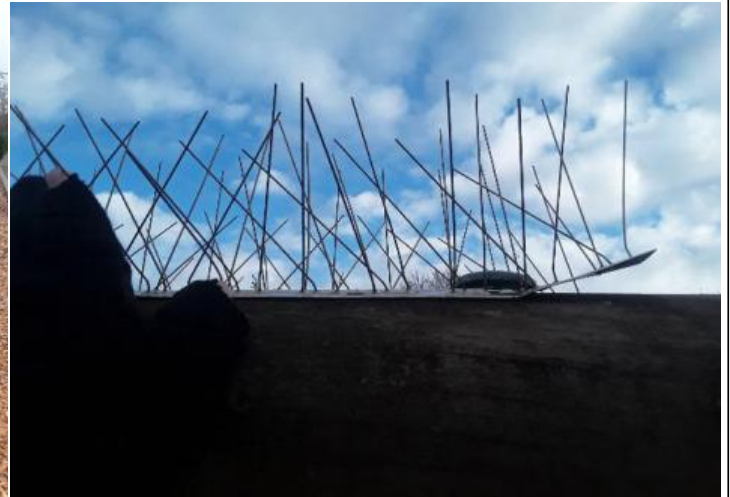
### 8 - Low Risk (Finding 1)

**Finding:** Hard wire bird deterrents have been used on the cross bar

**Action:** Replace with a soft option such as rubber spikes or upturned cable ties

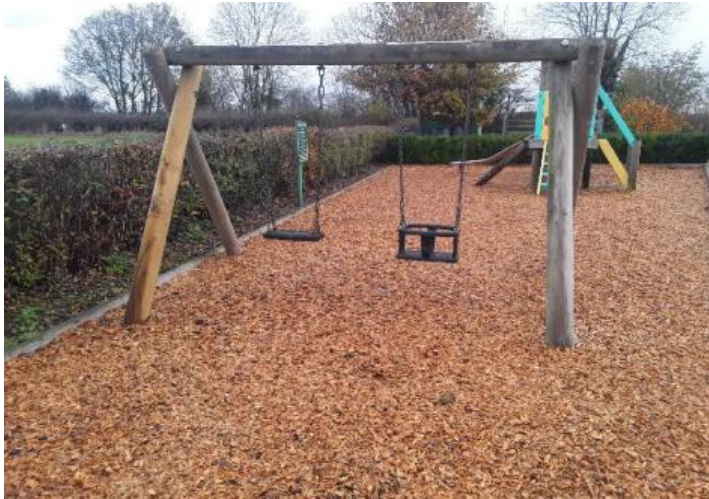
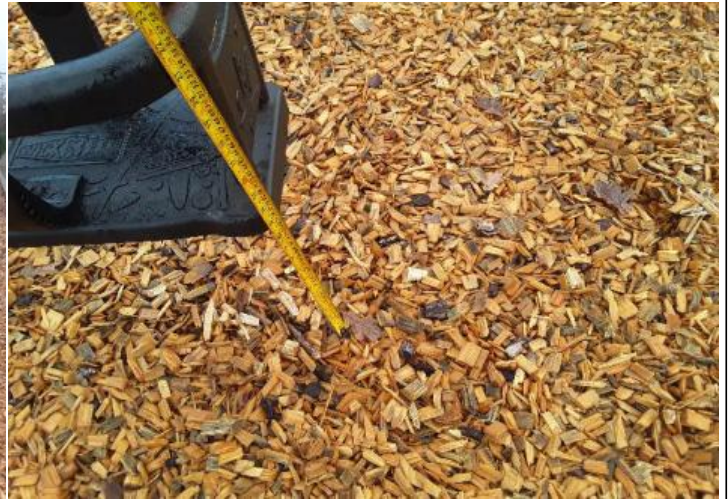
### 8 - Low Risk (Finding 3)

**Finding:** The seat clearance from finished surface level to the underside of the seat is too low and does not meet the requirements of BS EN 1176 Part 2 (350mm minimum clearance required)

**Action:** Adjust seat height/s (400mm-500mm is recommended)

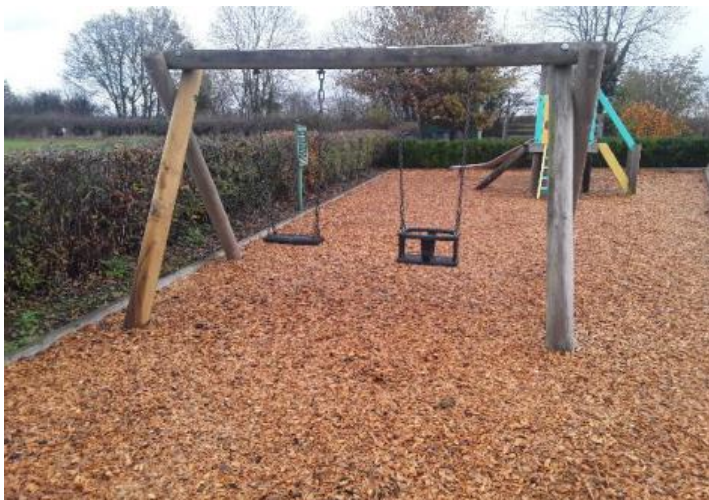
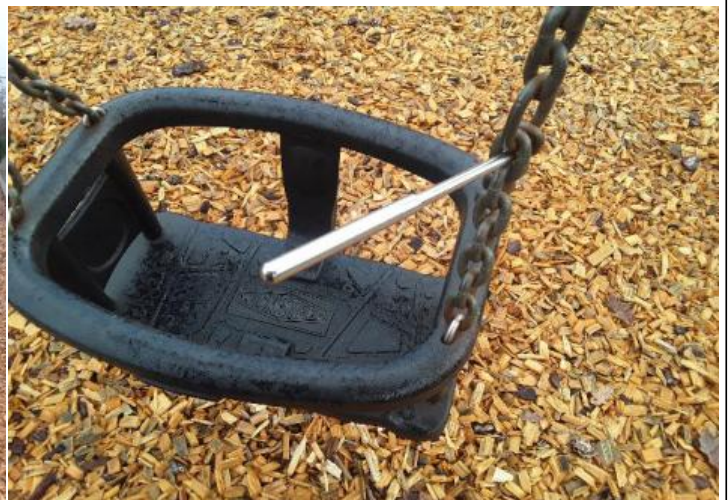
### 5 - Very Low Risk (Finding 4)

**Finding:** The chain openings are in excess of the 8.6mm as recommended by BS EN 1176

**Action:** Monitor - No action given the risk assessment

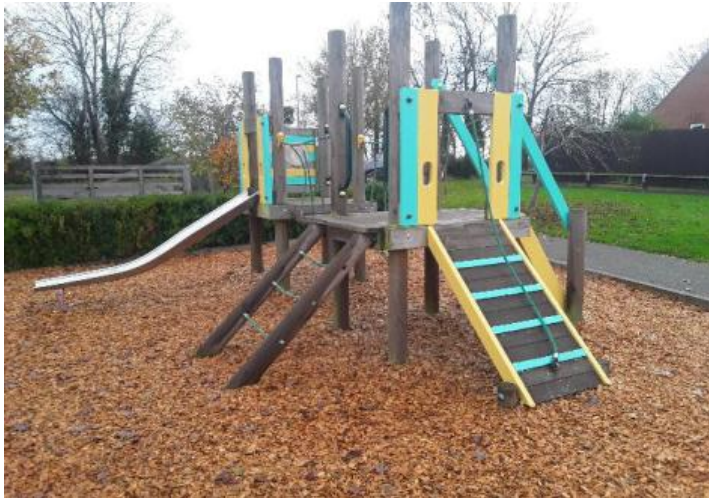
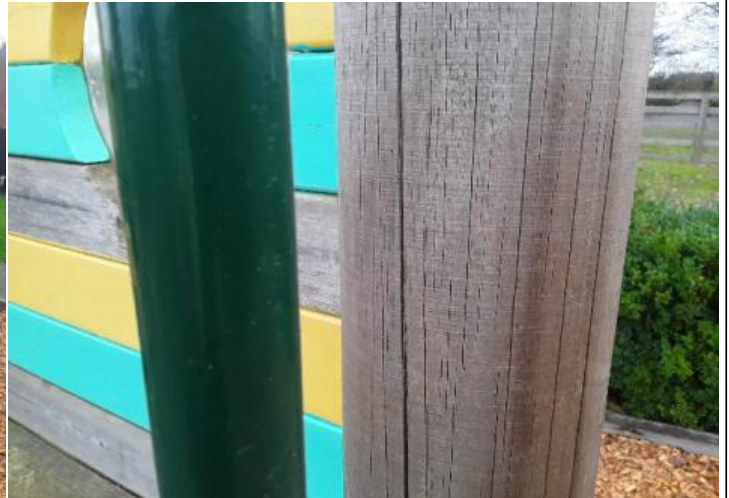
### 6 - Low Risk (Finding 1)

**Finding:** The timber has a number of splits/shakes or air cracks and this may affect the stability or allow water ingress which will accelerate the rotting process. Timber splits may also create rough / splintering edges.

**Action:** Monitor, sand down any rough edges and ensure the splits do not cross through fixing points of the structure and/or cause any instability

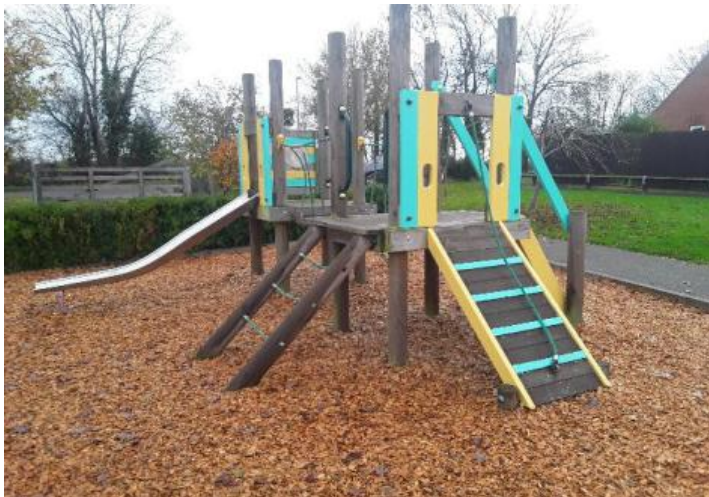
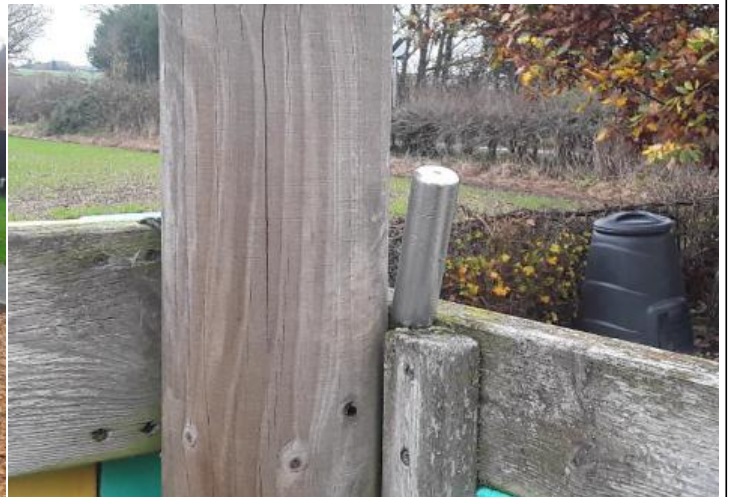
### 5 - Very Low Risk (Finding 2)

**Finding:** There is/are finger entrapment/s in the barriers and the item fails to meet the requirements of BS EN 1176 Part 1 4.2.7.6 Entrapment of fingers

**Action:** Monitor - No action given the risk assessment

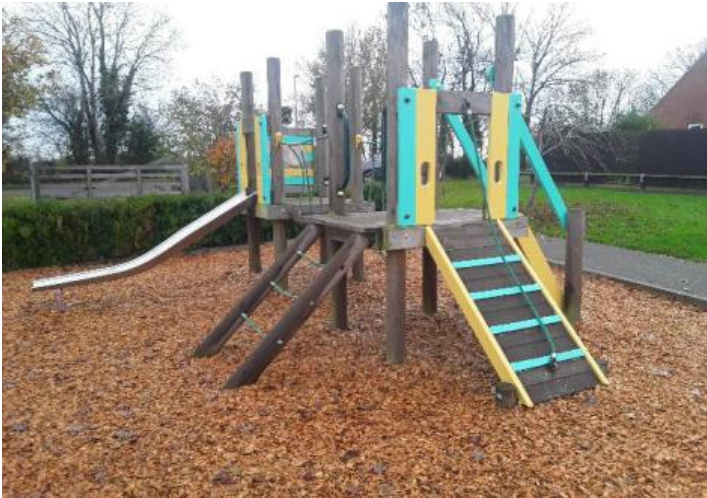
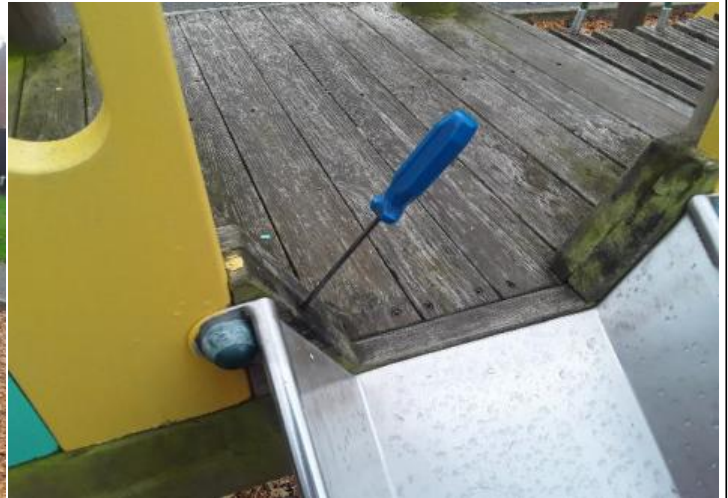
### 6 - Low Risk (Finding 3)

**Finding:** There is some evidence of rot in the timber cladding adjacent to the slide entry

**Action:** Monitor for any further deterioration and replace as required

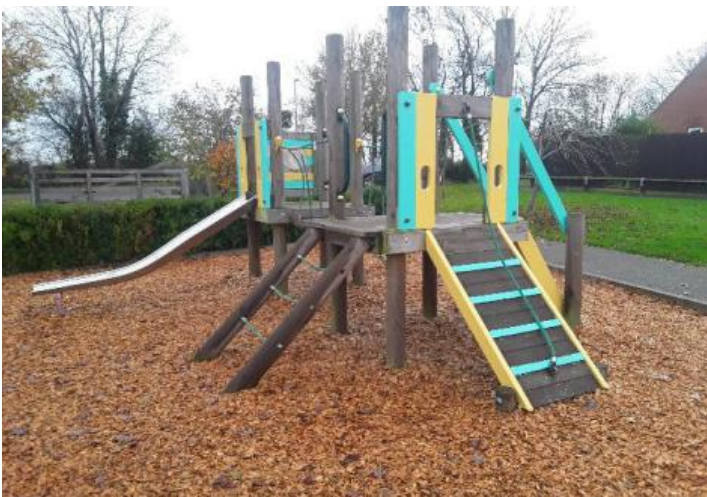
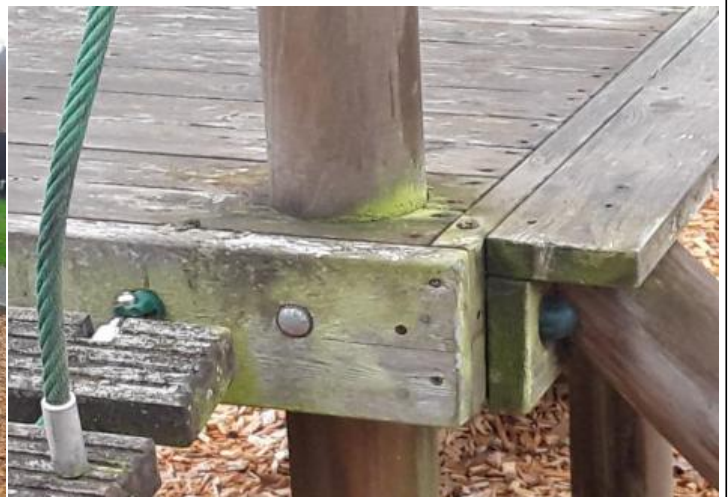
### 6 - Low Risk (Finding 4)

**Finding:** There is algae or moss on the equipment

**Action:** Clean and treat appropriately
