Annual Inspection

Carlton Parish Council

Toddlers Play Area

Carlton Diamond Jubilee Orchard, Nailstone Road,
Carlton, Nuneaton , CV13 0BN

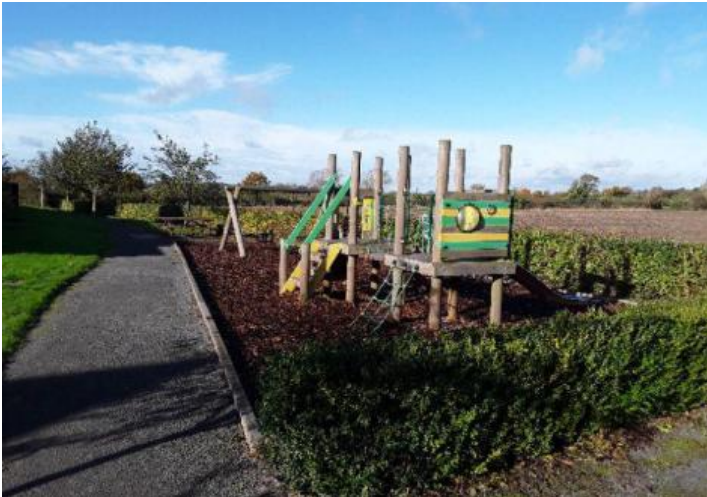
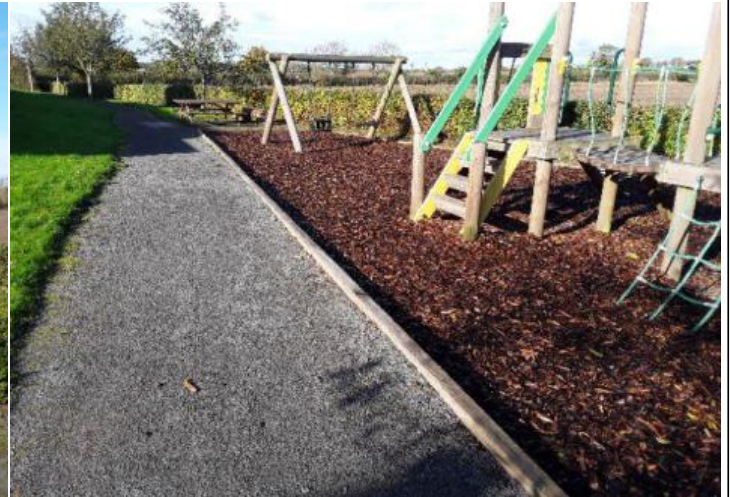
i 8 - Low Risk (Finding 1)

Finding: There are trip hazards at the edges of the surface

Action: Reinstate surrounding surface levels to remove the trip points

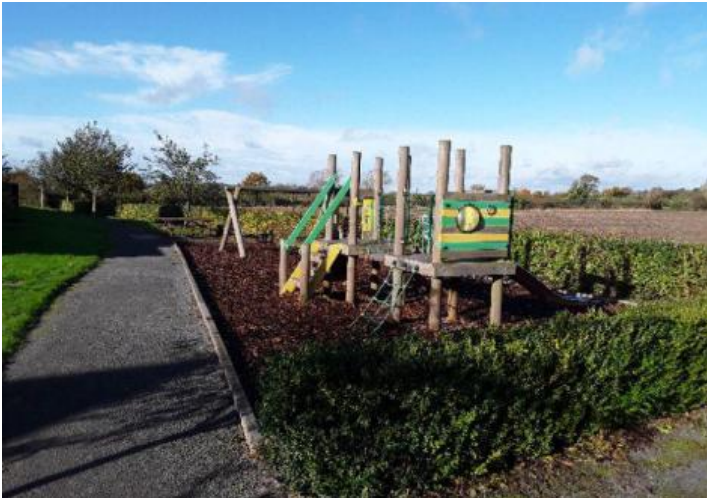
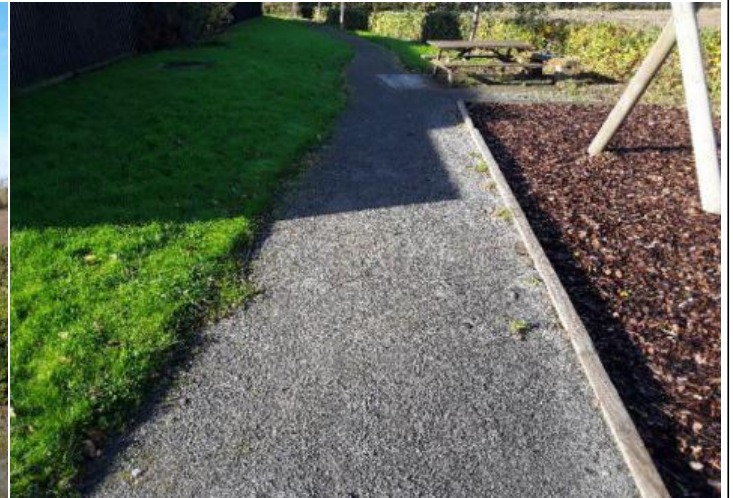
i 6 - Low Risk (Finding 2)

Finding: There is weed / vegetation growth on, between, or around the edges of the surfacing
Action: Remove weed / vegetation growth

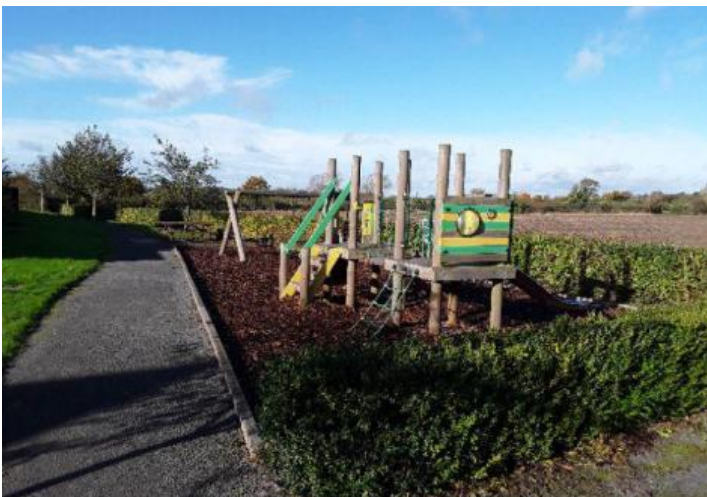
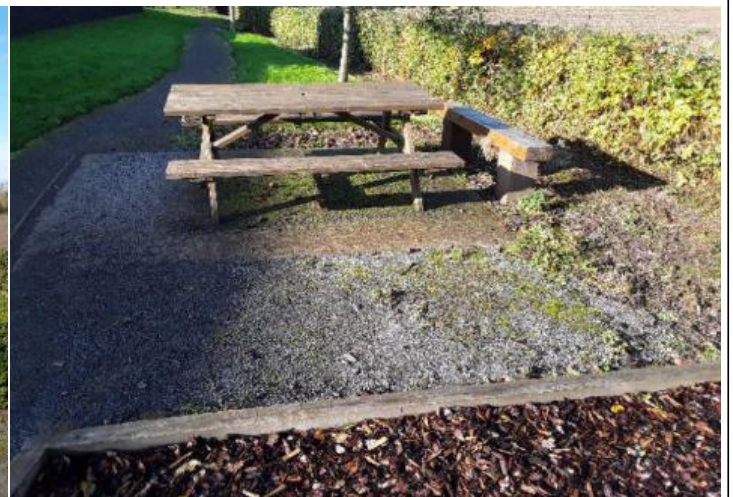
i 6 - Low Risk (Finding 3)

Finding: There is algae, silt or moss growth on the surface resulting in slippery conditions
Action: Clean and treat appropriately

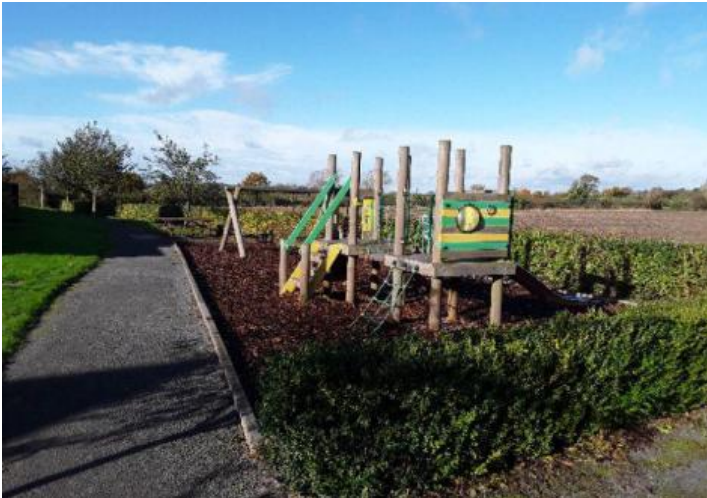
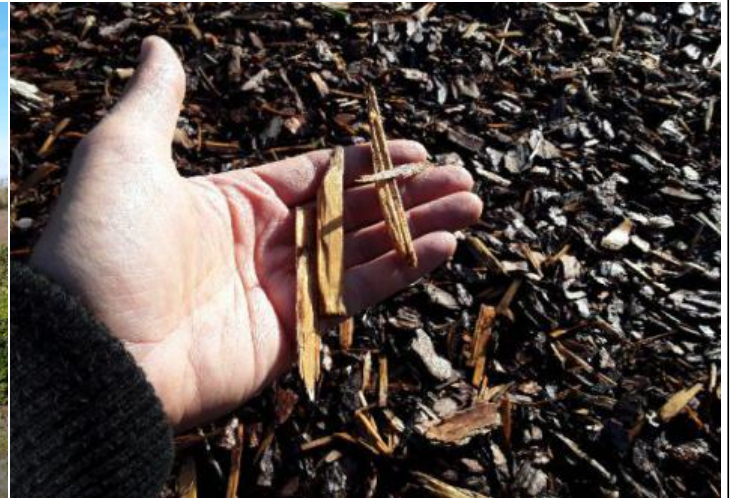
i 8 - Low Risk (Finding 4)

Finding: There are some particles present within the surface that comprise of long, shard like pieces and carry some risk of puncture injuries

Action: We would recommend that any long, shard like pieces are hand picked and removed from the area as they appear

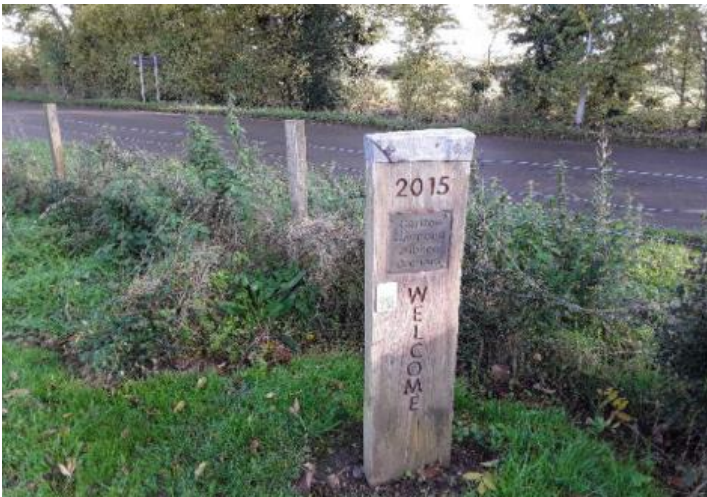
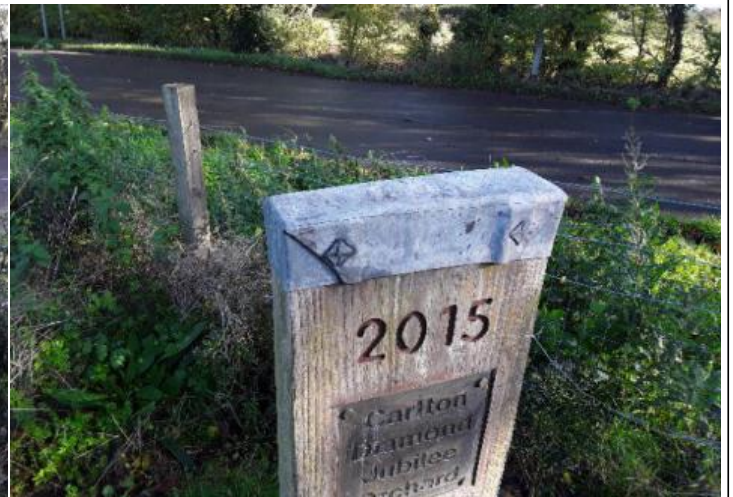
i 0 - Risk Assessment not Undertaken (Finding 1)

Finding: Lead flashing has been used to form a cap on the top of the sign

Action: Refer to the supplier for a toxicology assessment

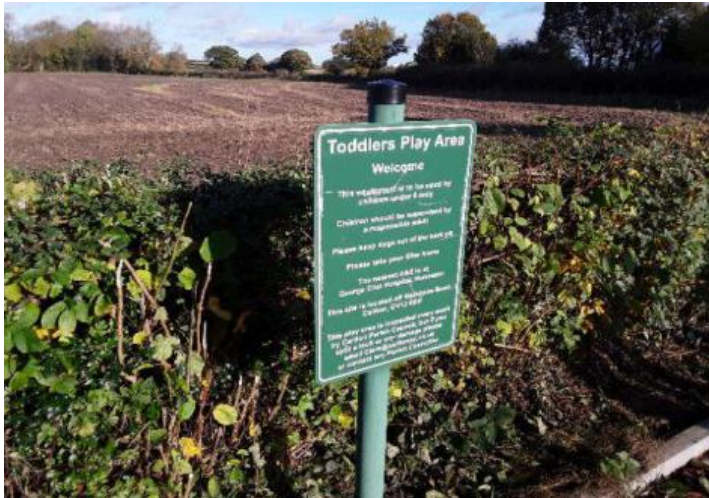
i 5 - Very Low Risk (Finding 1)

Finding: BS EN 1176 Part 7 recommends that signage shall include the site name / address
Action: Provide additional information

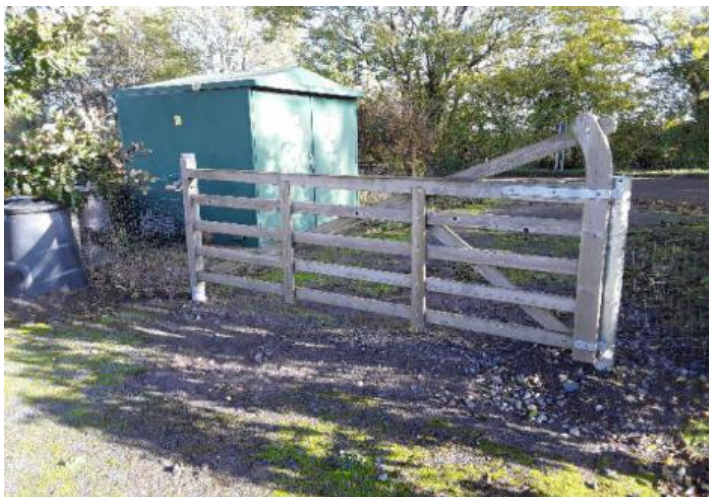
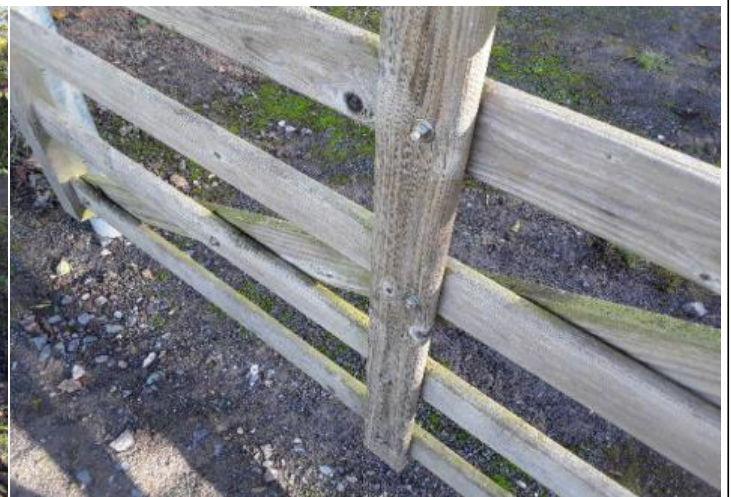
i 8 - Low Risk (Finding 1)

Finding: There are projecting bolt thread(s) present

Action: Remove excess thread length and deburr or provide cap

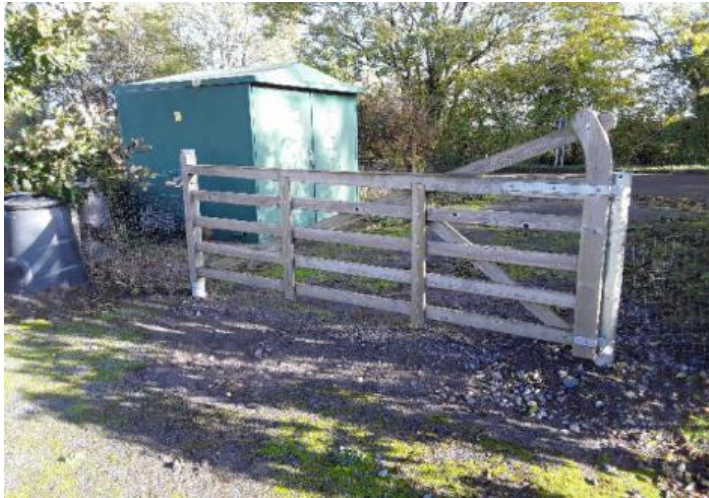
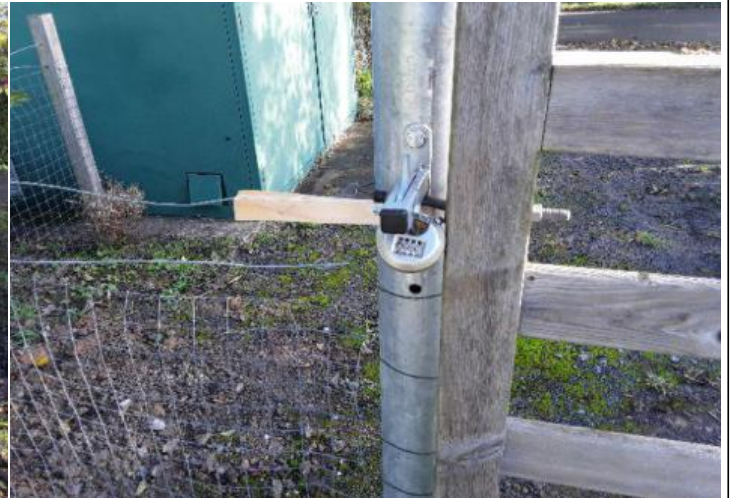
i 0 - Risk Assessment not Undertaken (Finding 2)

Finding: The maintenance gate was correctly padlocked at the time of inspection, however this means that the inspector was unable to fully assess the gate

Action: Ensure that there are 12mm gaps throughout the full range of motion on gate/s and between leaves where relevant

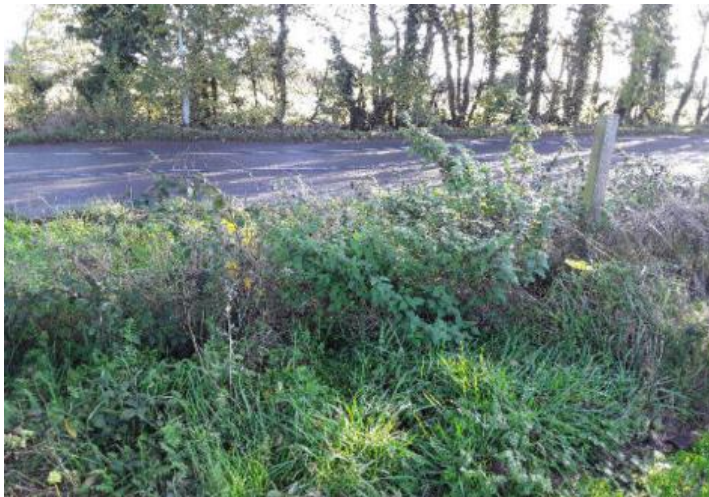
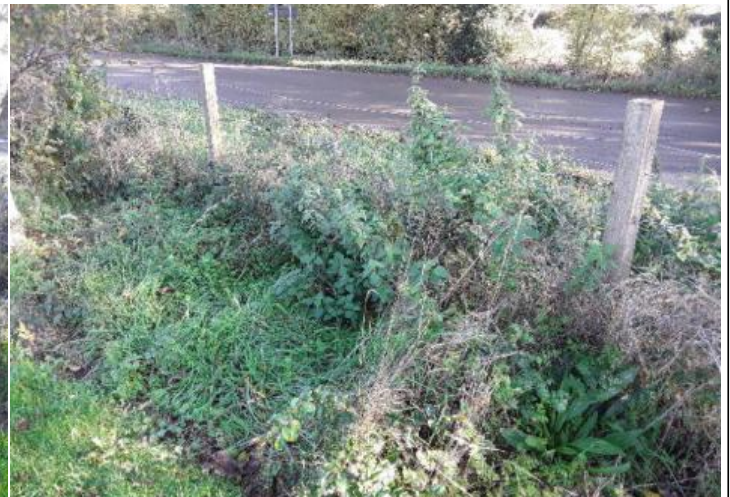
i 6 - Low Risk (Finding 1)

Finding: The adjacent foliage is overhanging

Action: Cut back and maintain

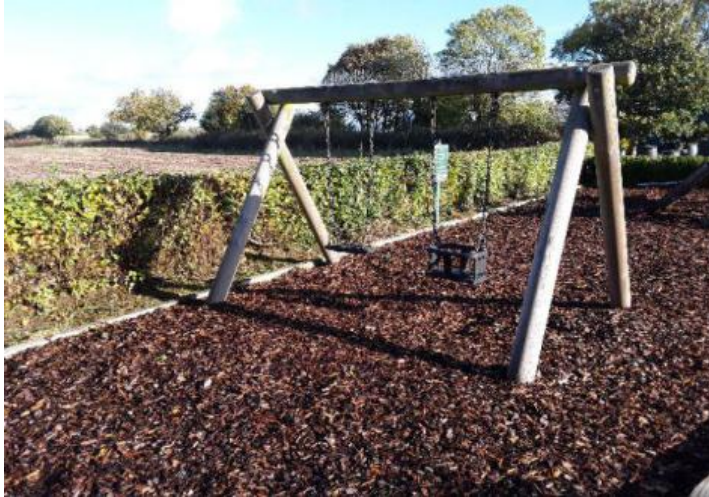
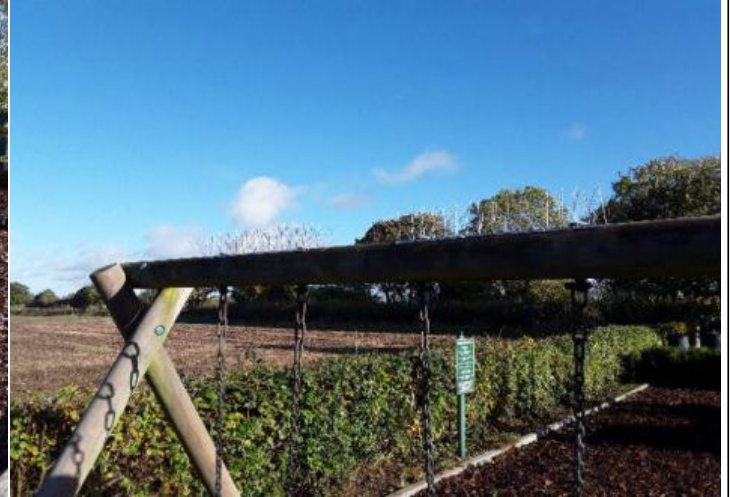
i 6 - Low Risk (Finding 1)

Finding: Bird deterrent spikes have been fitted to the swing and present hazards

Action: Remove and replace with upturned cable ties

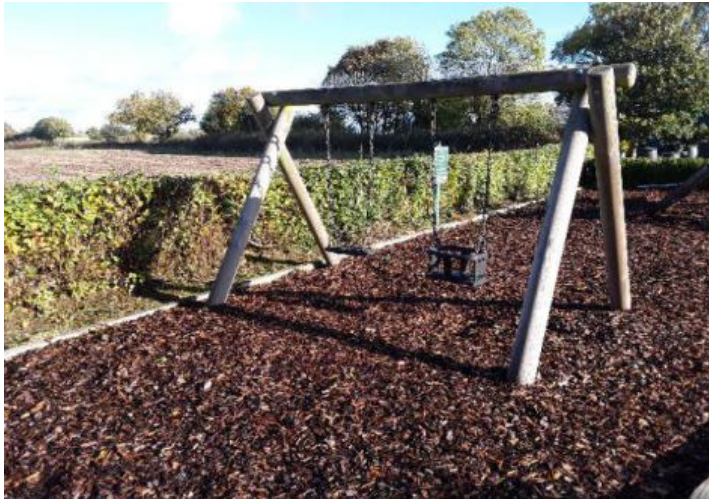
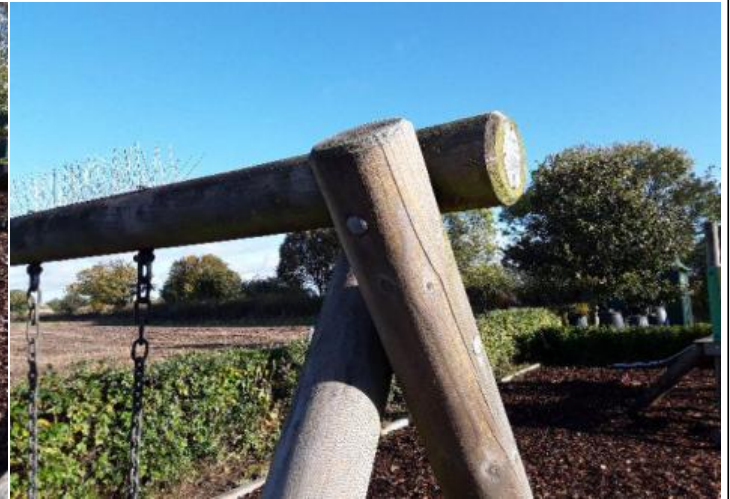
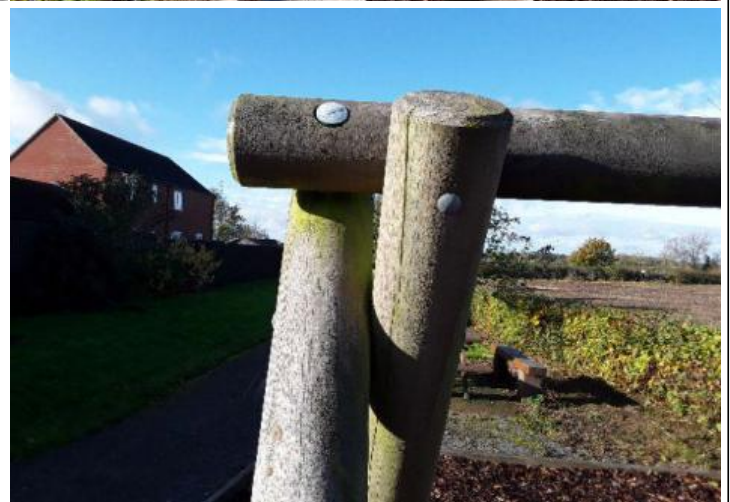
i 6 - Low Risk (Finding 2)

Finding: The timber has a number of splits/shakes or air cracks and this may affect the stability or allow water ingress which will accelerate the rotting process

Action: Monitor to ensure the splits do not cross through fixing points of the structure and/or cause any instability

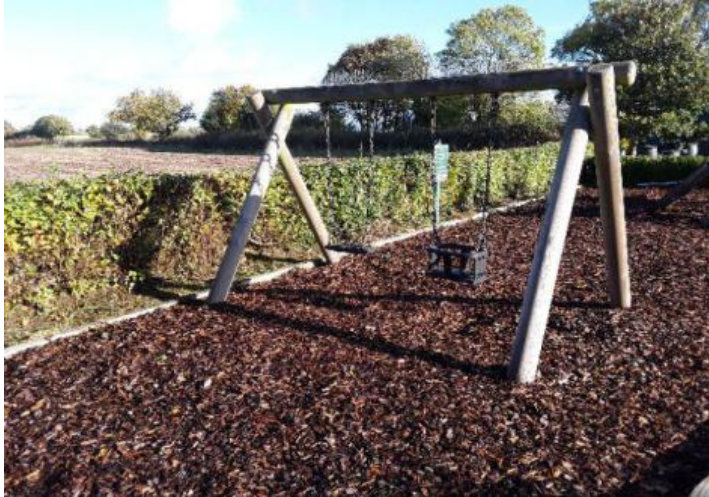
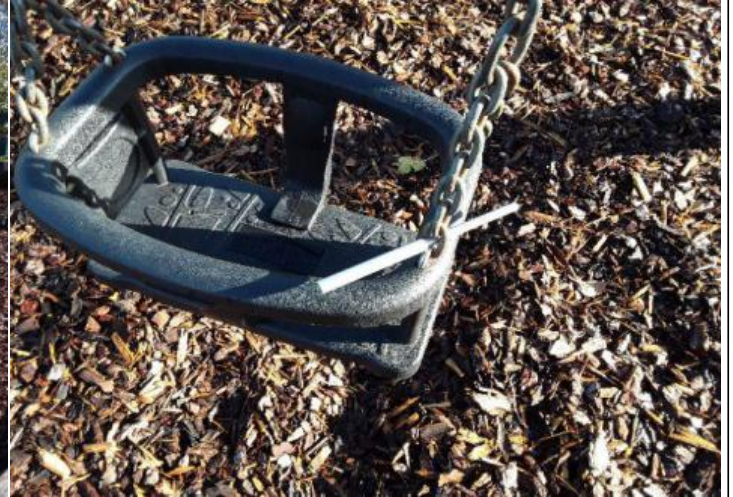
i 5 - Very Low Risk (Finding 3)

Finding: The chain openings are in excess of 8.6mm and do not meet the recommendations of BS EN 1176 Part 1

Action: Monitor - No remedial work recommended

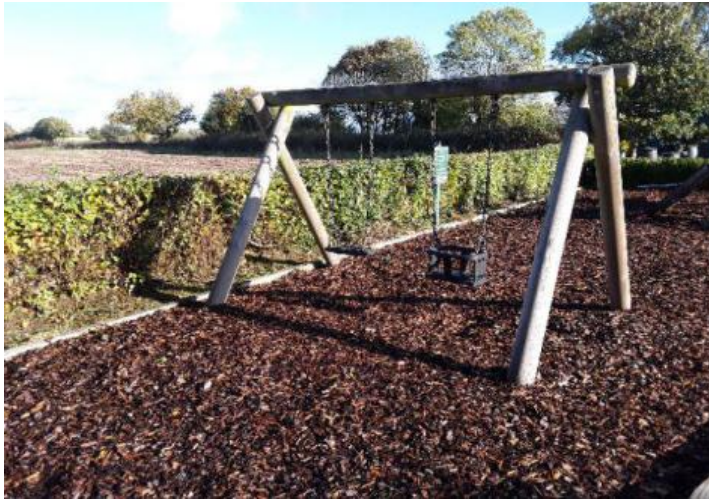
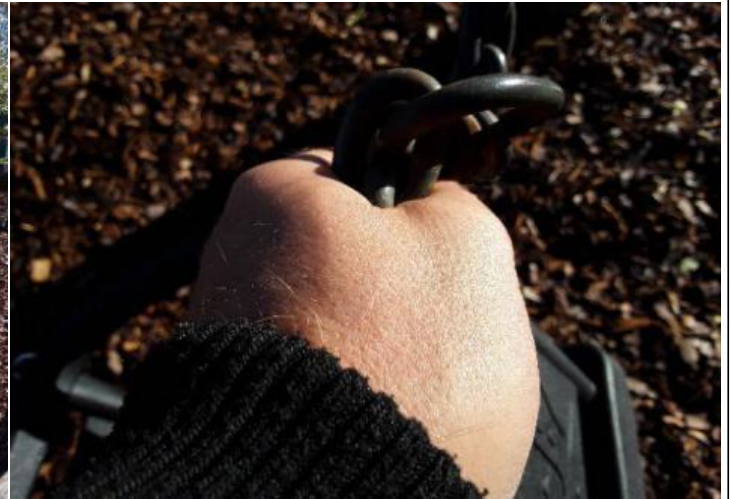
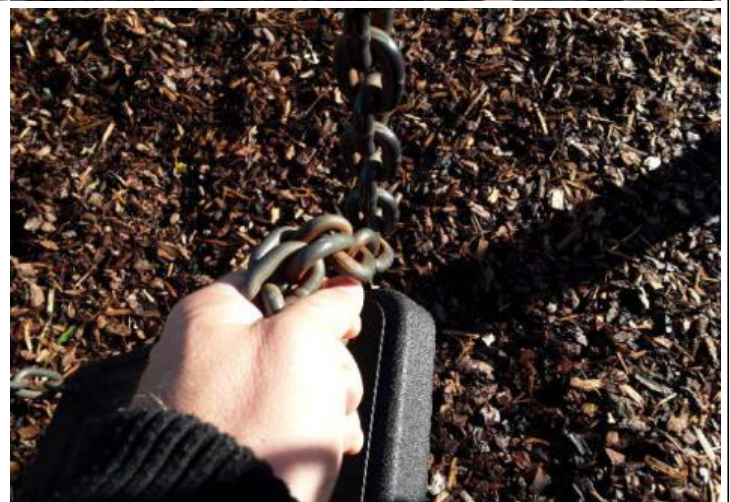
i 6 - Low Risk (Finding 4)

Finding: There is some notable evidence of chain wear

Action: Monitor for any further deterioration and replace when 40% worn

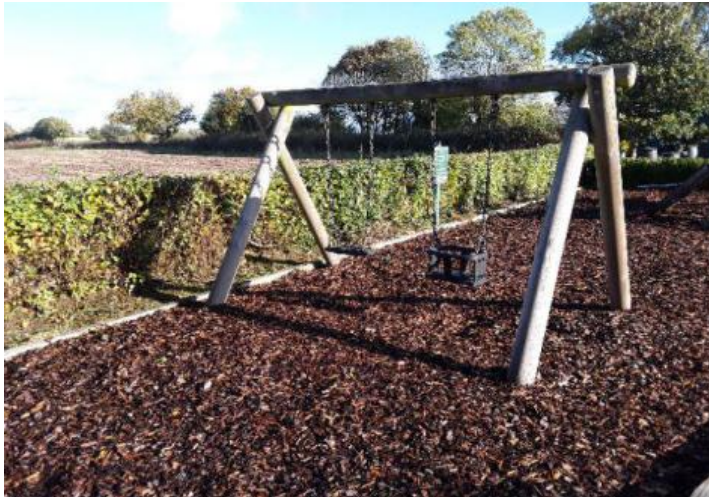
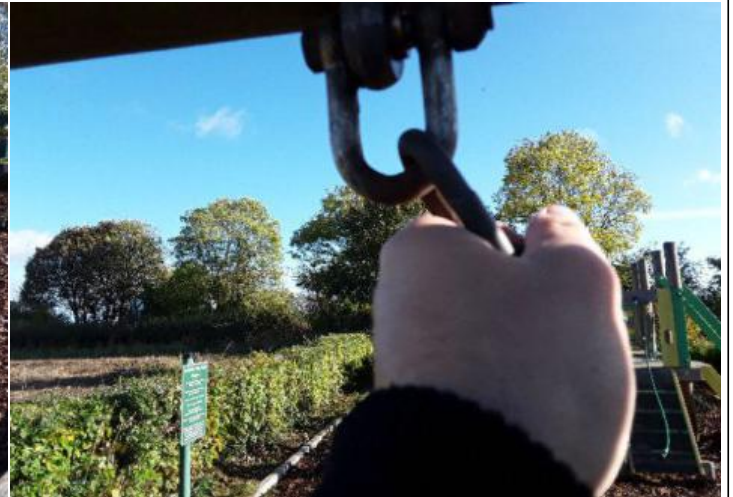
6 - Low Risk (Finding 5)

Finding: There is some wear to the shackles

Action: Monitor for any further deterioration and replace when 40% worn

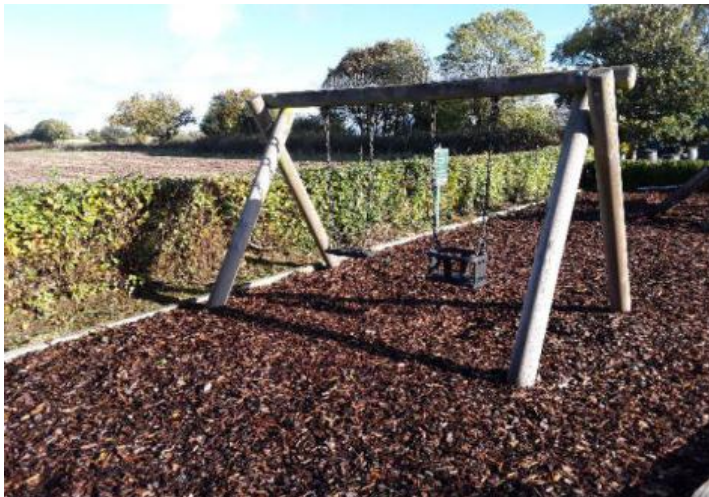
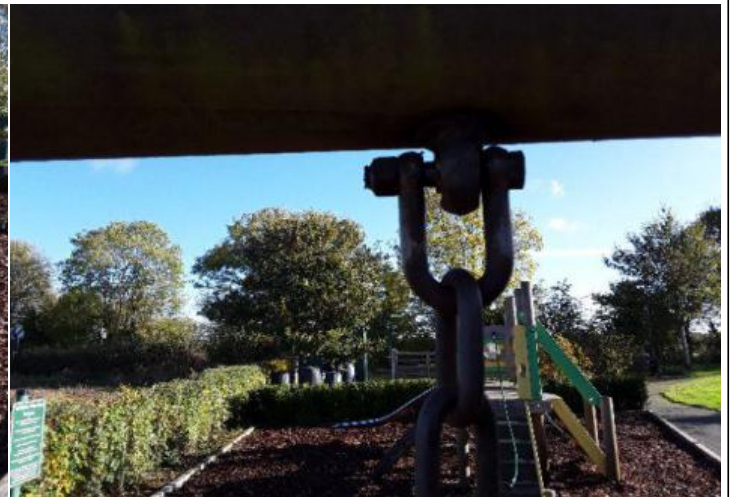
8 - Low Risk (Finding 6)

Finding: The bushes are worn or missing

Action: Replace worn or missing bushes

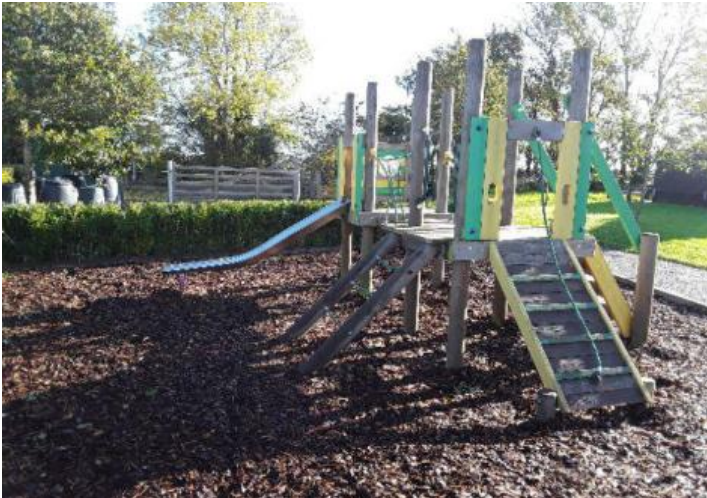
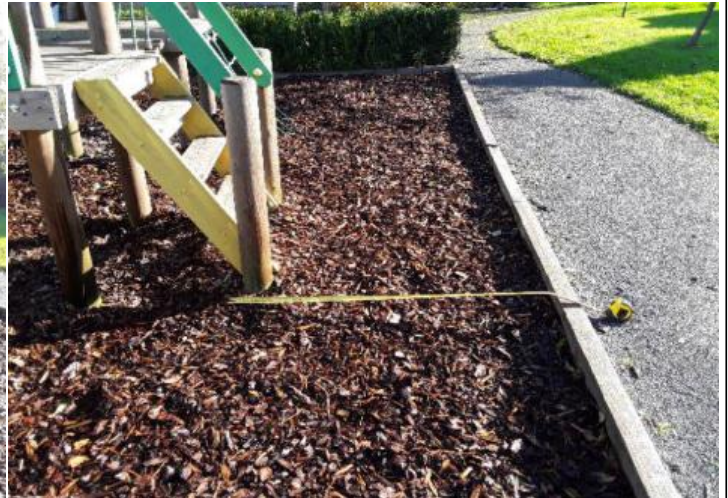
i 8 - Low Risk (Finding 1)

Finding: The raised timber edging forms a hard object within the impact area of the equipment in contravention of the requirements of BS EN 1176 Part 1

Action: Monitor - No remedial work recommended

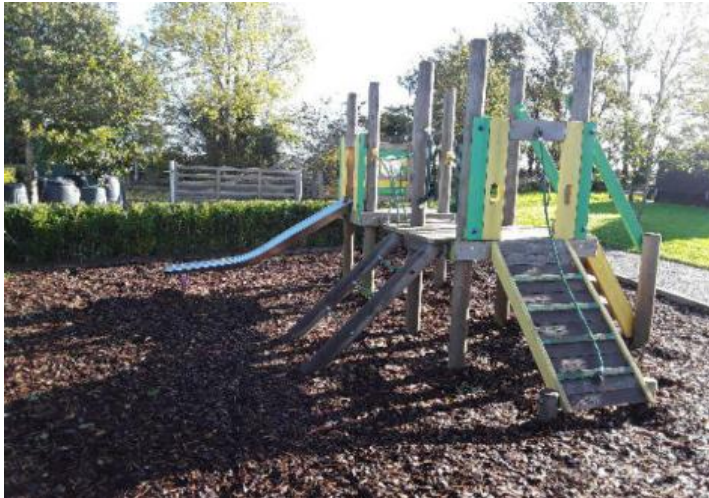
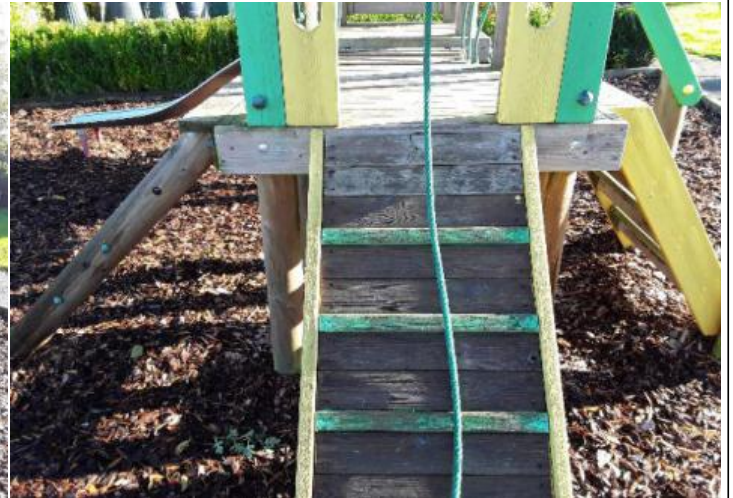
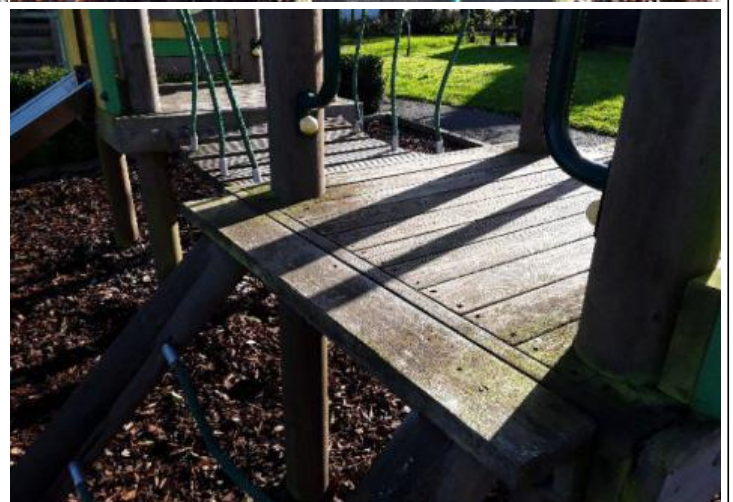
i 8 - Low Risk (Finding 2)

Finding: There is algae or moss on the surface of the equipment

Action: Clean and treat appropriately

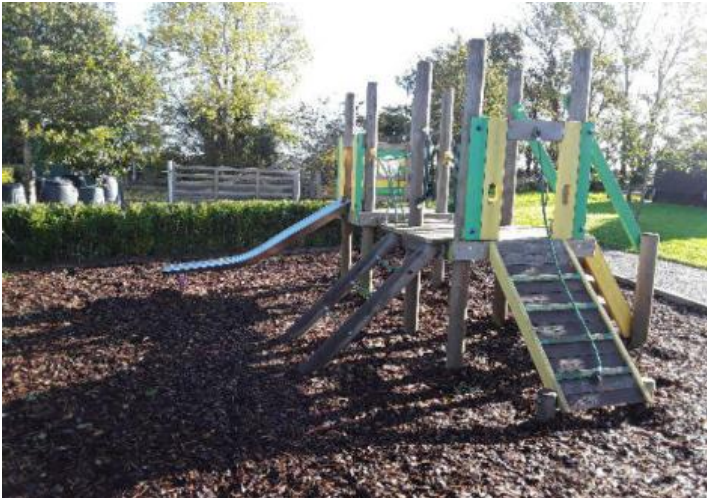
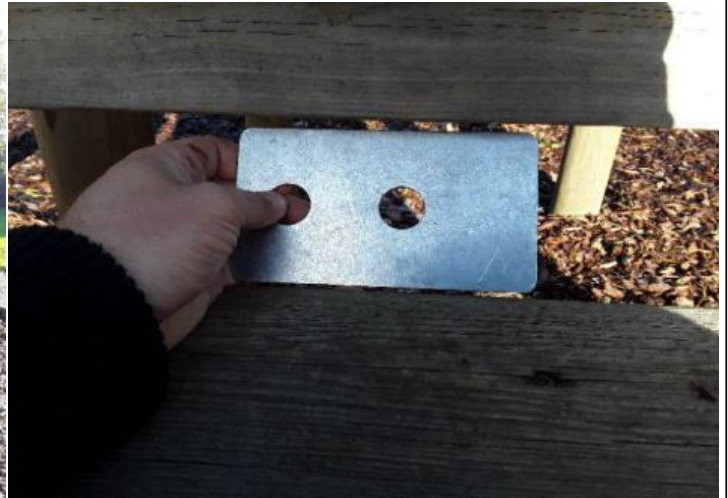
i 5 - Very Low Risk (Finding 3)

Finding: The item fails to meet the requirements of BS EN 1176 Part 1 4.2.7.2 head and neck entrapment in the barriers and/or steps

Action: Monitor - No remedial work recommended

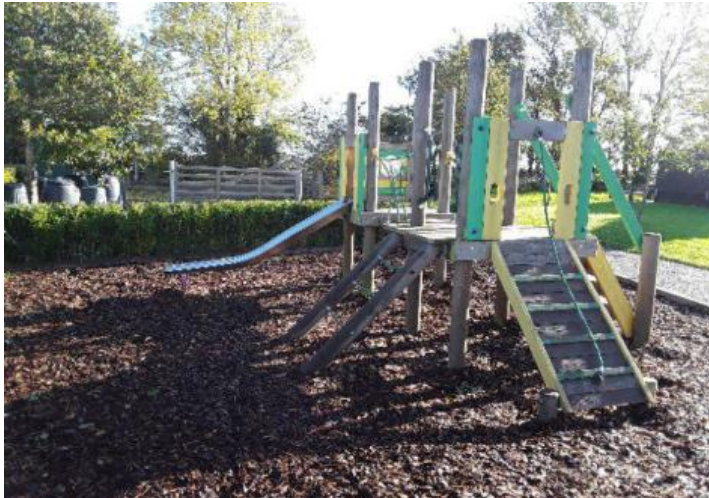
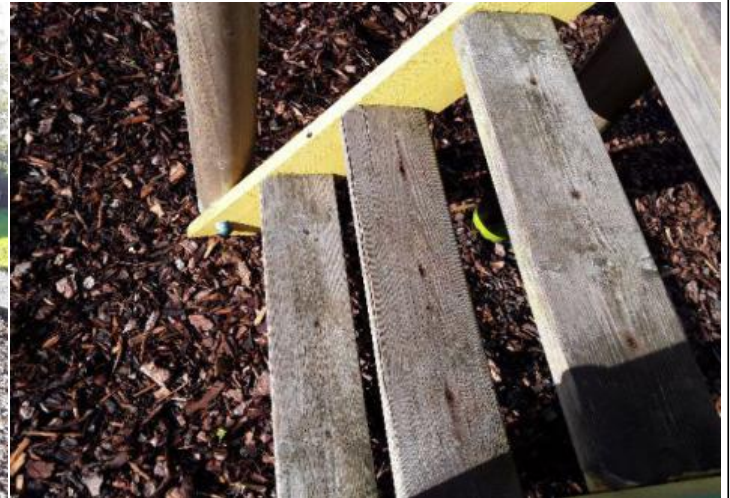
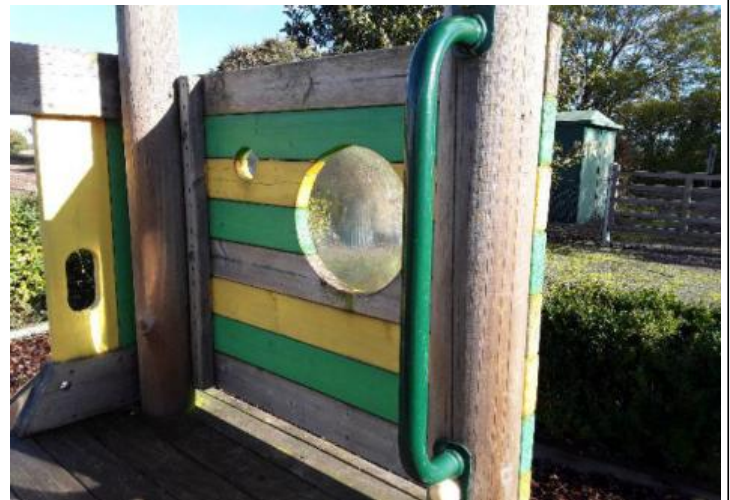
i 6 - Low Risk (Finding 4)

Finding: The timber has a number of splits/shakes or air cracks and this may affect the stability or allow water ingress which will accelerate the rotting process

Action: Monitor to ensure the splits do not cross through fixing points of the structure and/or cause any instability

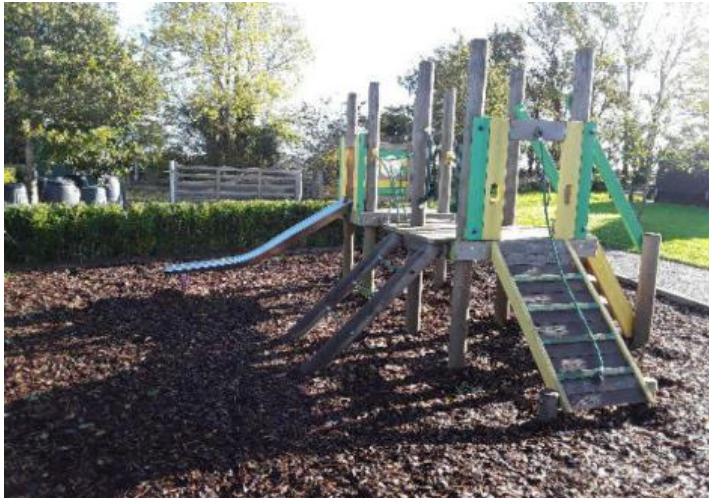
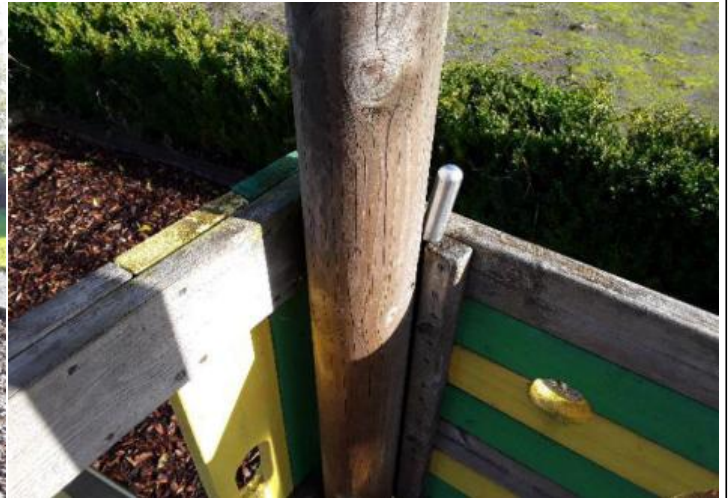
i 5 - Very Low Risk (Finding 5)

Finding: There is/are finger entrapment/s in the barrier and the item fails to meet the requirements of BS EN 1176 Part 1 4.2.7.6 Entrapment of fingers
Action: Monitor - No remedial work recommended
