Carlton Hall research

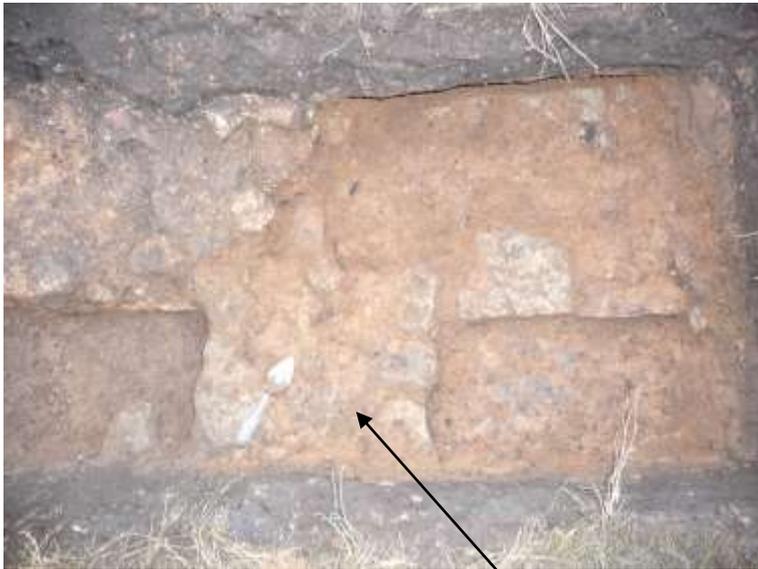
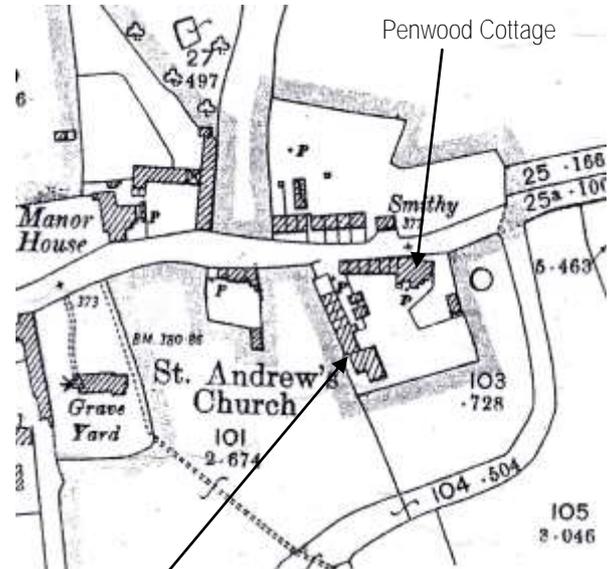
Wall of Carlton Stone joining south wall of cellar at this point

The only trace of the larger building to the south of the cellar was a short length of wall built of Carlton Stone at the southern end of the brickwork footings. The brick buildings are thought to be of late 17th century date, based on the large number of pottery fragments of this age found alongside them.

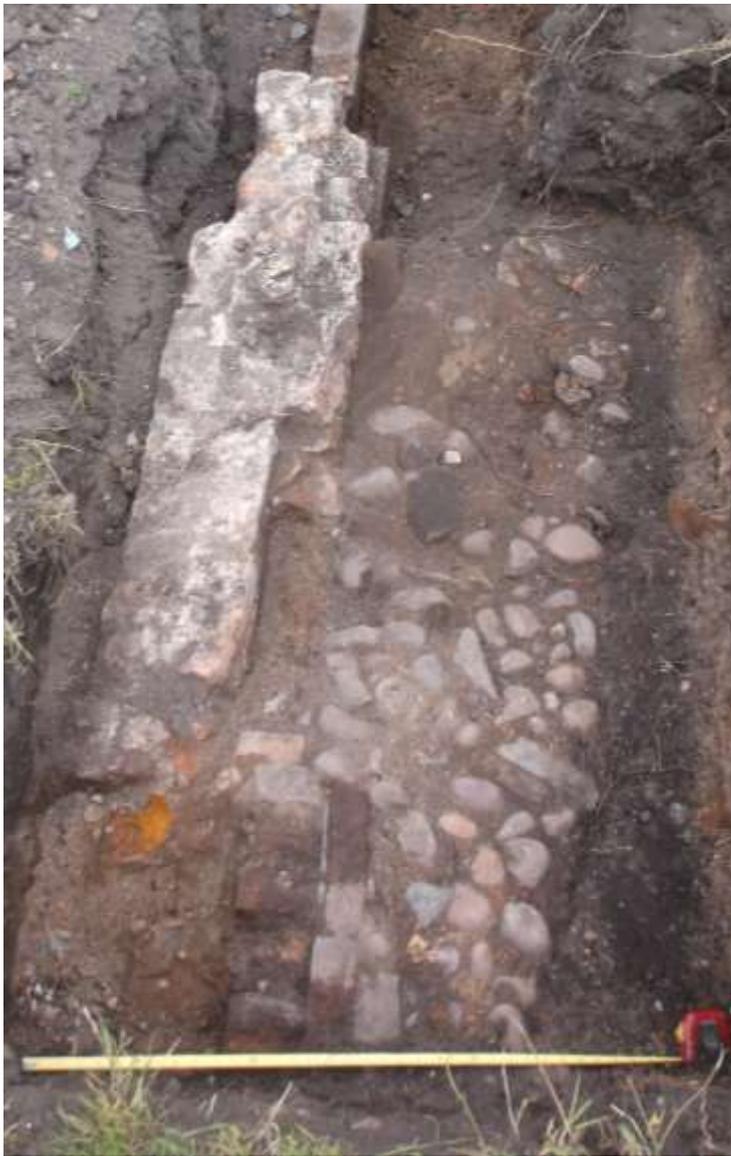
Above: inside eastern wall of cellar - note brick arch above well and lead pipe which carried water to Penwood Cottage

Excavations revealed the brickwork footings of the line of buildings along the western edge of the site, which had a cellar at the southern end. The south western corner of the cellar was illustrated in the Feb 2017 issue of Carlton News. The picture on the opposite page shows the eastern wall of the cellar, and the top of an arch which supported the wall above a well. The lead pipe carried water from the well to a hand pump in Penwood Cottage.
