# the play inspection company

## Annual Inspection

Carlton Parish Council

Toddlers Play Area

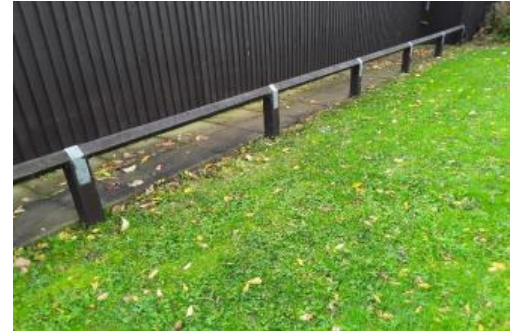
**Item:** Fencing - Post & Rail  
**Manufacturer:** Not Identified  
**Surface Type:** Grass  
**Item Quantity:** 1  
**Equipment Compliance:** N/A  
**Surface Area Compliance:** N/A  
**Life Expectancy:** 5 -10 Years  
**Total Findings:** 1

**Finding 1**

This item is satisfactory - no work required -

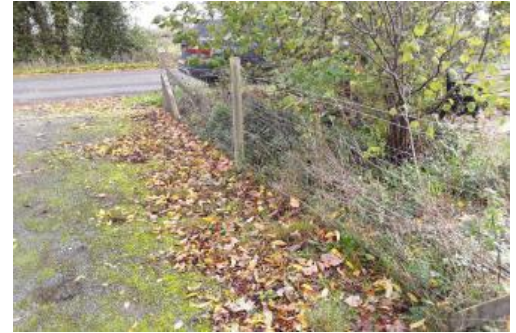
**Item:** Fence - Timber & Mesh Infill  
**Manufacturer:** Not Identified  
**Surface Type:** Soil  
**Item Quantity:** 1  
**Equipment Compliance:** N/A  
**Surface Area Compliance:** N/A  
**Life Expectancy:** 5 -10 Years  
**Total Findings:** 1

**Finding 1**

This item is satisfactory - no work required -

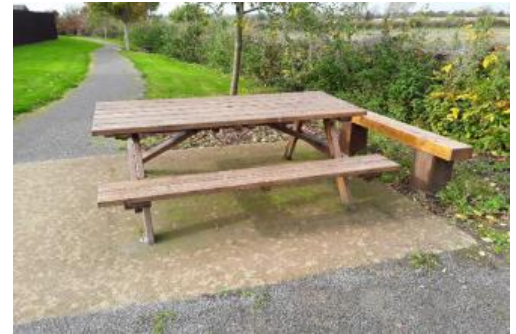
**Item:** Picnic Table  
**Manufacturer:** Not Identified  
**Surface Type:** Concrete  
**Item Quantity:** 1  
**Equipment Compliance:** N/A  
**Surface Area Compliance:** N/A  
**Life Expectancy:** 5 -10 Years  
**Total Findings:** 1

**Finding 1**

This item is satisfactory - no work required -
