Report on the condition of the churchyard retaining wall

Report 2018-07

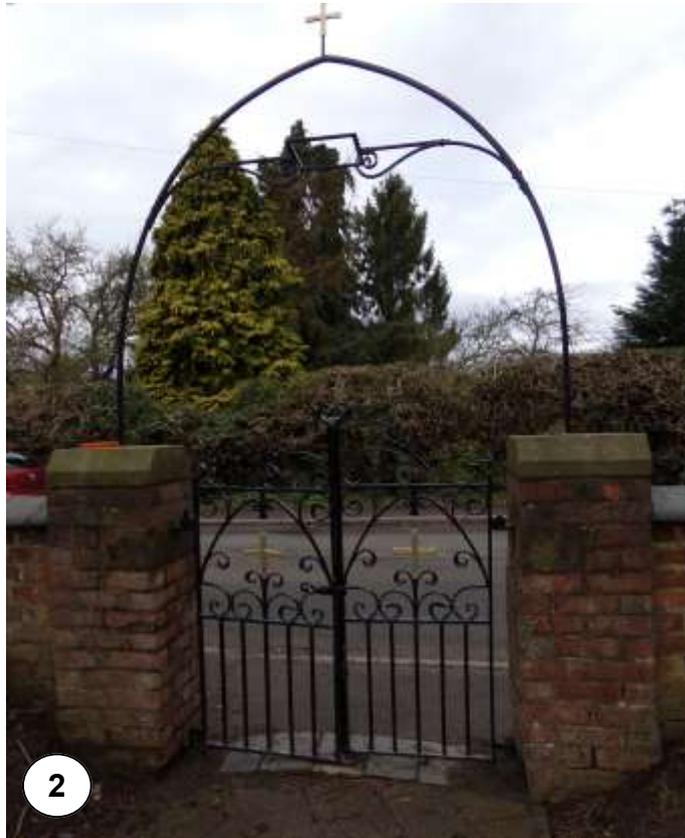
Figures 2-4. 2. Church gates. 3. Gate column patched with modern brick and showing stone cap and hinge bracket support. 4. Lower hinge bracket for western gate showing adjustment ring and decayed brickwork.

The double church gates are wrought iron, and the top hinges are supported by stone blocks. There is a wrought iron arch with a lamp holder over the gateway. The gates do not close, probably because the lower hinge bracket for the western gate has moved.
