## Annual Inspection

Carlton Parish Council

Toddlers Play Area

Carlton Diamond Jubilee Orchard, Nailstone Road /  
Northfields, Carlton, Nuneaton , CV13 0EW

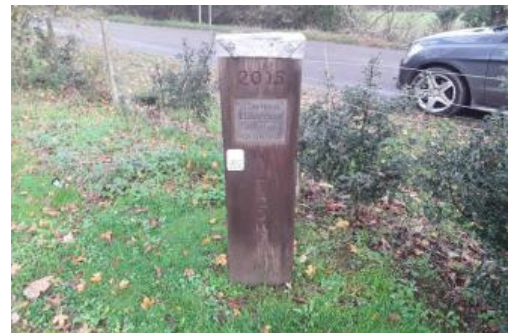
**Item:** Sign  
**Manufacturer:** Owner/Operator  
**Surface Type:** Grass  
**Item Quantity:** 2  
**Equipment Compliance:** N/A  
**Surface Area Compliance:** N/A  
**Life Expectancy:** 5 -10 Years  
**Total Findings:** 1

#### Finding 1

This item is satisfactory - no work required -

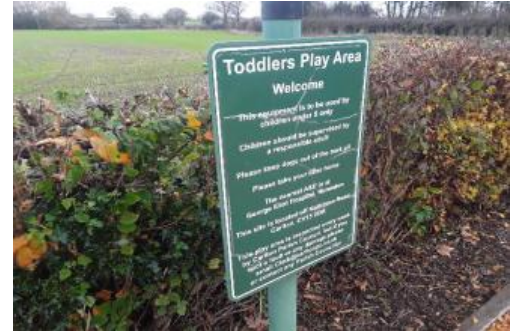
#### Finding 1

This item is satisfactory - no work required -

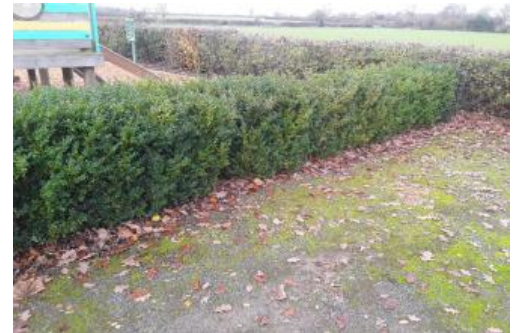
**Item:** Hedge  
**Manufacturer:** Owner/Operator  
**Surface Type:** Grass  
**Item Quantity:** 1  
**Equipment Compliance:** N/A  
**Surface Area Compliance:** N/A

##### Finding 1

This item is satisfactory - no work required -
