Annual Inspection

Carlton Parish Council

Toddlers Play Area

Carlton Diamond Jubilee Orchard, Nailstone Road,
Carlton, Nuneaton , CV13 0BN

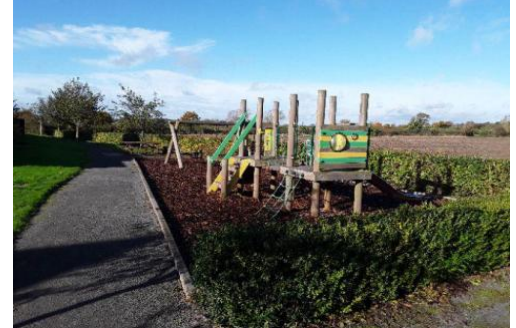
Item: Site General
Manufacturer: Owner/Operator
Surface Type: N/A
Item Quantity: 1
Equipment Compliance: N/A
Surface Area Compliance: N/A

There are trip hazards at the edges of the surface - Reinstate surrounding surface levels to remove the trip points

There is algae, silt or moss growth on the surface resulting in slippery conditions - Clean and treat appropriately

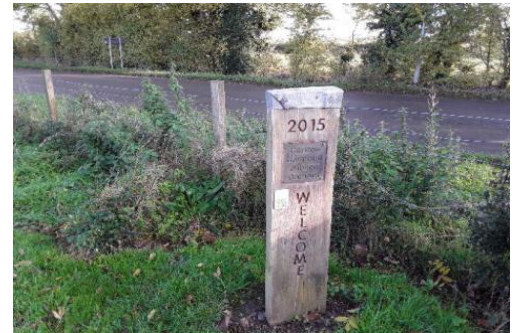
Item: Sign
Manufacturer: Owner/Operator
Surface Type: Grass
Item Quantity: 2
Equipment Compliance: N/A
Surface Area Compliance: N/A

Lead flashing has been used to form a cap on the top of the sign - Refer to the supplier for a toxicology assessment

i 5 - Very Low Risk

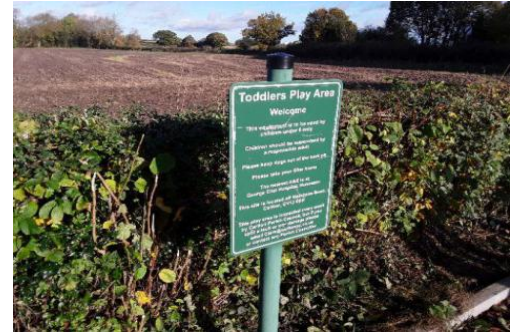
Item: Sign
Manufacturer: Owner/Operator
Surface Type: Woodchip
Item Quantity: 1
Equipment Compliance: N/A
Surface Area Compliance: N/A

BS EN 1176 Part 7 recommends that signage shall include the site name / address - Provide additional information

i 8 - Low Risk

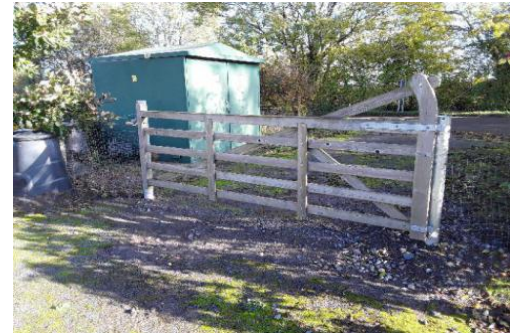
Item: Gate - Maintenance
Manufacturer: Not Identified
Surface Type: Gravel
Item Quantity: 1
Equipment Compliance: N/A
Surface Area Compliance: N/A

i 4 - Very Low Risk

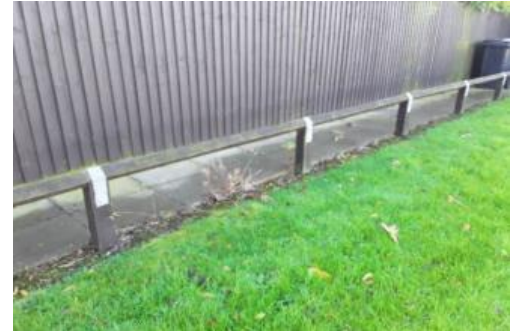
Item: Fencing - Post & Rail
Manufacturer: Not Identified
Surface Type: Grass
Item Quantity: 1
Equipment Compliance: N/A
Surface Area Compliance: N/A

i 4 - Very Low Risk

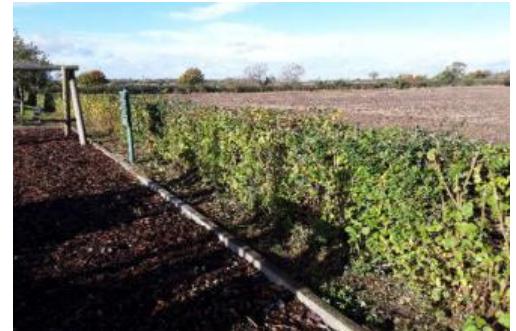
Item: Hedge
Manufacturer: Owner/Operator
Surface Type: Grass
Item Quantity: 1
Equipment Compliance: N/A
Surface Area Compliance: N/A

i 6 - Low Risk

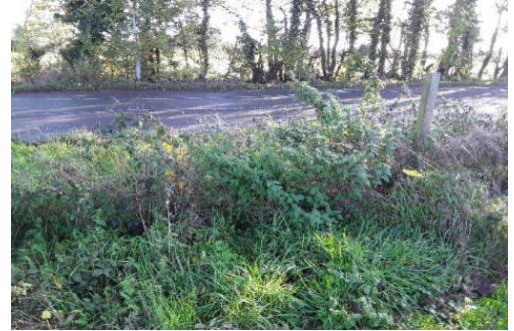
Item: Fence - Timber & Mesh Infill
Manufacturer: Not Identified
Surface Type: Soil
Item Quantity: 1
Equipment Compliance: N/A
Surface Area Compliance: N/A

i 4 - Very Low Risk

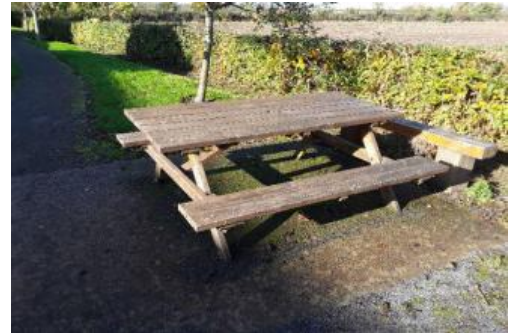
Item: Picnic Table
Manufacturer: Not Identified
Surface Type: Concrete
Item Quantity: 1
Equipment Compliance: N/A
Surface Area Compliance: N/A

i 8 - Low Risk

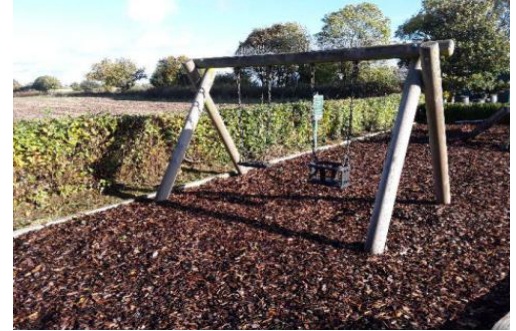
Item: 1 Bay Mixed Seat, 1 Cradle, 1 Flat
Manufacturer: Wicksteed Playgrounds
Surface Type: Bark Mulch
Item Quantity: 1
Equipment Compliance: No
Surface Area Compliance: Yes
Life Expectancy: >10 Years
Total Findings: 6

Bird deterrent spikes have been fitted to the swing and present hazards - Remove and replace with upturned cable ties

There is some notable evidence of chain wear - Monitor for any further deterioration and replace when 40% worn

i 8 - Low Risk

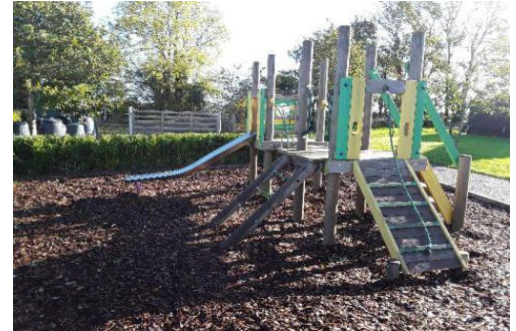
Item: Multi Play (Junior)
Manufacturer: Wicksteed Playgrounds
Surface Type: Bark Mulch
Item Quantity: 1
Equipment Compliance: No
Surface Area Compliance: No
Life Expectancy: >10 Years
Total Findings: 5

The raised timber edging forms a hard object within the impact area of the equipment in contravention of the requirements of BS EN 1176 Part 1 - Monitor - No remedial work recommended
