## Carlton Stone in the Bosworth Area

From Aspect, April 2023, Vol.32, No.7, p.3-5.

#### Carlton Stone In the Bosworth Area

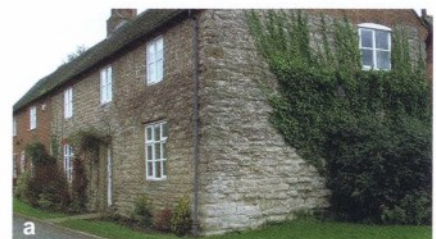
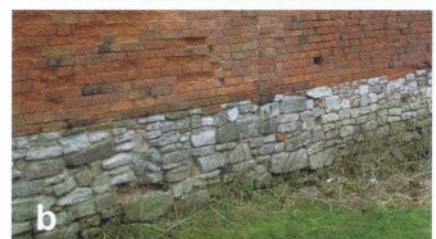
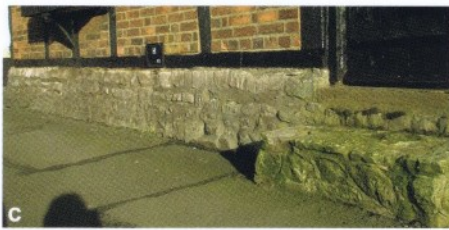
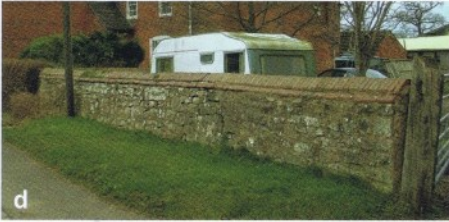
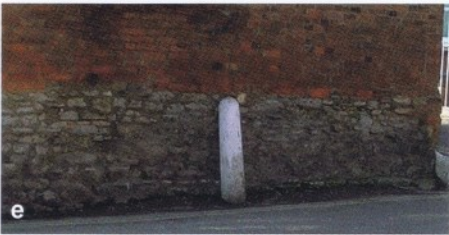
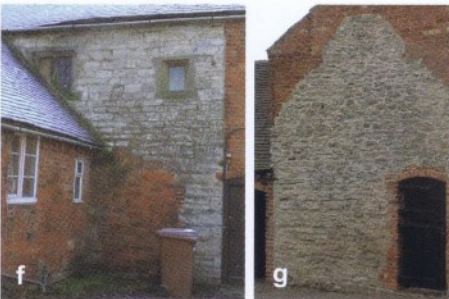
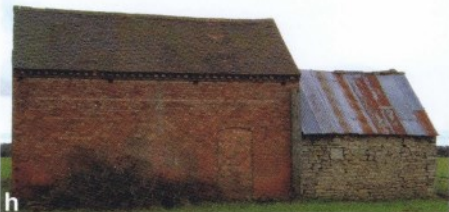
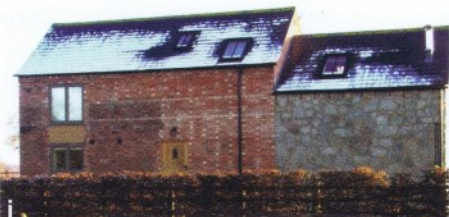
barn between Sutton Lane and Far Coton Lane photographed in 2006 (h) and 2022 (i), after conversion into a dwelling. There are more examples shown in the second picture montage featuring Congerstone, Barton in the Beans, Sutton Cheney and Shenton.

(a) The Stone House, Carlton; (b) Barn at Manor House Farm, Carlton; (c) Building plinth, Rotary Cottages, Mkt Bosworth; (d) Boundary wall, Manor House Farm, Carlton; (e) Rainbow Cottage, Mkt Bosworth; (f) Central section, Manor House Farmhouse, Carlton; (g) Gable wall of former barn preserved in later brickwork, Friezeland Farm, Mkt Bosworth; (h and i) Field

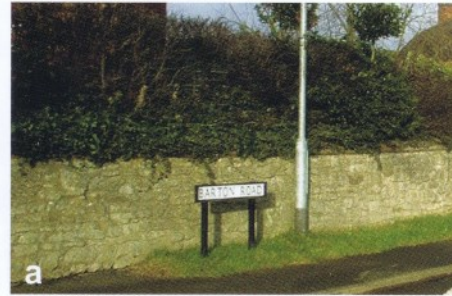
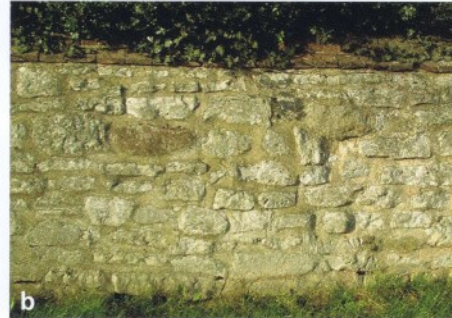
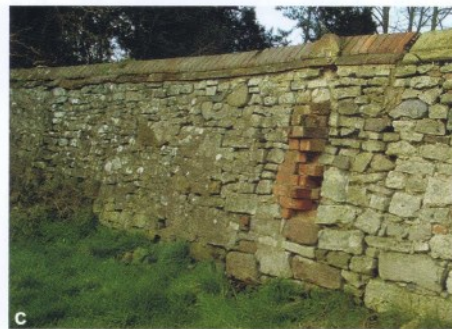
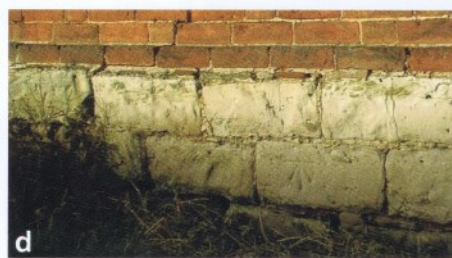
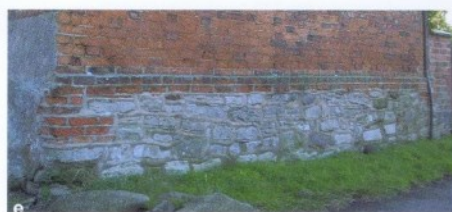
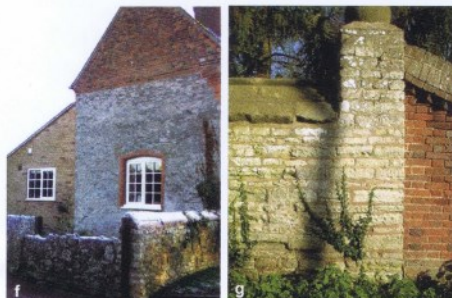
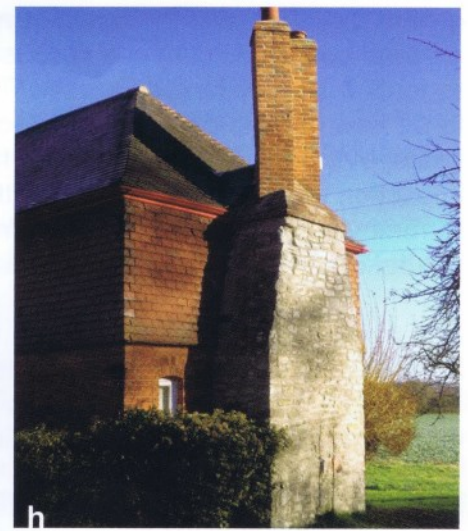
The legend for these follows:

(a-b) Garden wall, Barton Road, Congerstone. The stone is laid in irregular courses, and some of the stones are rounded, suggesting that they were picked from the fields; (c) Photograph taken in 2006 of the wall on the northern side of the car park at Congerstone Village Hall. This wall included bricks and exotic boulders and showed sections which had been repaired or rebuilt at different times, sometimes without mortar. The section of wall nearest the camera has now been re-built and the remainder re-pointed; (d) Base of barn wall at Grange Farm, Barton in the Beans, built of cut blocks laid in courses. Note the Ordnance Survey bench mark in the centre; (e) Barn plinth, Ivy Lodge, Main St, Sutton Cheney; (f) Gable wall of Fox Covert Farmhouse, Congerstone; (g) Wall to The Hall, Cadeby. Here the gateway, pillars and highway boundary wall are a very fine example of Carlton Stone construction, using split stone in regular courses; (h) Projecting fireplace and chimney, Aqueduct Cottage, Shenton Lane.

Many boundary walls in Congerstone are built of Carlton Stone, and are identified as an important visual feature of the Conservation Area. Some of these walls contain blocks and boulders of other stone, no doubt picked from the fields. To preserve the character of the area, some

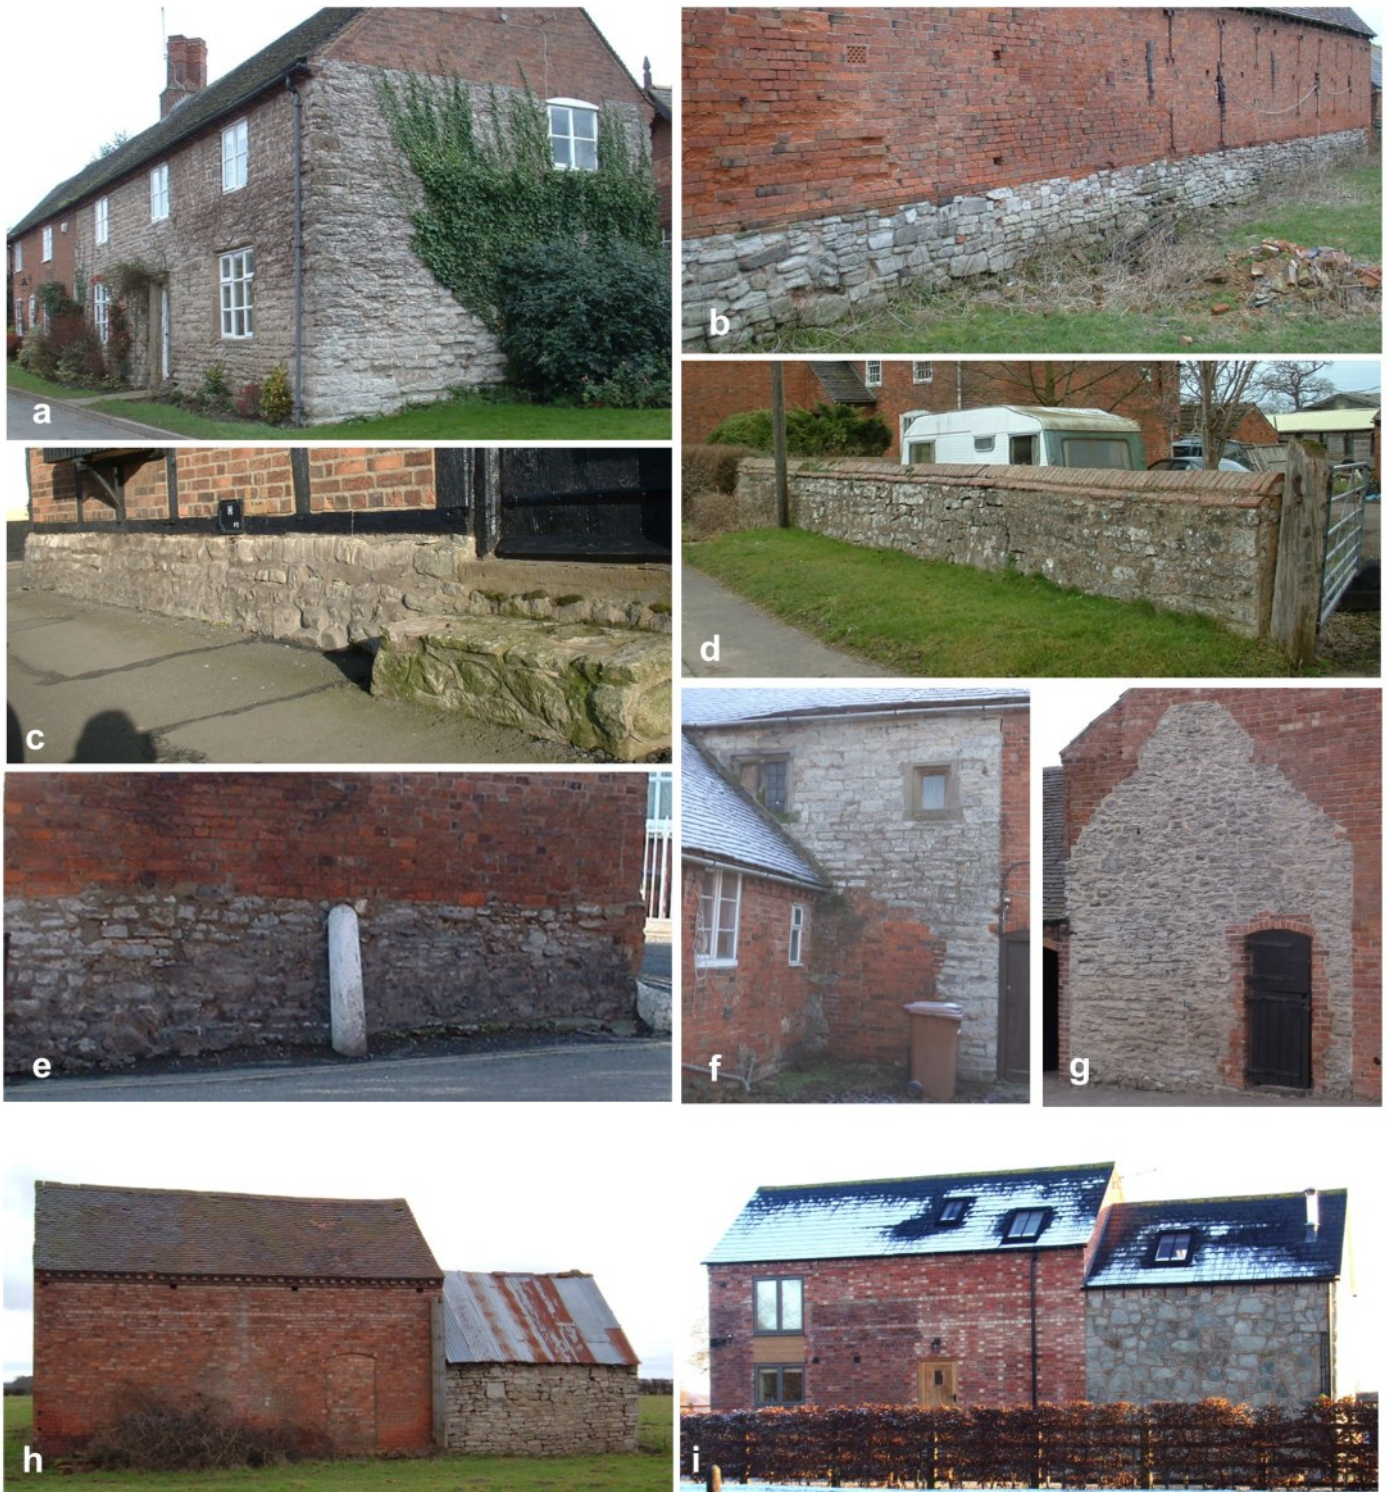
**Plate 1 (above)**

a) The Stone House, Carlton; b) Barn at Manor House Farm, Carlton; c) Building plinth, Rotary cottages, Mkt Bosworth; d) Boundary wall, Manor House Farm, Carlton; e) Rainbow Cottage, Mkt Bosworth; f) Central section, Manor House Farmhouse, Carlton; g) Gable wall of former barn preserved in later brickwork, Friezeland Farm, Mkt Bosworth; h, i) Field barn between Sutton Lane and Far Coton Lane photographed in 2006 (h) and 2022 (i), after conversion into a dwelling.

The central part of the farmhouse at Manor House Farm is built of Carlton Stone, and is possibly much older than the 17<sup>th</sup> century date ascribed to it in the Register of Listed Buildings. Probably best-known to walkers, Westfields Farmhouse, is built of Carlton Stone, while a recent extension was faced with reclaimed Carlton Stone and is in keeping with the older farmhouse. A recently built wall between the farmhouse and the farmyard was constructed of Carlton Stone scavenged from older farm buildings and the fields. Near to the footpath between Carlton and Market Bosworth, Harcourt Mill is built of Carlton Stone.

At Friezeland Farm, the gable wall of an old farm building has been preserved in the wall of a later brick barn. Between Shenton Lane and Far Coton Lane a brick field barn had a section built of Carlton Stone. When this was converted into a dwelling, the Carlton Stone was reclaimed, cut into slabs, and used as a cladding on the western part of the house. The slabs were

cut parallel to bedding, resulting in a striking new use of this ancient local material.

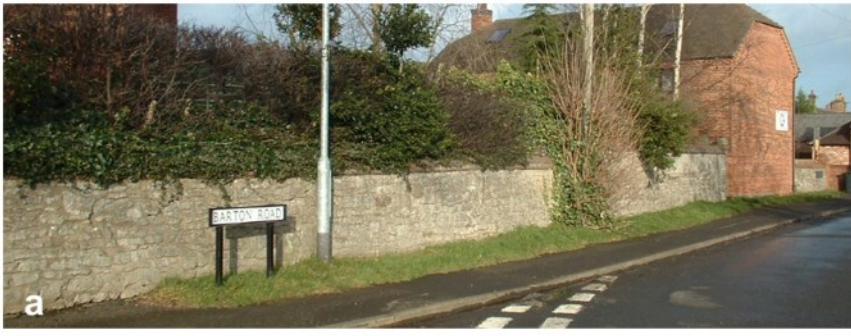
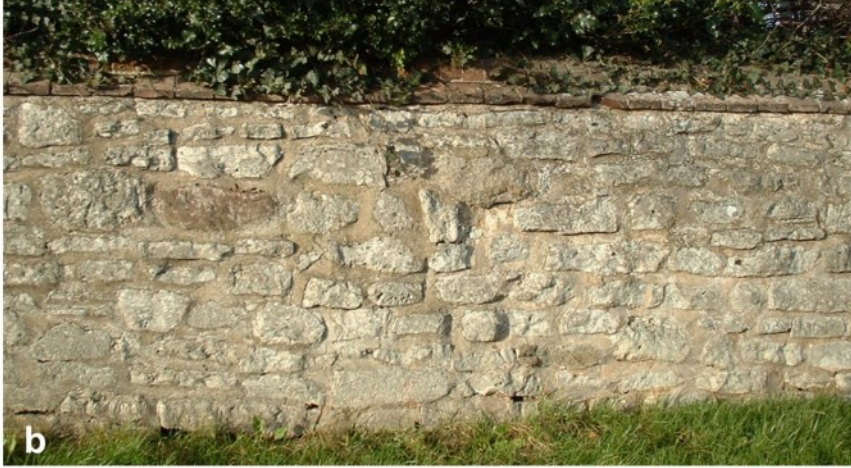
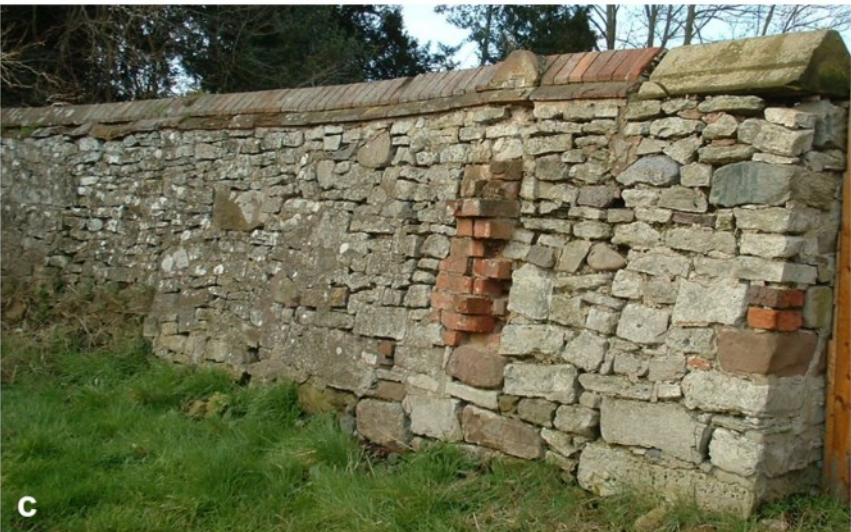
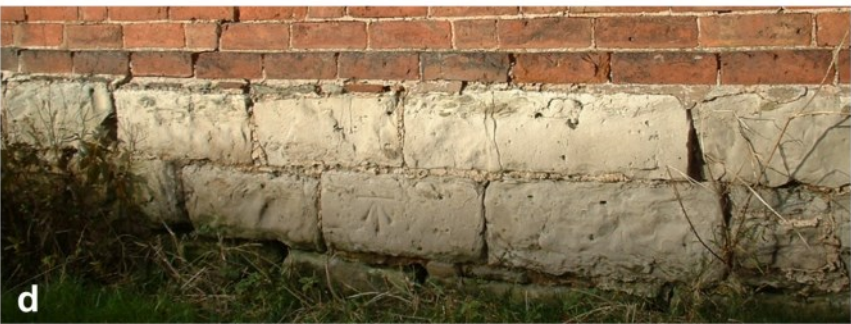
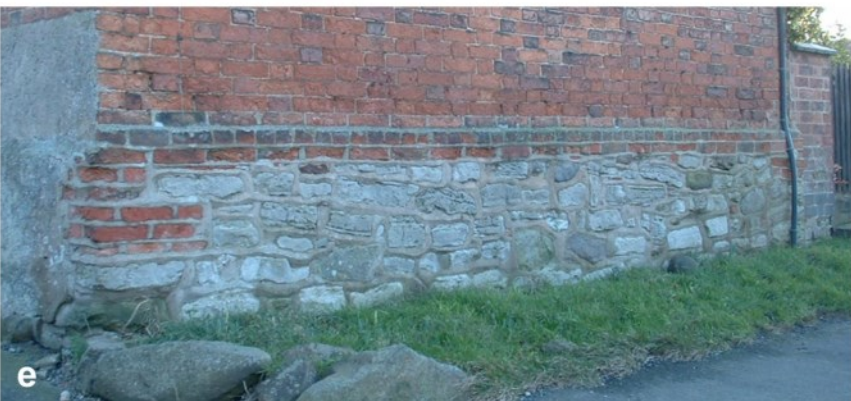
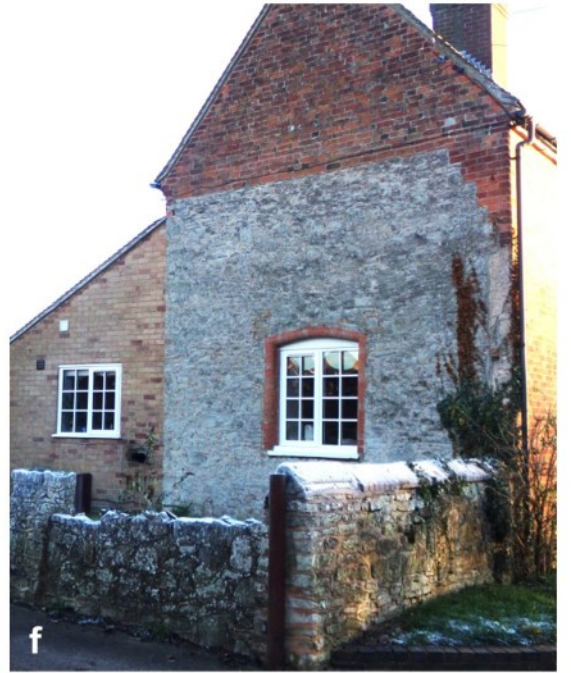
**Plate 2 (overleaf)**

a-b) Garden wall, Barton Road, Congerstone. The stone is laid in irregular courses, and some of the stones are rounded, suggesting that they were picked from the fields; c) Photograph taken in 2006 of the wall on the northern side of the car park at Congerstone Village Hall. This wall included bricks and exotic boulders and showed sections which had been repaired or rebuilt at different times, sometimes without mortar. The section of wall nearest the camera has now been re-built and the remainder re-pointed; d) Base of barn wall at Grange Farm, Barton in the Beans, built of cut blocks laid in courses. Note the OS bench mark in the centre; e) Barn plinth, Ivy Lodge, Main St, Sutton Cheney; f) Gable wall of Fox Covert Farmhouse, Congerstone; g) Wall to The Hall, Cadeby. Note the accurate coursing using split blocks. h) Projecting fireplace and chimney, Aqueduct Cottage, Shenton Lane.

new walls, for example on the southern side of Barton Road, have been built of a different stone which has a similar appearance. Carlton Stone can also be seen in the northern gable wall of Fox Covert Farmhouse, and in many building plinths. The front of 'The Horse and Jockey' is rendered, but the western gable wall (apart from the chimney) is built of Carlton Stone. Around Carlton itself, the stone is best displayed in The Stone House, 24 Main Street, the farmyard wall next to the road at Manor House Farm, 45 Main St, and in the footings of the adjacent barn at right angles to the road. There is also some Carlton Stone in the footings of Church Cottage (38 Main St) across the road. The wall in front of 40 Main St next door to Church Cottage is not of Carlton Stone, but the closest look-alike that could be found when this new house was built, and is very much in keeping with its surroundings.
